## CCT/23 CS 454 Assessment and Inspection Report

### A675 Bolton Road Bridge, Lancashire

**National Highways – Historical Railways Estate**  
VAR9/7070

**HRE Assessment Programme**  
April 2023

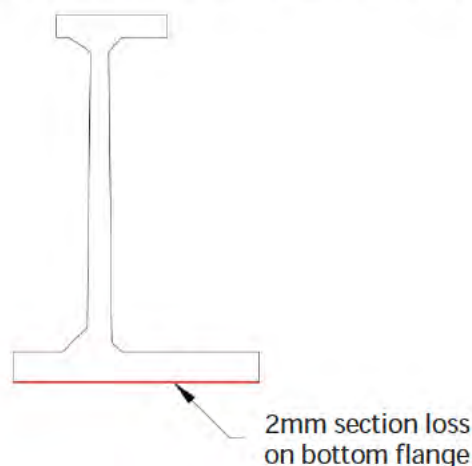
Figure 5: Section loss on edge girder

There is full paint loss to the bottom flanges with moderate lamination and pitting corrosion to the underside. Corrosion was observed along the full length of the girder. Section loss up to 2mm deep was recorded at midspan.

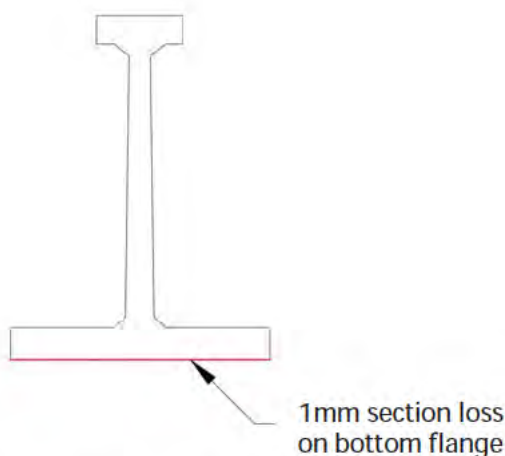
Figure 6: Section loss on internal girder

The internal girders are in a fair condition (Photograph 6, 18 and 19) though there is moderate corrosion along the underside of the bottom flanges. De-lamination and pitting corrosion are evident along the full length of the girders. Section loss up to 1mm was recorded.

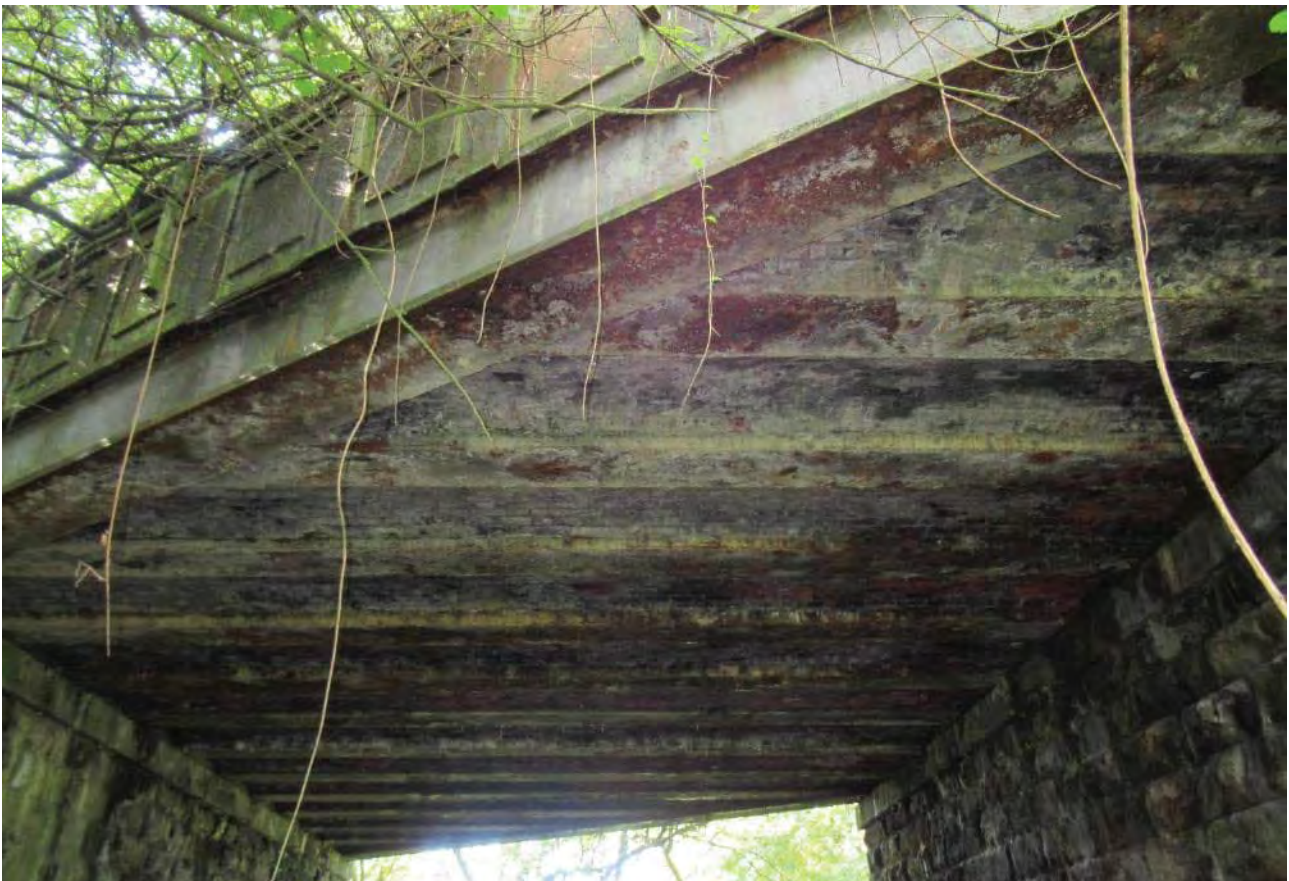
The edge girders are in a fair condition (Photograph 6 and 18). There is paint loss to the outer face of the webs with the exposed cast iron exhibiting minor corrosion.

6. General soffit view

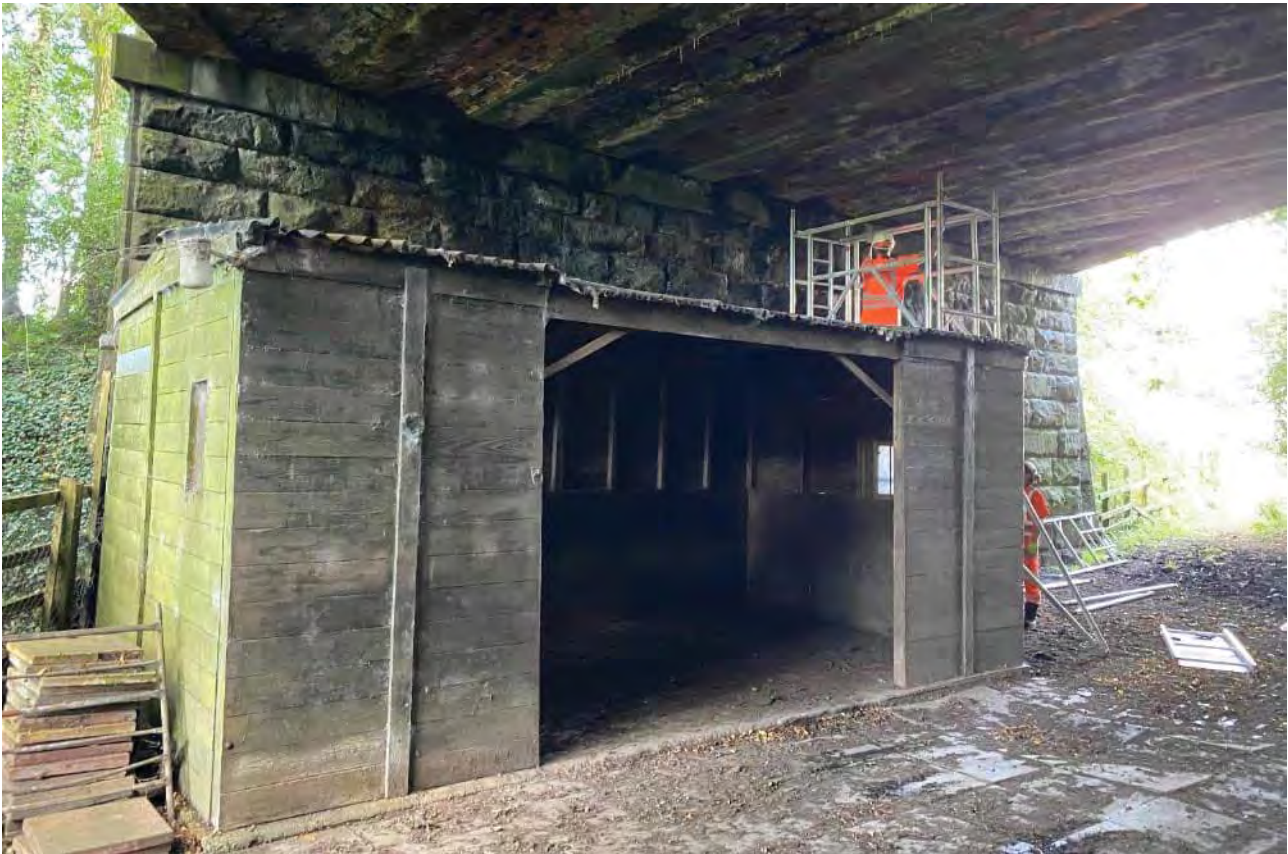
Both abutments are in a fair condition (Photograph 7 and 8). The western half of the north abutment is not visible due to the horse stable which has been built in the formation. Water staining and damp areas are present throughout the visible areas of both abutments and is concentrated around the bearing stones. The walls exhibit isolated areas of calcite staining.

7. North abutment

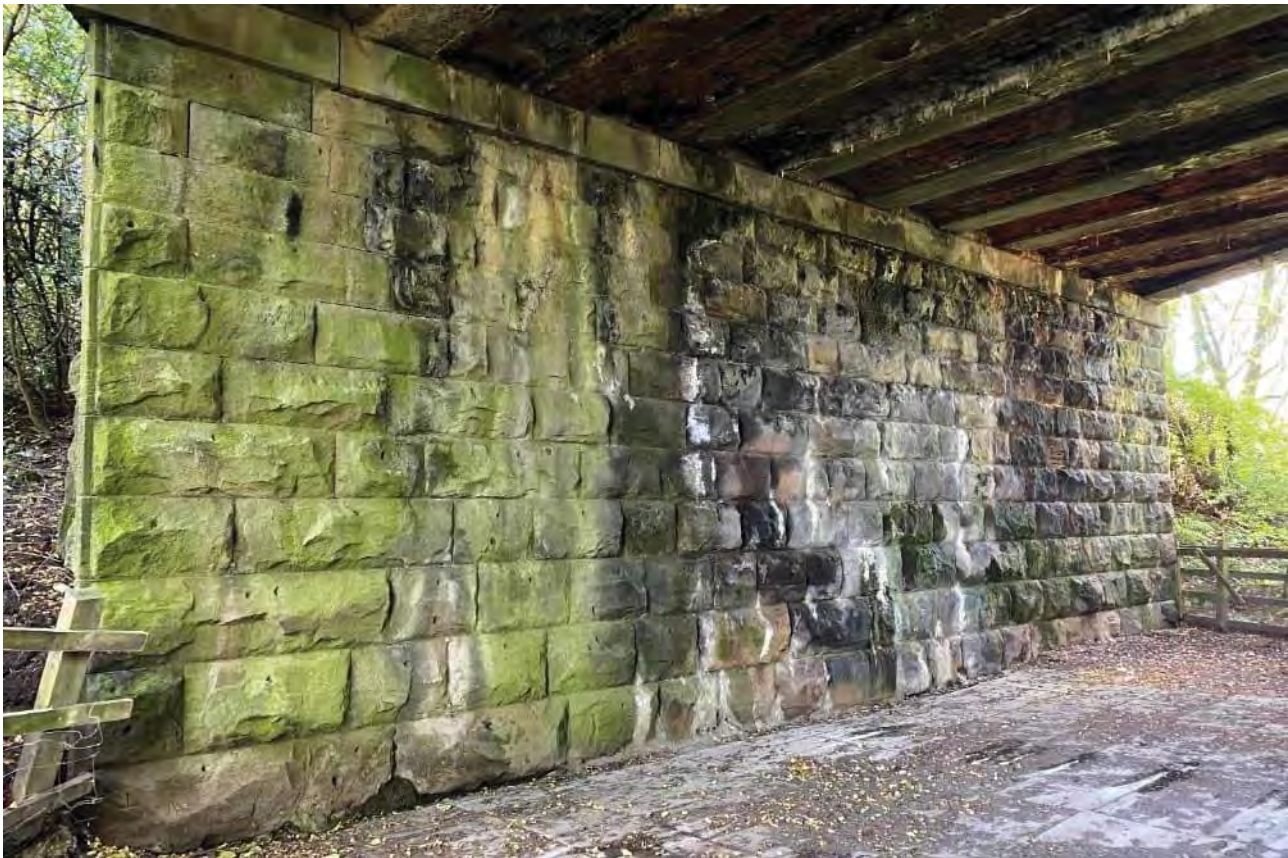
8. South abutment

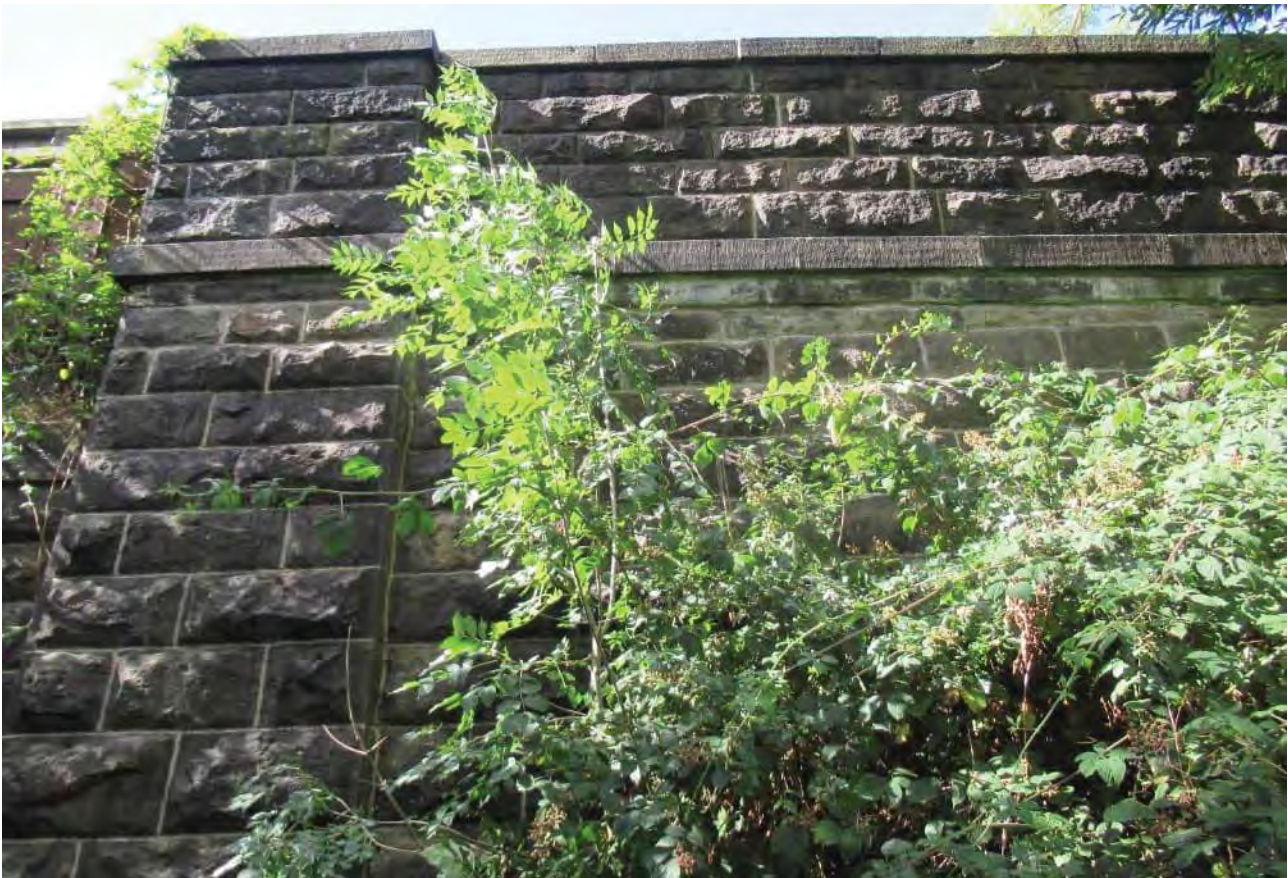
The north east wingwall is partially obscured by vegetation. There is light vegetation growth on the bearing shelf. Joints are well filled throughout the wall. There is a crack through a mortar tab located on the pilaster return dated 31.10.09 (Photograph 15).

9. North east wingwall

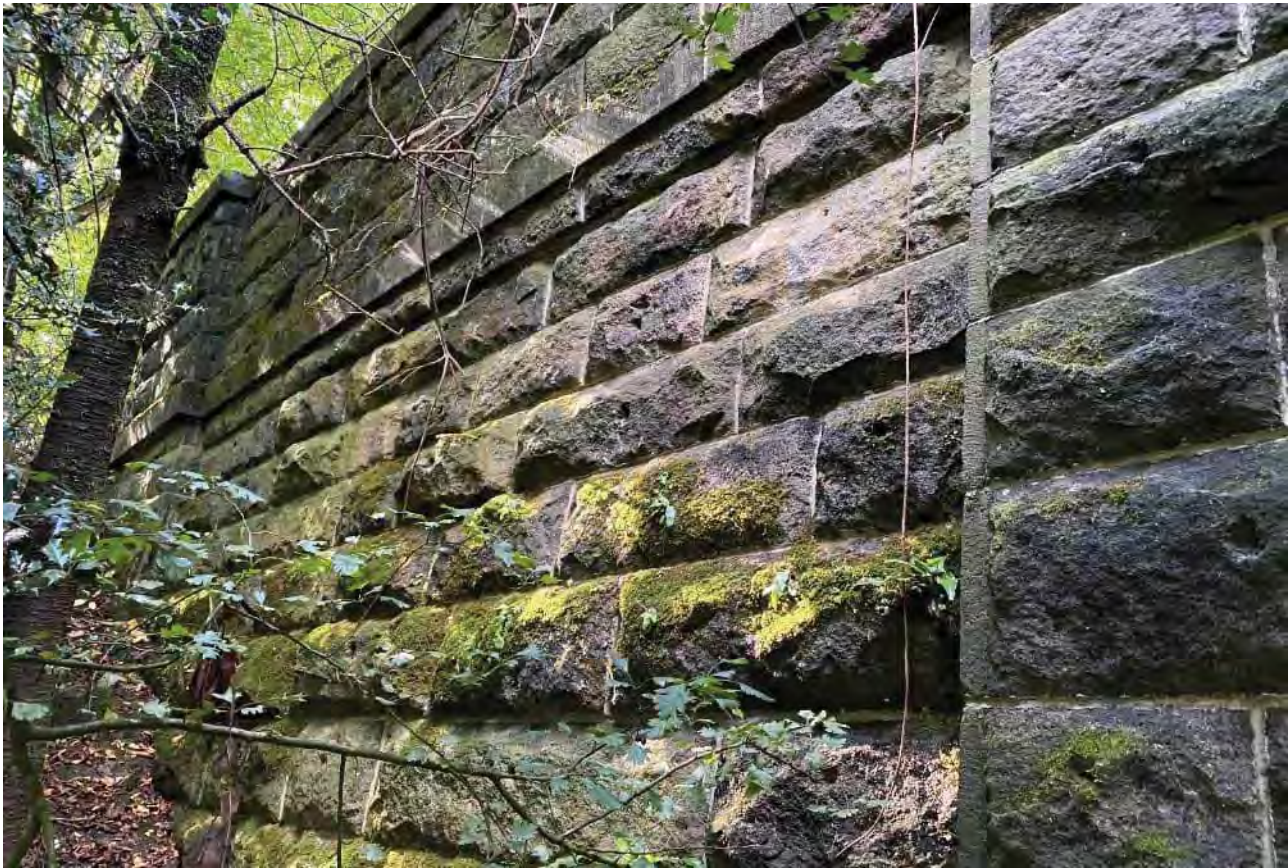
10. South east wingwall

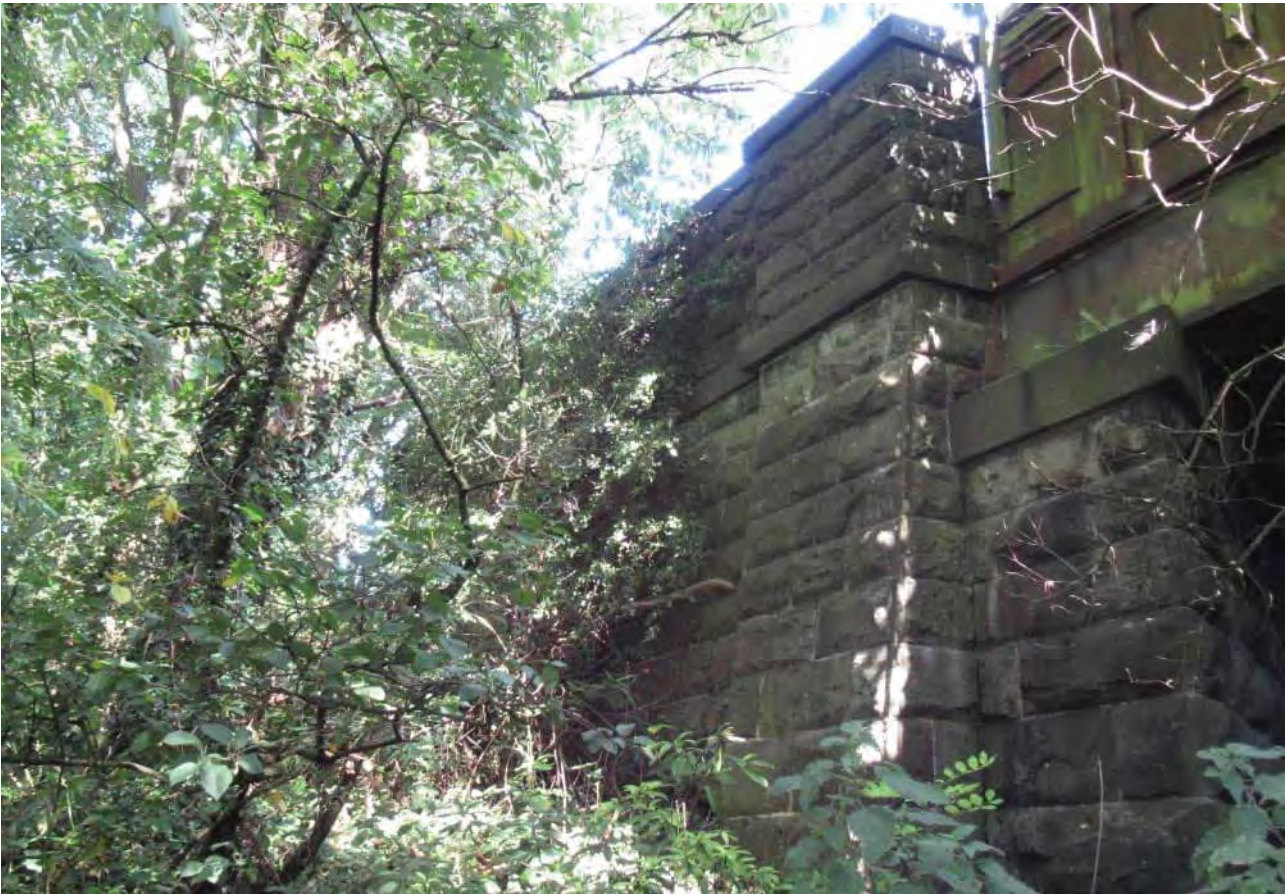
The north west wingwall is only partially visible due to vegetation and tree growth. Ivy growth covers the bottom two courses of the wall. The visible areas of the wall are in a fair condition.

11. North west wingwall

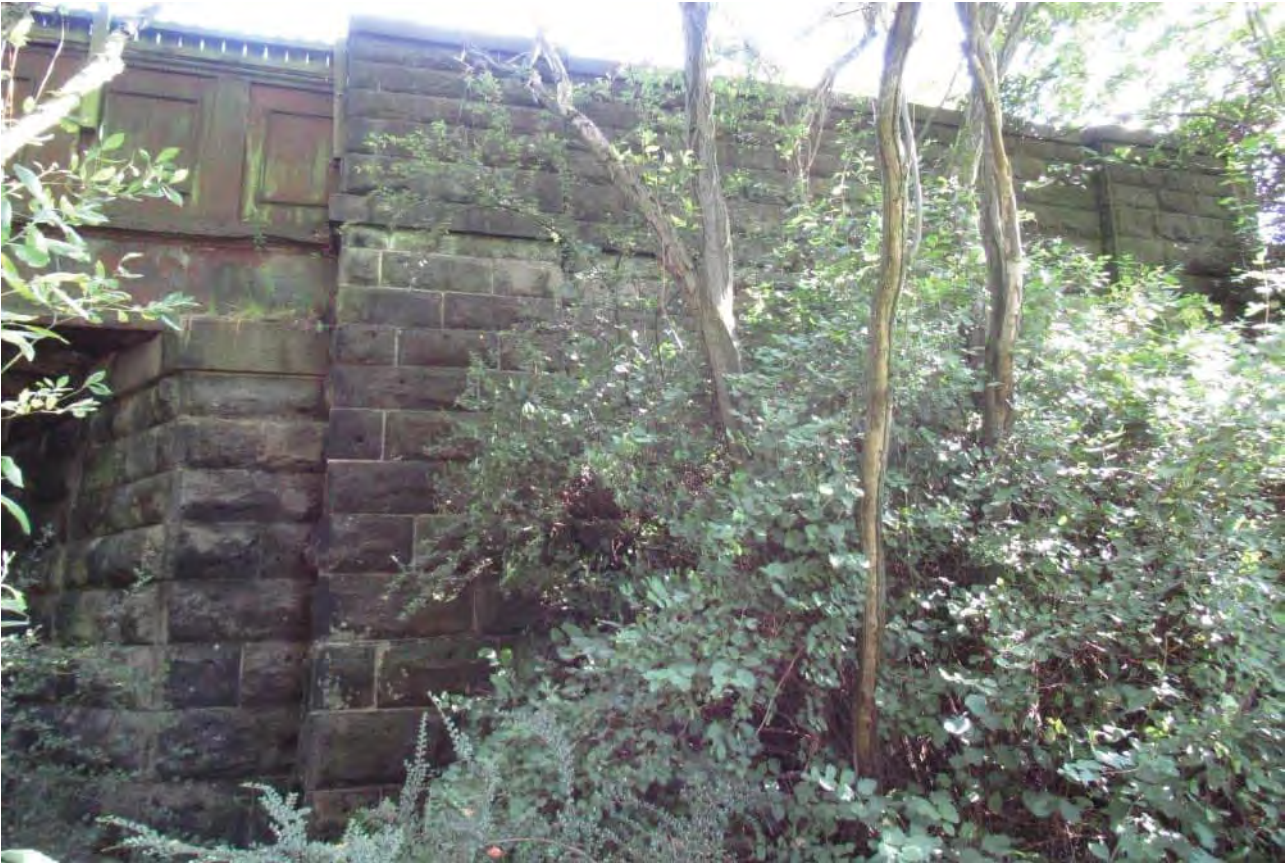
12. South west wingwall

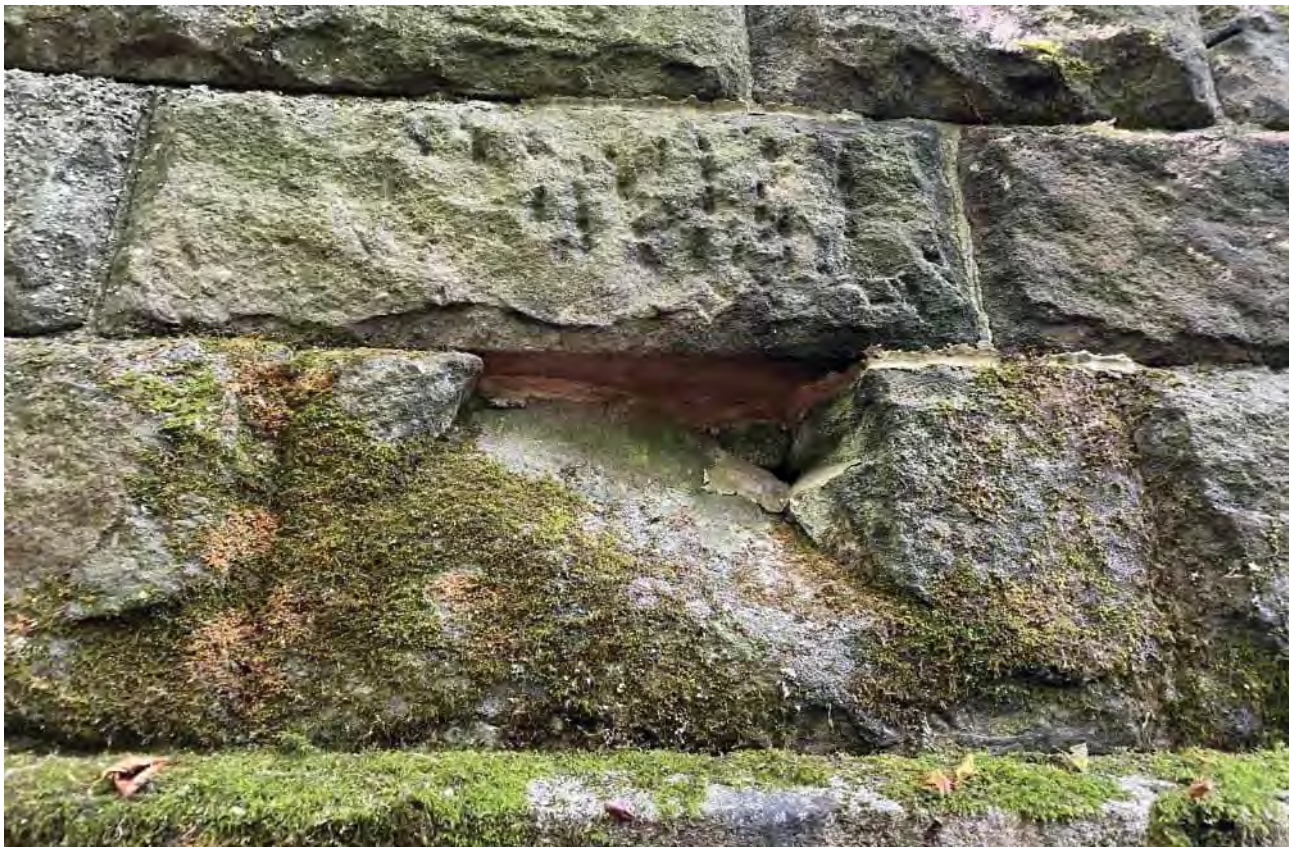
On the south east wingwall there is an individual brick spalled to a depth of 200mm located above string course (Photograph 13). There is widespread moss growth and algal staining across the wall. Joints are well filled though there are isolated areas of vegetation growth in some joints (Photograph 14).

13. Spalling to south east wingwall

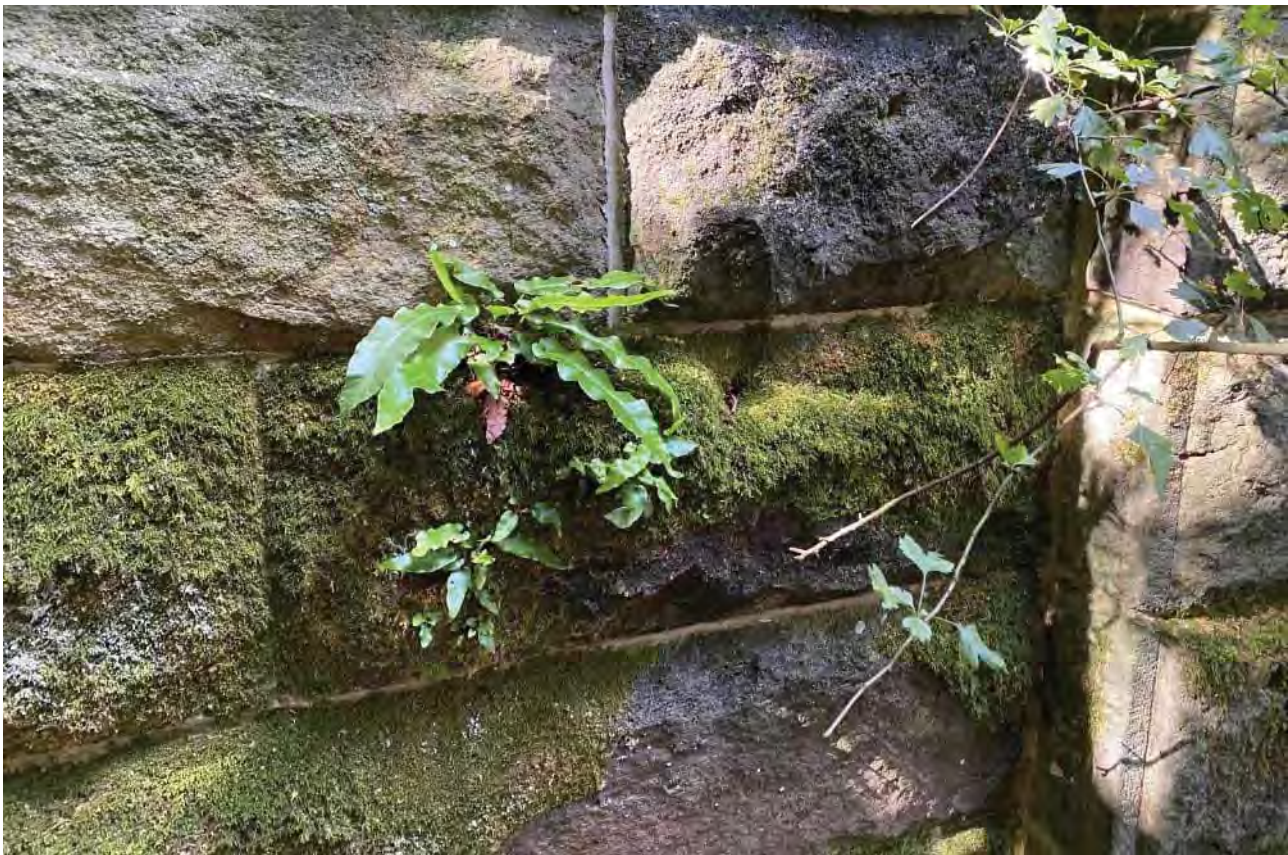
14. Vegetation in joints on south east wingwall

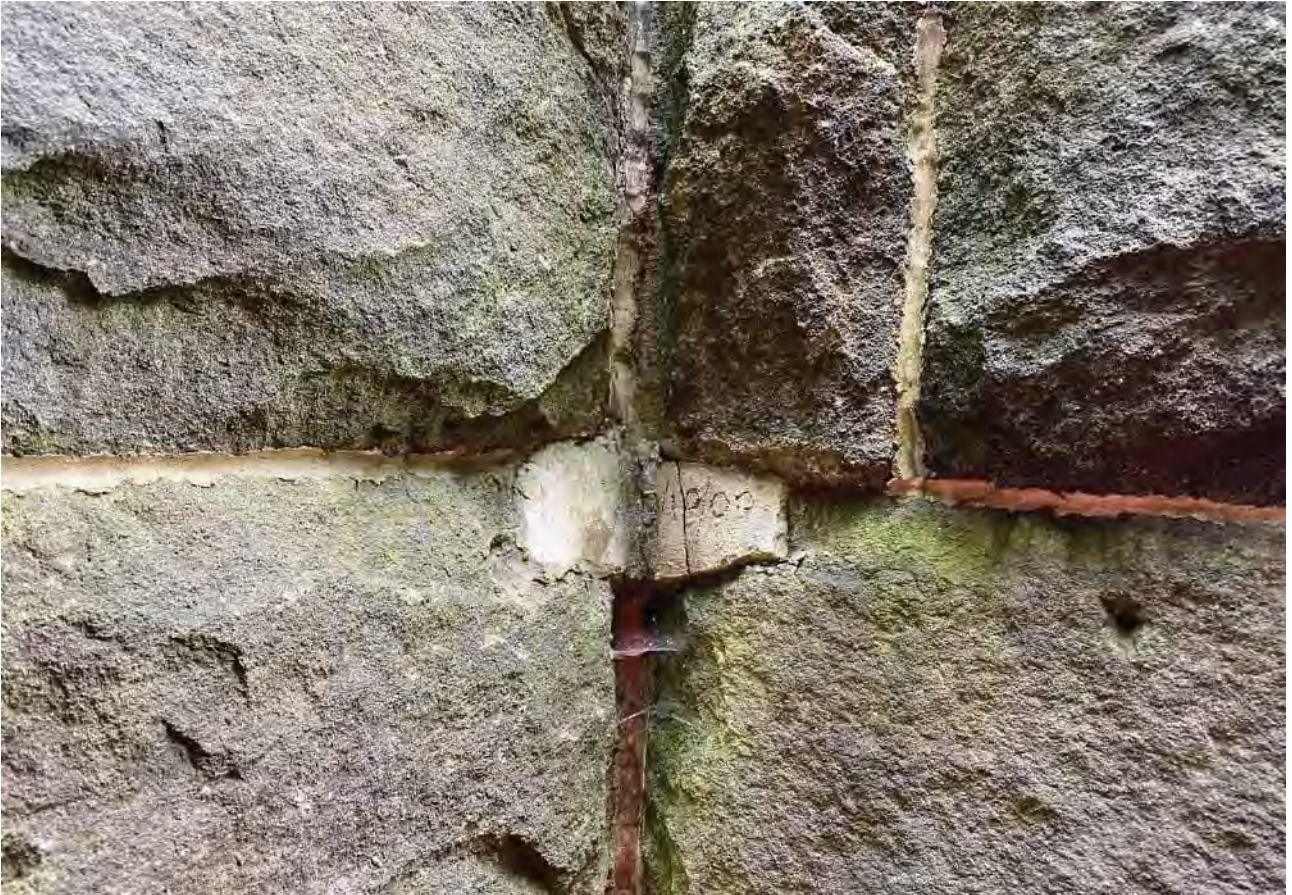
15. Fracture through mortar tab on north east pilaster return

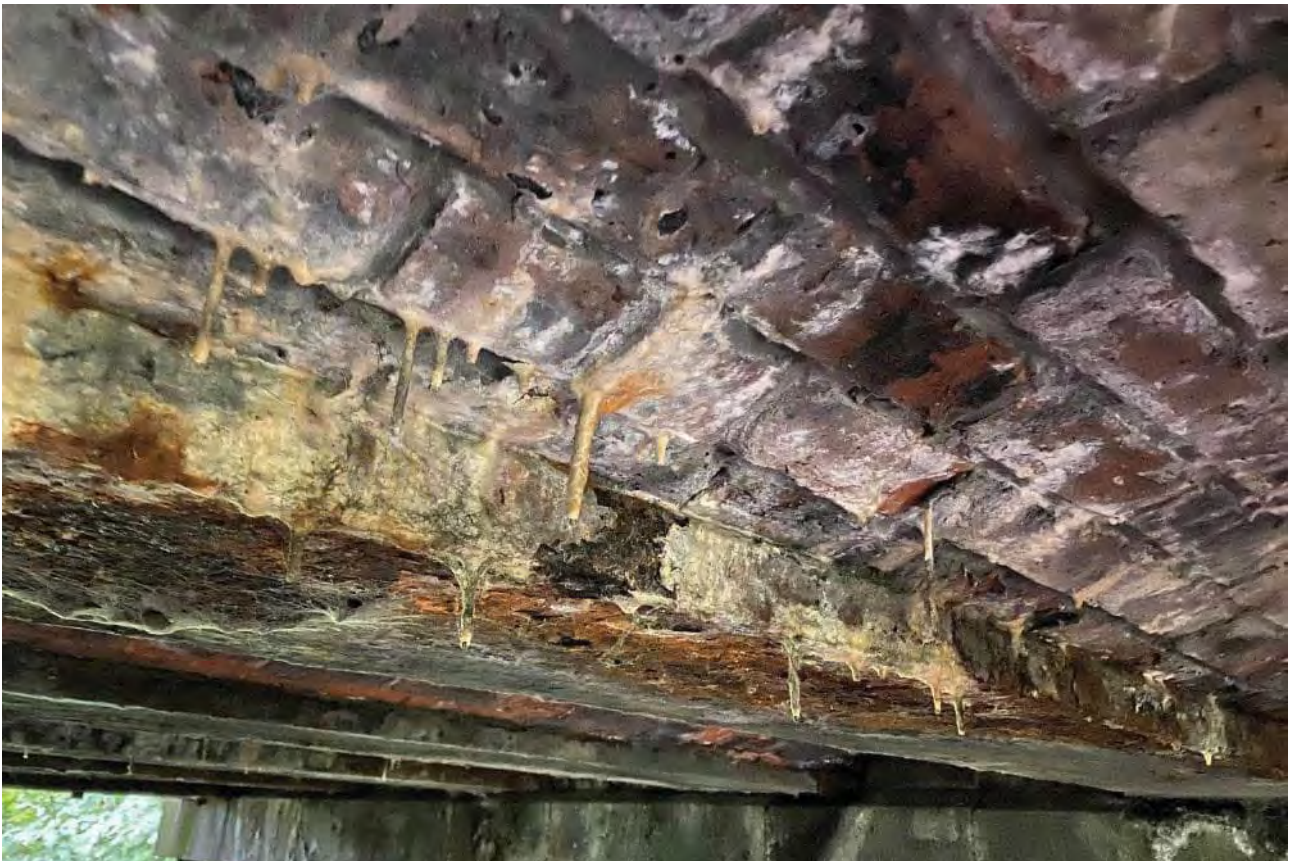
Calcite deposits and stalactite formations are visible below the steel and jack arch interface (Photograph 16). This suggests the bridge waterproofing has been locally compromised with active seepage occurring through the bridge deck.

16. Calcite deposits and stalactite formations on jack arches

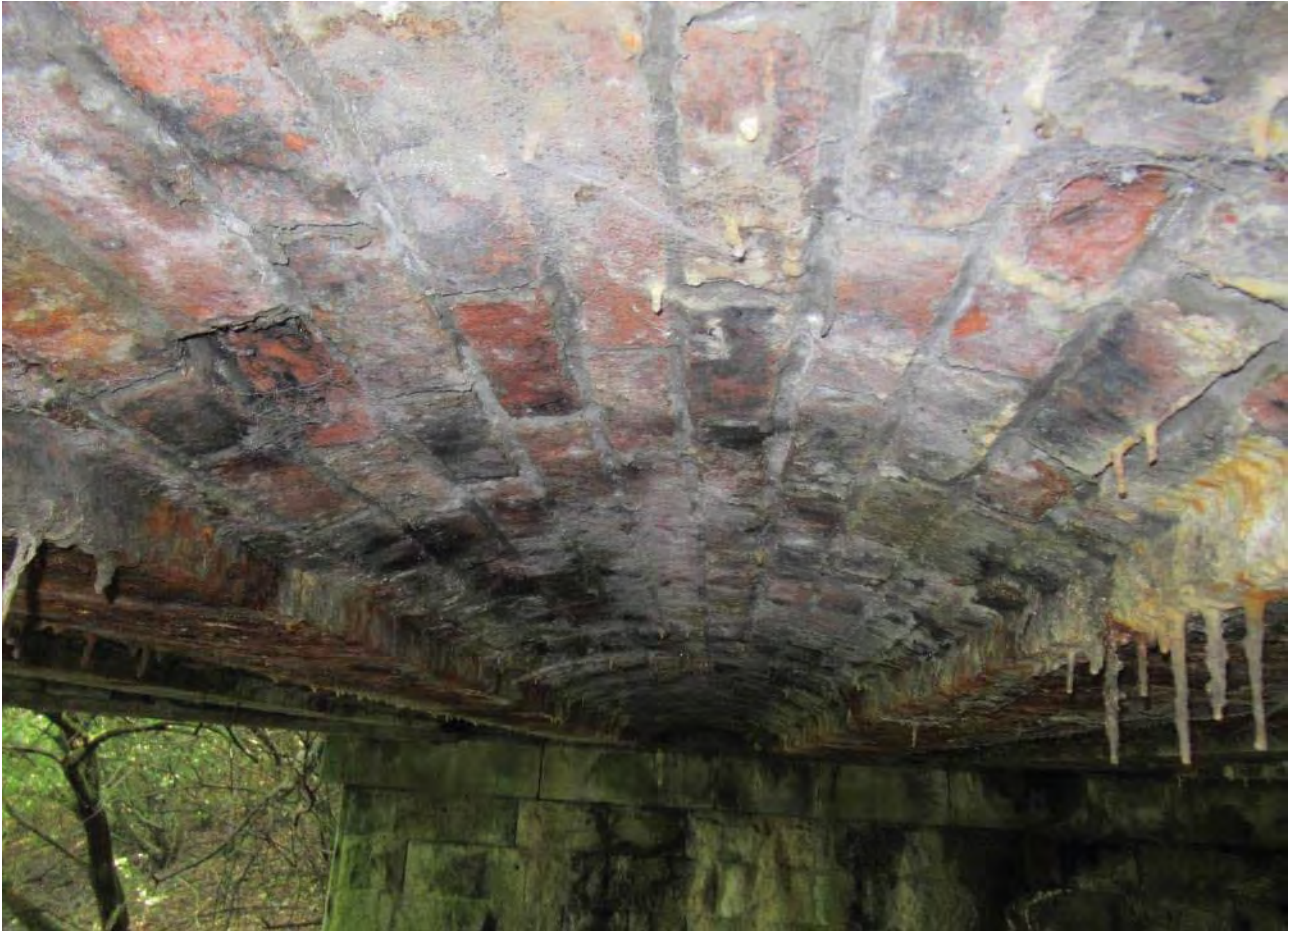
The jack arches located below the carriageway are in a fair condition. Several of the jack arches display a distorted profile with two courses out of line at the most severe location (Photograph 17). In a number of bays, the jack arch rise appears flattened. Isolated areas of displaced brickwork were noted.

17. Jack arch profile distortion

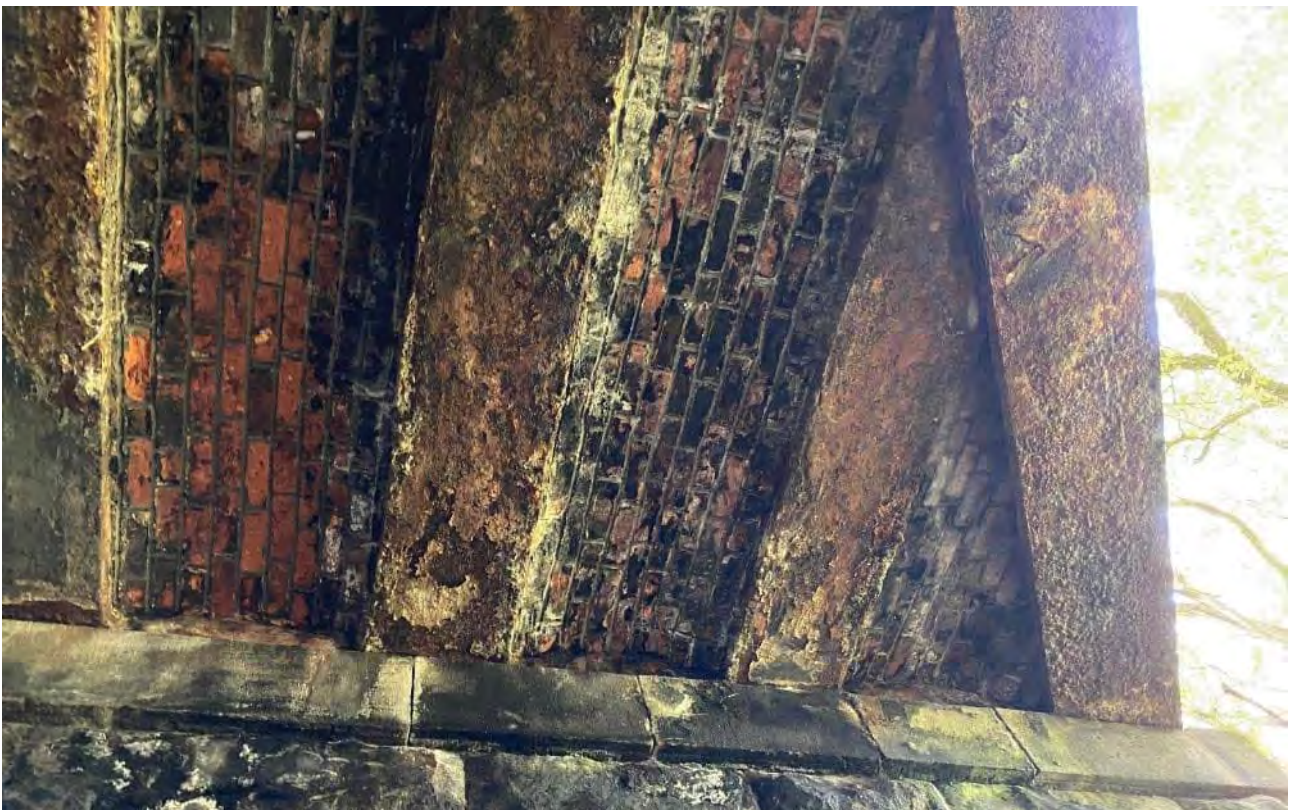
18. Corrosion to edge and internal girders

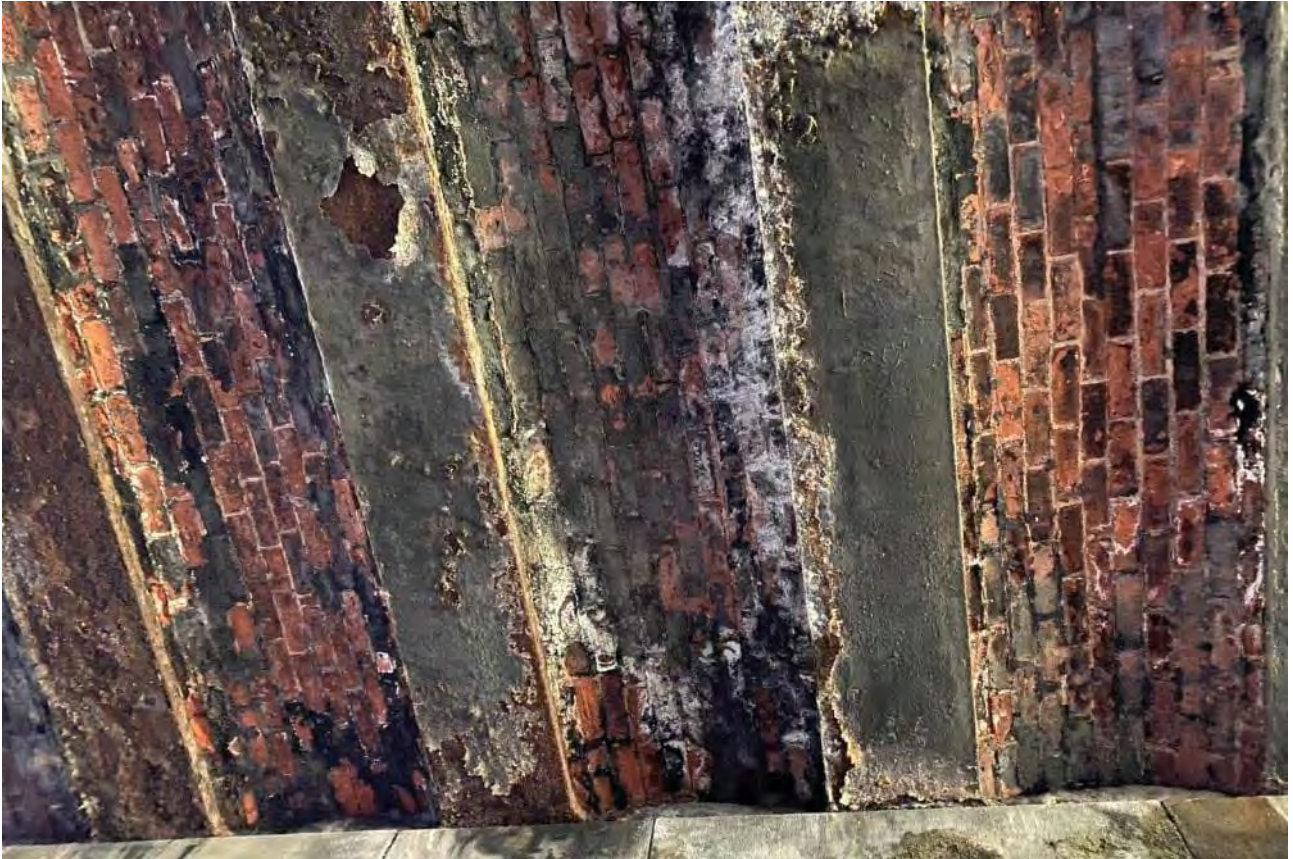
19. Corrosion to internal girders

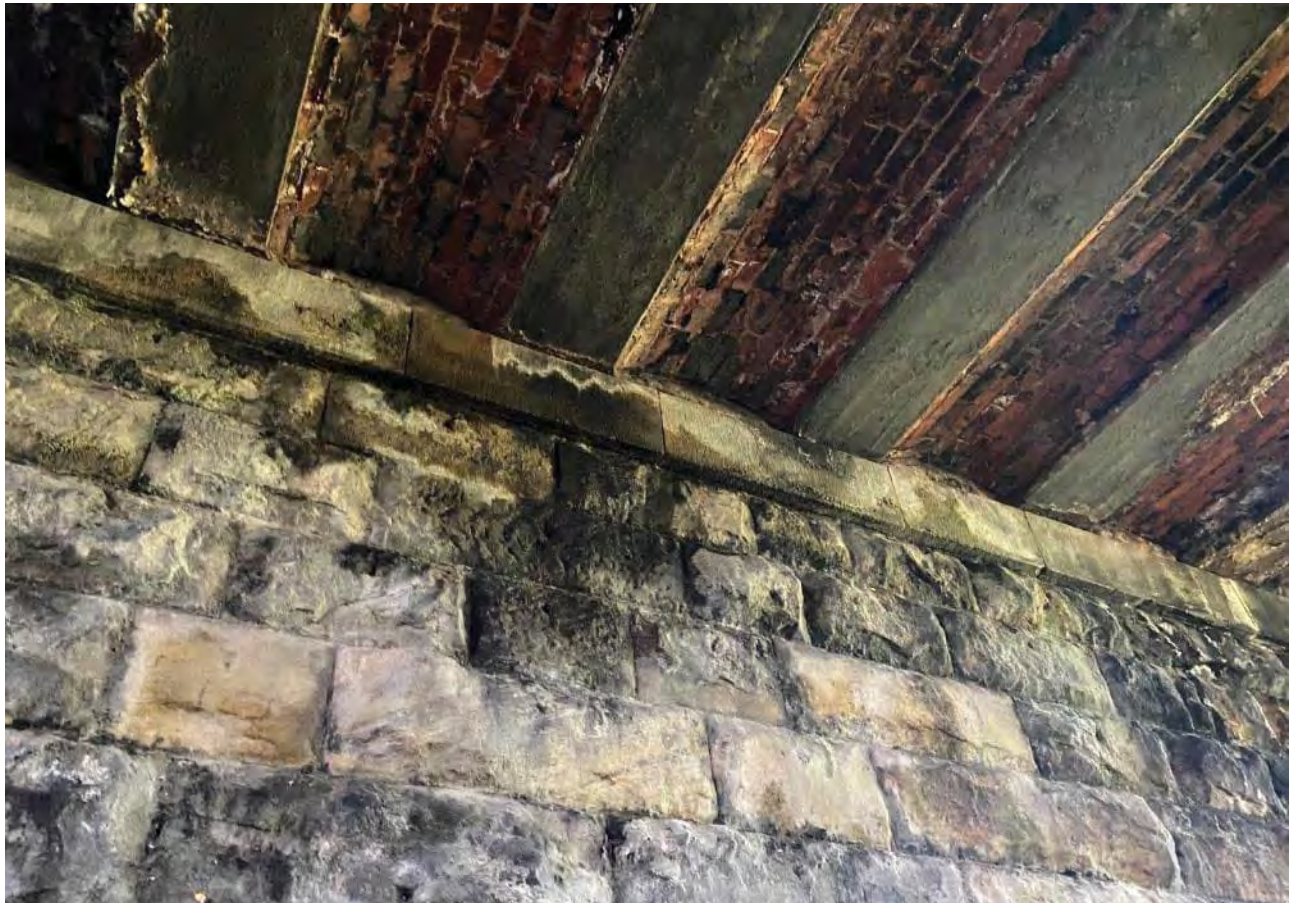
20. Damp on padstones

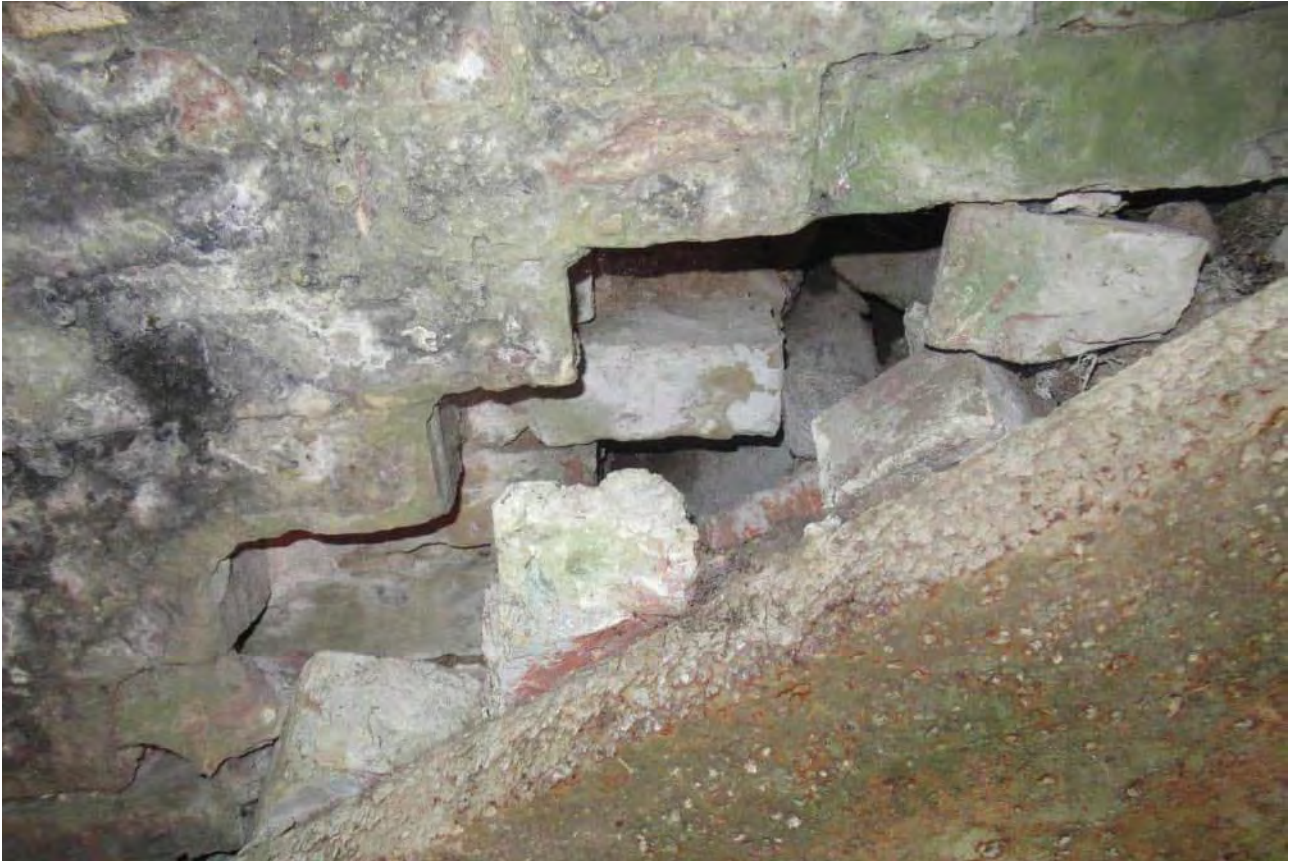
Several missing bricks were noted in the skewed corner of the north east end jack arch at the connection between the jack arch and edge girder. The arch has partially collapsed with the fill below the verge visible through the hole in the arch (Photograph 21). This jack arch is in a poor condition.

The jack arch in the skewed north east corner has partially collapsed. There is a wide verge at this point, so the damaged section would only be affected by extreme positioning of accidental vehicle loading.

21. Partially collapsed jack arch at north east corner of bridge soffit

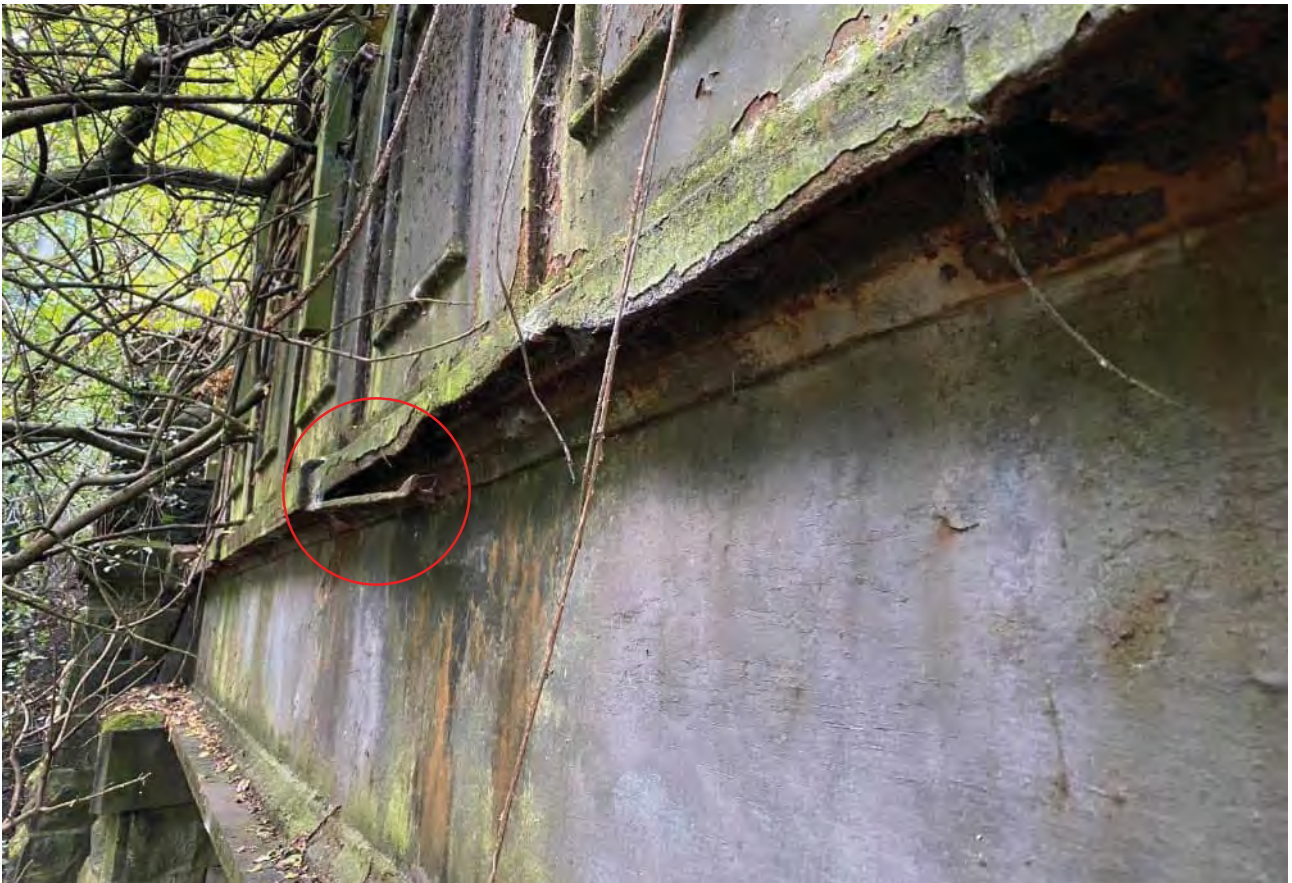
22. Fracture to top flange of edge girder

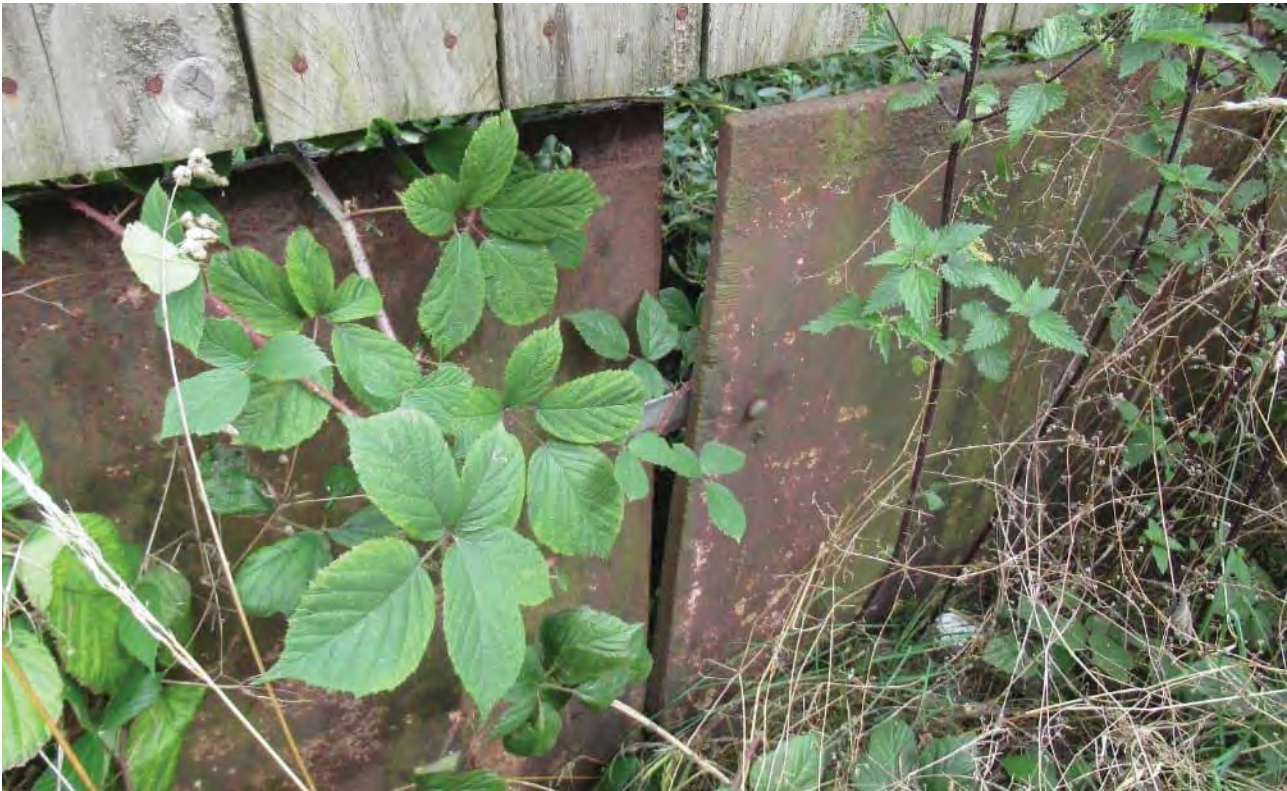
The cast iron parapets exhibit paint loss and minor corrosion throughout (Photograph 25 and 26). There are displaced panels on both the east and west parapets (Photograph 23 and 24).

23. Displaced parapet panels

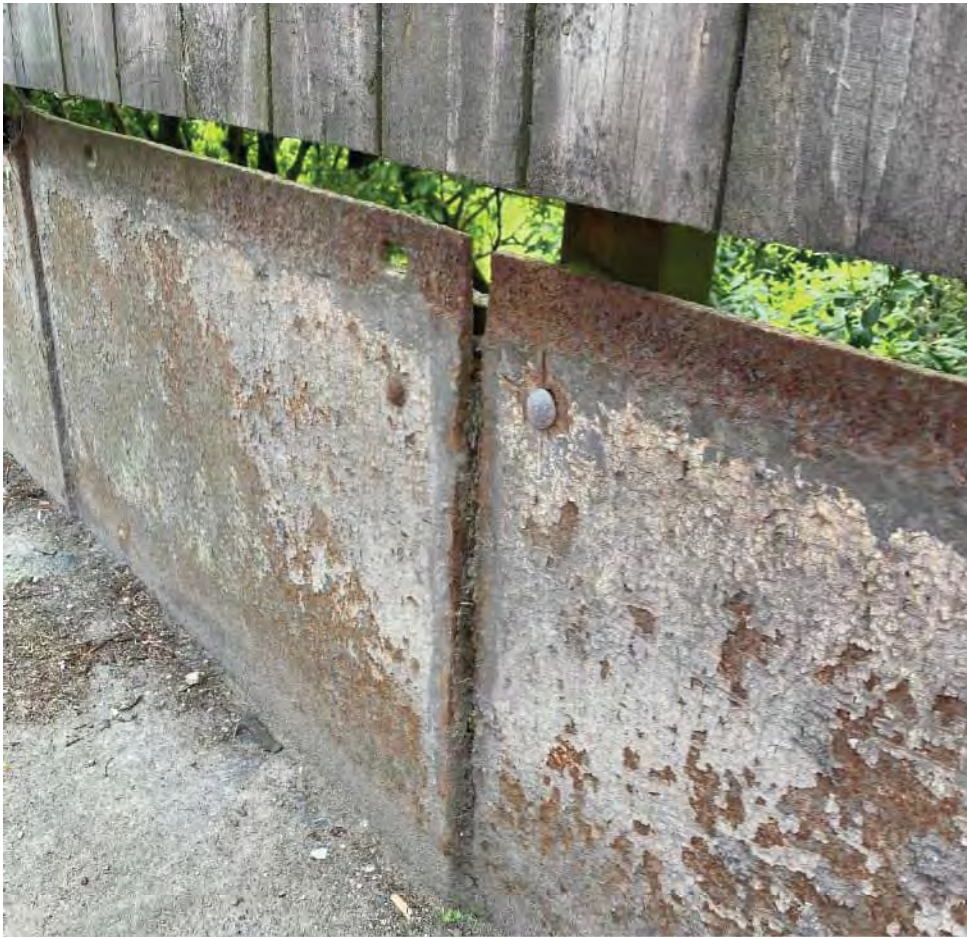
24. Displaced parapet panels
