## CCT/23 CS 454 Assessment and Inspection Report

### A675 Bolton Road Bridge, Lancashire

**National Highways – Historical Railways Estate**  
VAR9/7070

**HRE Assessment Programme**  
April 2023

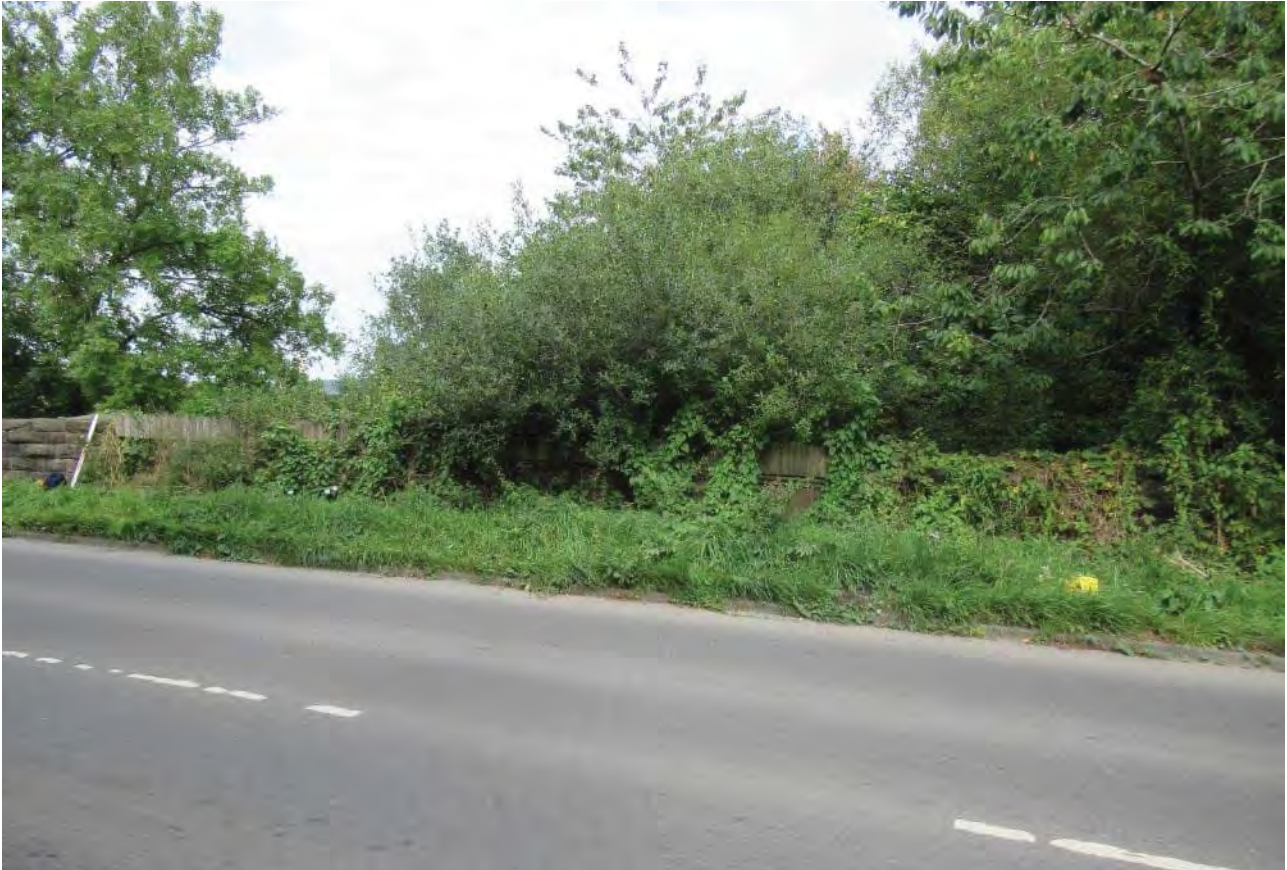
The cast iron parapets exhibit paint loss and minor corrosion throughout (Photograph 25 and 26). There are displaced panels on both the east and west parapets (Photograph 23 and 24).

25. East parapet

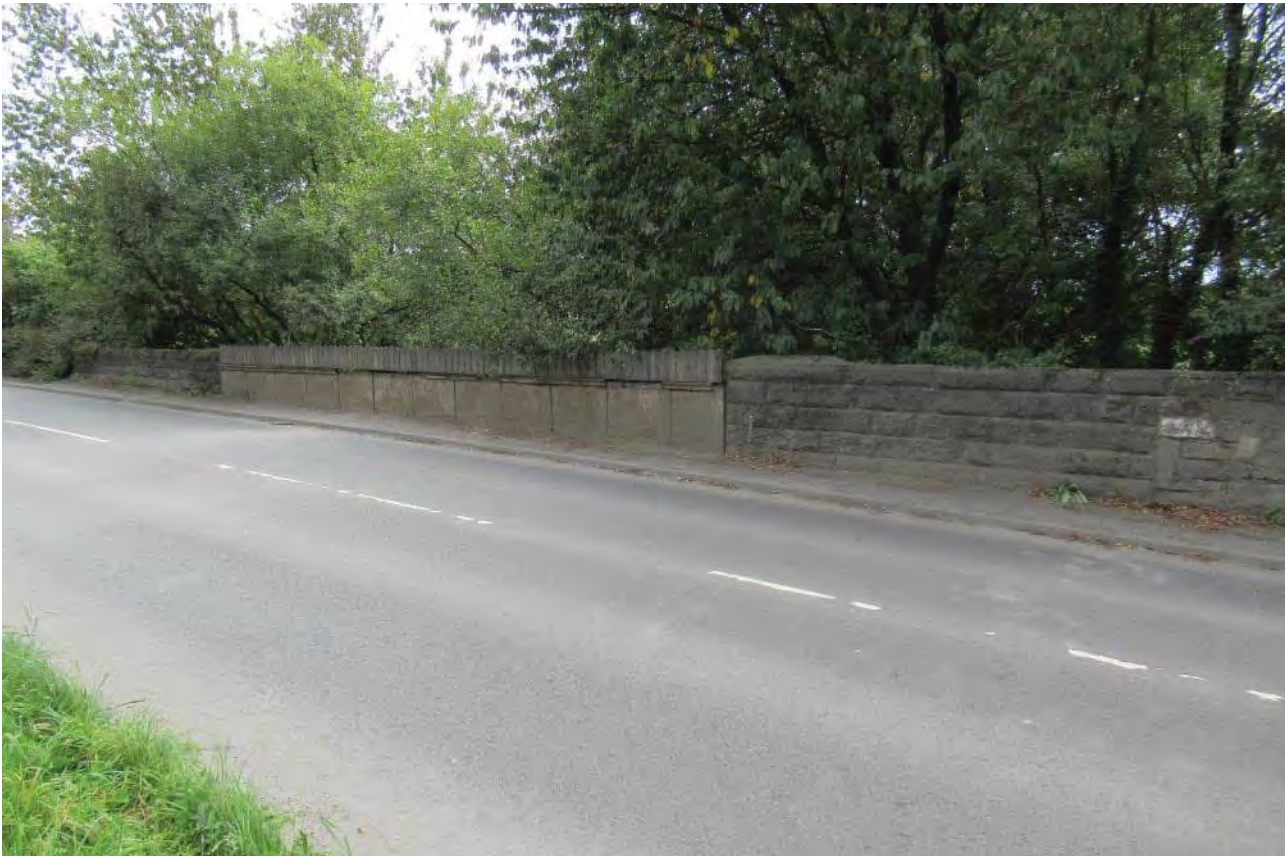
26. West parapet
