Project: Hurlston Brook Flood Event December 2015

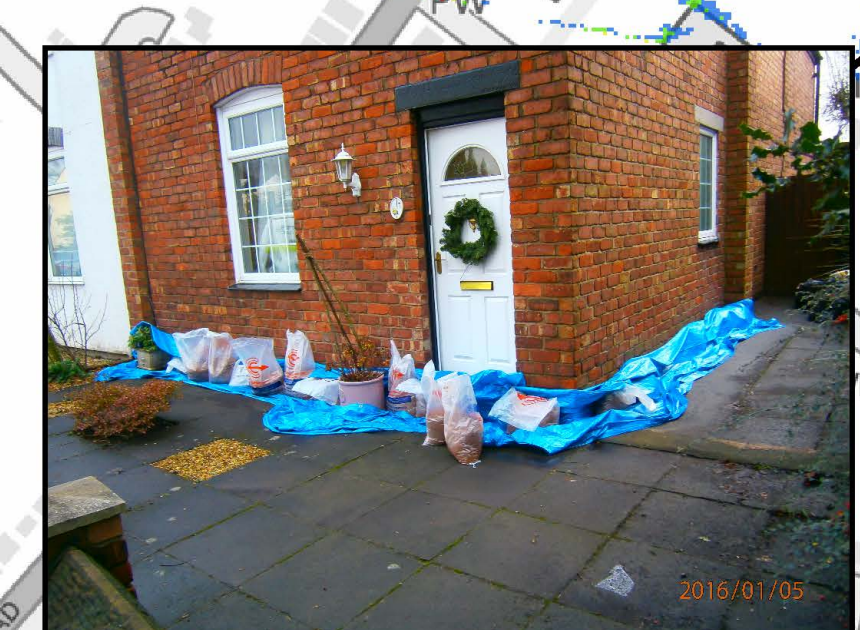
Dyers Lane: Properties were flooded when the stream overtopped. It did this opposite 10 Dyers Lane and at Ryburn Road.

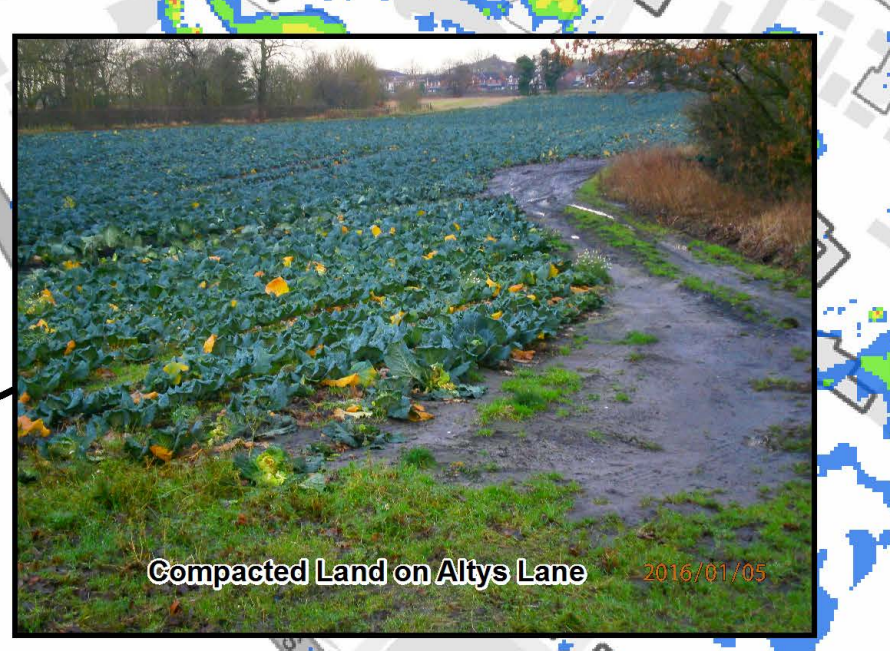
Alty's Lane: It was reported that the culverted section near 75 Alty's Lane had blocked, causing field runoff to overflow through properties. This was exacerbated by blocked highway drains. The screen does not appear to be EA asset. The fields draining to this point appear to be sandstone, yet ponding heavily. Some flooding could be avoided if compaction within the fields could be avoided.
