# Old Tram Bridge - Preston

**Summary of Principal Bridge Inspection Report  
6<sup>th</sup> February 2019**

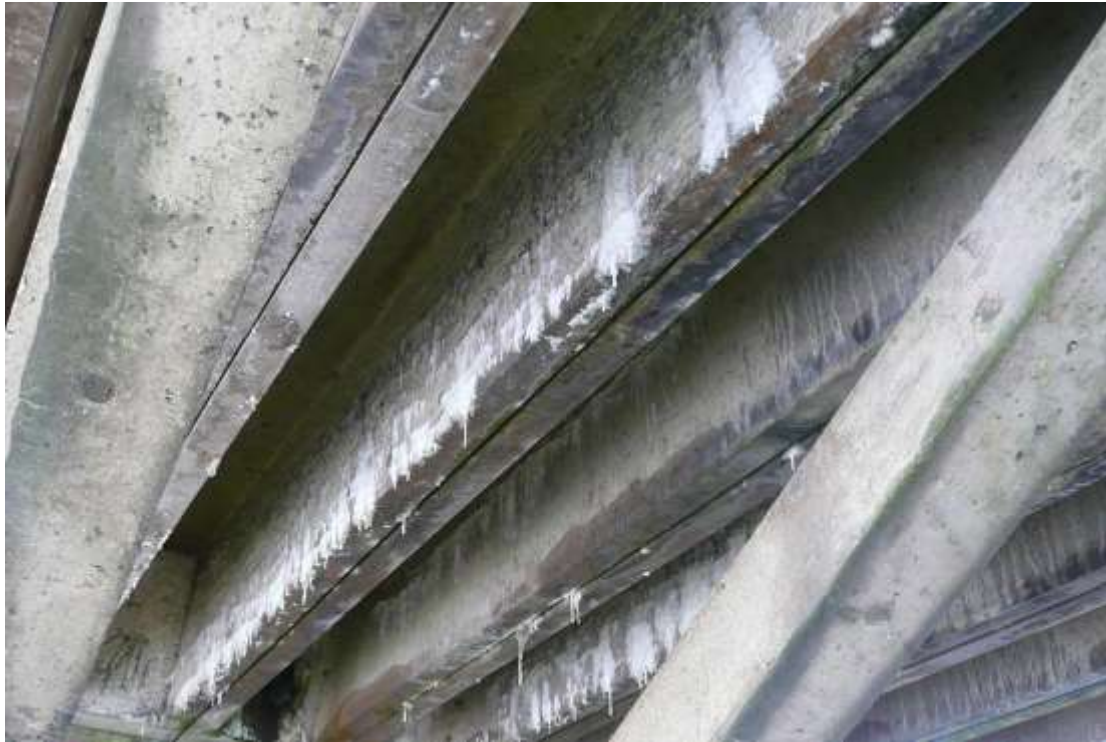
Around two thirds of the 1960's pre-stressed concrete bridge beams have extensive horizontal cracking. This is particularly concerning for this type of beam for two main reasons. Firstly, the cracking indicates that the beams are suffering distress due to the effects of loading. Secondly the cracks allow water to penetrate into the concrete, leaching out minerals from the concrete and potentially corroding the steel pre-stressing wires within the beams. The beams could fail suddenly due to weakening of the concrete and weakening of the pre-stressing wires.

Extensive cracking to the concrete beams with associated leached deposits

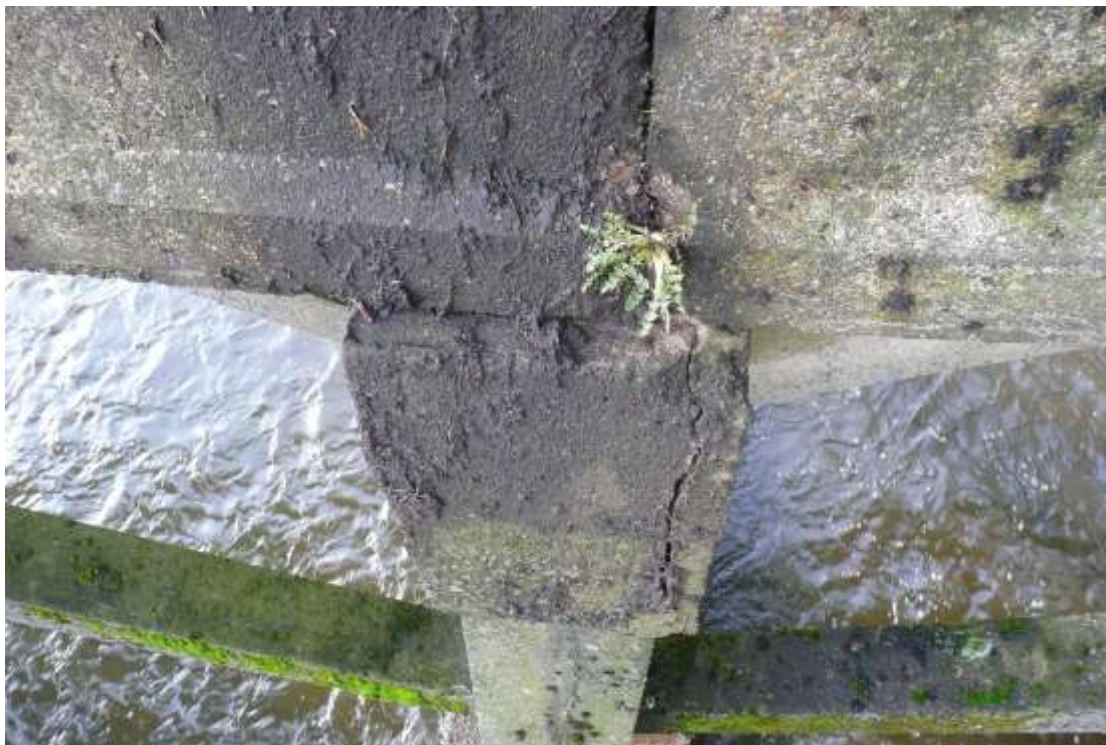
Many of the beams are not seated correctly on the supporting bridge piers. This means that the load from the beam is concentrated over a smaller area resulting in higher stresses in the beam end and in the supporting pier. This has been the situation since its construction. Areas of the supporting piers have already broken off, reducing the supporting area even further. In other areas there are large cracks where the supporting piers are failing. There is a significant risk that support to one or more beams will be completely lost and a beam will collapse.

Poor seating of the beams leading to cracking in the support

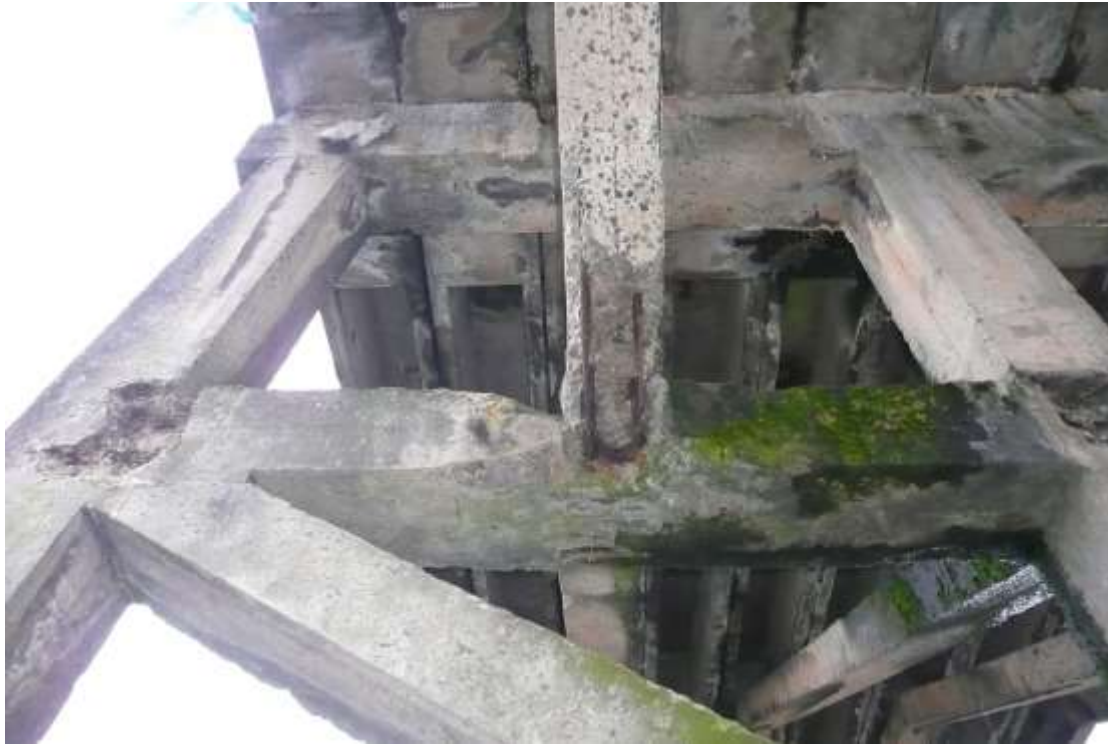
The 1930's concrete piers and struts are in very poor condition. There are extensive areas where the concrete has fallen away leaving the reinforcement exposed and badly rusted. A number of struts have already fallen off causing damage to the piers. There is potential for more concrete, including complete struts, to fall off with a significant risk to anyone below.

Spalled concrete and exposed reinforcement in the supports with damage from falling struts

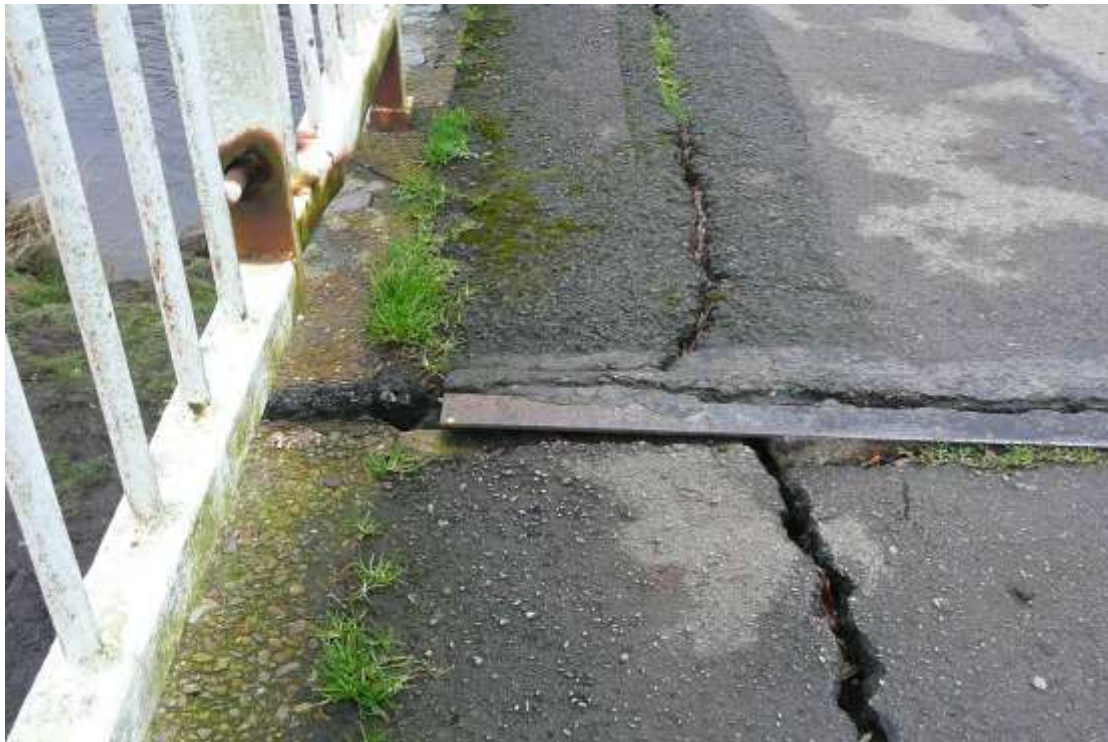
The connections between the beams appear to have failed. This means that the beams no longer support each other and share the loads. There is a risk that the beams could fail suddenly or could roll off their supports.

Surface cracking indicating beam movement and allowing water to penetrate the structure

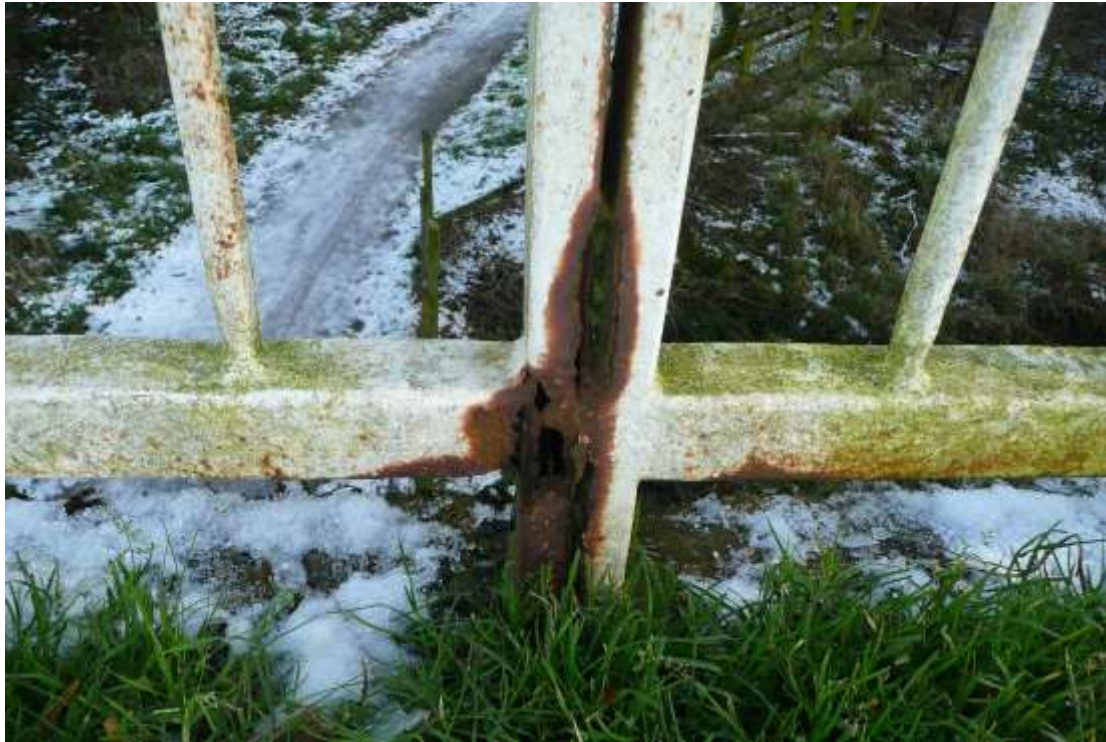
The parapets are badly corroded, particularly at the supporting posts. There is a risk that the parapets could give way if there were crowds on the bridge leaning on them.

Corrosion of the parapets where they are connected to the bridge
