SERVICE REPORT

Site: LCC - Accrington Union Street Area Office (2743)
44 Union Street, ACCRINGTON, BB5 1PL

Visit Description - Legionella PPM Works - TMV Servicing

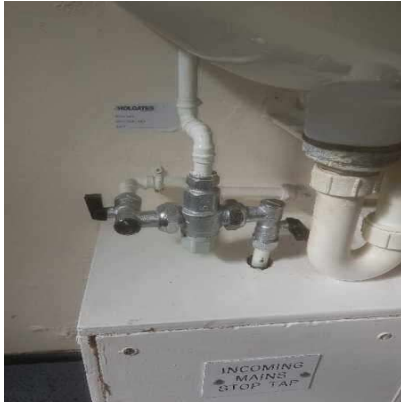
Room 3 Disabled Toilet 1 x WHB
TMV01
Disabled toilet

Equipment Type	location	Valve Size	Cold input temperature	Hot Input temperature	Isolation Valves Fitted	Fail safe working	Filters Cleaned	Mixed Temperature	Recommendations	Con/Non-Con
1x TMV01	Room 3 Disabled Toilet 1 x WHB	15mm	19.0	72.0	Yes	Yes	Yes	38.0		Conformance
