Asbestos Survey Report –
Management Survey

**Accrington Union Street Area Office 44 Union Street,
Accrington, BB5 1PL**

Our Reference: MS579/24PB

Date(s) of Survey: 05/11/2024

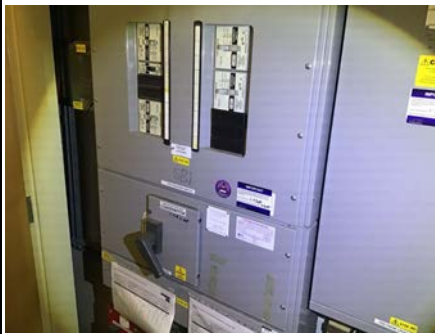
Room number	Location / Reason / Action	Photo
002	No access within live electrics - Asbestos containing materials should be presumed to be present until the area/unit can be inspected as part of an R&D survey by LCSS

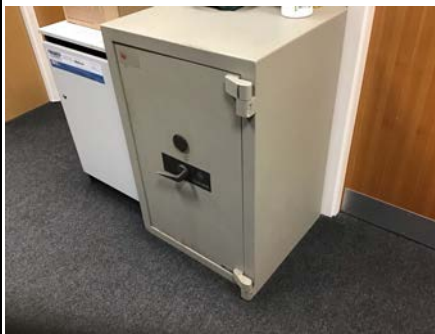
011	No access with in safe - Asbestos containing materials should be presumed to be present until the area/unit can be inspected as part of an R&D survey by LCSS

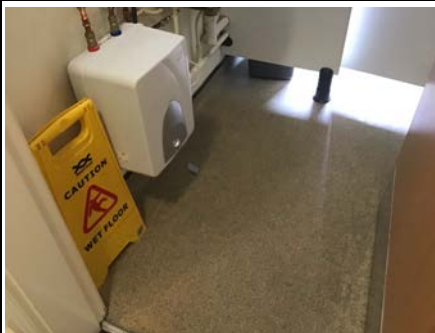
017	No access under watertight flooring without causing damage - Asbestos containing materials should be presumed to be present until the area/unit can be inspected as part of an R&D survey by LCSS

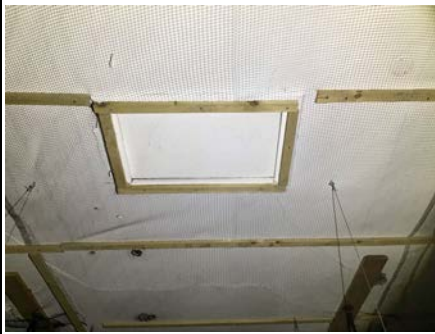
030	No access above timber loft hatch due to the ceiling grid & height - Asbestos containing materials should be presumed to be present until the area/unit can be inspected as part of an R&D survey by LCSS

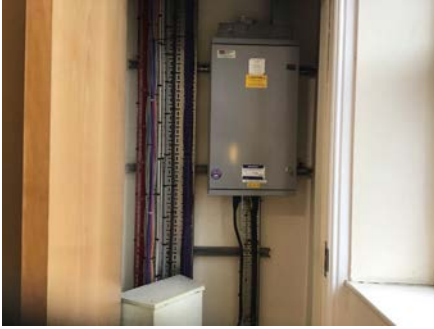
035	No access within live electrics - Asbestos containing materials should be presumed to be present until the area/unit can be inspected as part of an R&D survey by LCSS

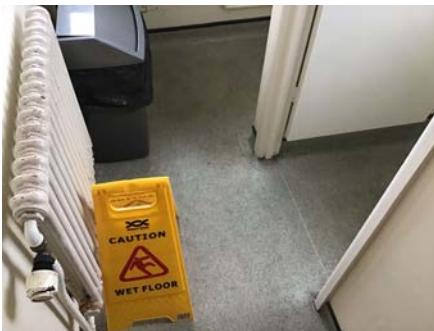
037	No access under watertight flooring without causing damage - Asbestos containing materials should be presumed to be present until the area/unit can be inspected as part of an R&D survey by LCSS

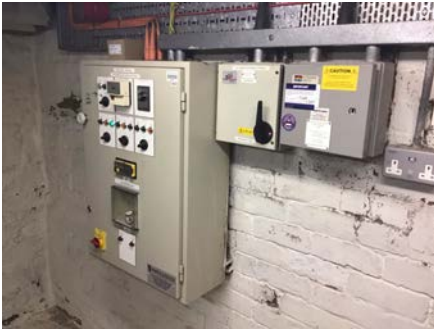
040	No access within live electrics - Asbestos containing materials should be presumed to be present until the area/unit can be inspected as part of an R&D survey by LCSS

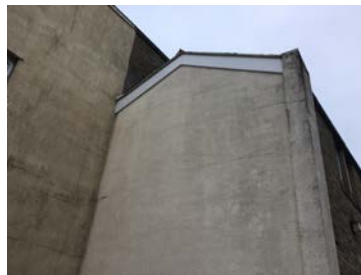
Sampled On: 26/08/2021
Sampled By: Philip Rawcliffe - LOC
Analysed On: 27/08/2021
Analysed By: Rachel Hood - LOC

Code: ASBRK045838
Status: CURRENT
Completed Date: 26/08/2021
ACM Code: AQMD33255

Product Type: 1 - Asbestos reinforced composites (plastics, resins, mastics, roofing felts, vinyl floor tiles, semi-rigid paints or decorative finishes, asbestos cement etc)
Extent Damage: 1 - Low damage: a few scratches or surface marks; broken edges on boards, tiles etc
Surface Treatment: 1 - Enclosed sprays and lagging, asbestos insulating board (with exposed face painted or encapsulated), asbestos cement sheets etc.
Asbestos Type: 1 - CHRYSTILE
Material Score: 4

Action Code	Priority	Action Type	Target Date	Actual Date
ACC014762	02 - Routine	07 - Monitor condition

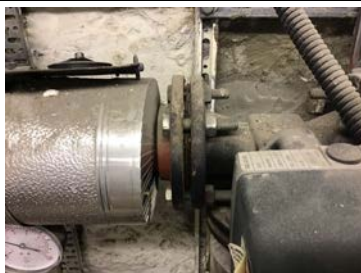
Site:	23300002200442000 - Accrington Union Street Area Office	Status:	DETECTED
Building:	23300002200443001 - MAIN BUILDING	Identified On:	05/11/2024
Room:	040	Identified By:	Paul Bibby - LCC
Description:	Gasket to pipe work		
Position:	Pipes		
Material Type:	Textiles	Sample:	TAKEN
Material Subtype:	Gaskets and Washers	Asbestos Type:	1 - CHRYSTILE
Quantity:	10 Unit		
Sample Details		Sampled On:	05/11/2024
Code:	MS579/24PB_S11-LR8700B	Sampled By:	Paul Bibby - LCC
Origin:	Gasket	Analysed On:	08/11/2024
Analysis:	Asbestos Detected - Chrysotile	Analysed By:	Lorraine Rawcliffe - LCC

Risk Assessment Details			
Code:	ASBRK047528	Completed Date:	05/11/2024
Status:	CURRENT	ACM Code:	ACM033282

Product Type:	1 - Asbestos reinforced composites (plastics, resins, mastics, roofing felts, vinyl floor tiles, semi-rigid paints or decorative finishes, asbestos cement etc)
Extent Damage:	1 - Low damage: a few scratches or surface marks; broken edges on boards, tiles etc
Surface Treatment:	0 - Composite materials containing asbestos: reinforced plastics, resins, vinyl tiles.
Asbestos Type:	1 - CHRYSTILE
Material Score:	3

Action Code	Priority	Action Type	Target Date	Actual Date
ACC015332	02 - Routine	07 - Monitor condition
