## **1223 – WITHNELL STATION BRIGE**

### **GENERAL INSPECTION**

Inspection Date: 26/05/2026

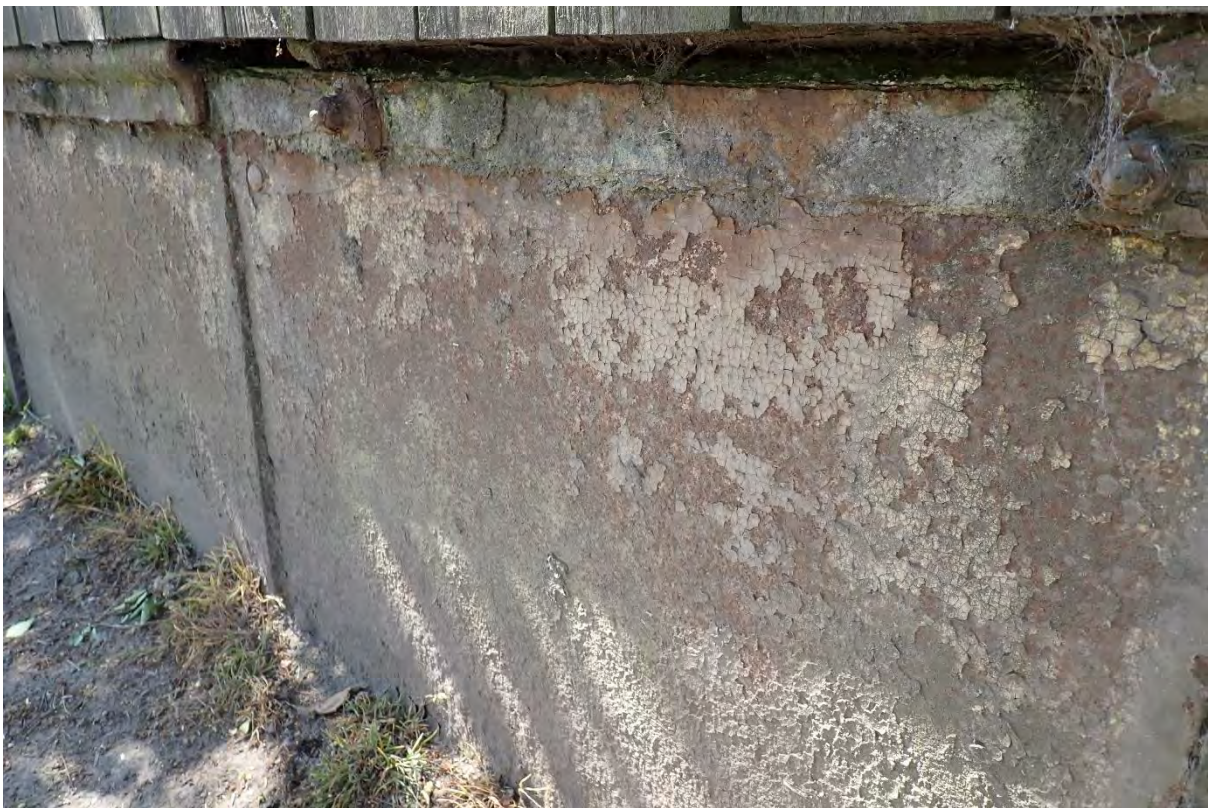
| Item No. | Defect 1 | | | Defect 2 | | | Defect 3 | | | Comments / Remarks |
|---|---|---|---|---|---|---|---|---|---|---|
| 23 | 3 | E | 1.1 | 3 | C | 2.3 | | | | Extensive moderate corrosion to parapets, loss of cast iron members, displacement and leaning. |

6. Corrosion and loss of cast iron member to the top of the SW parapet

| Ref. No | Suggested Remedial Works | Priority | Estimated Cost | Action/Work Ordered |
|---|---|---|---|---|
| | Replacement of deck and all superstructure elements, including parapets. | | | |

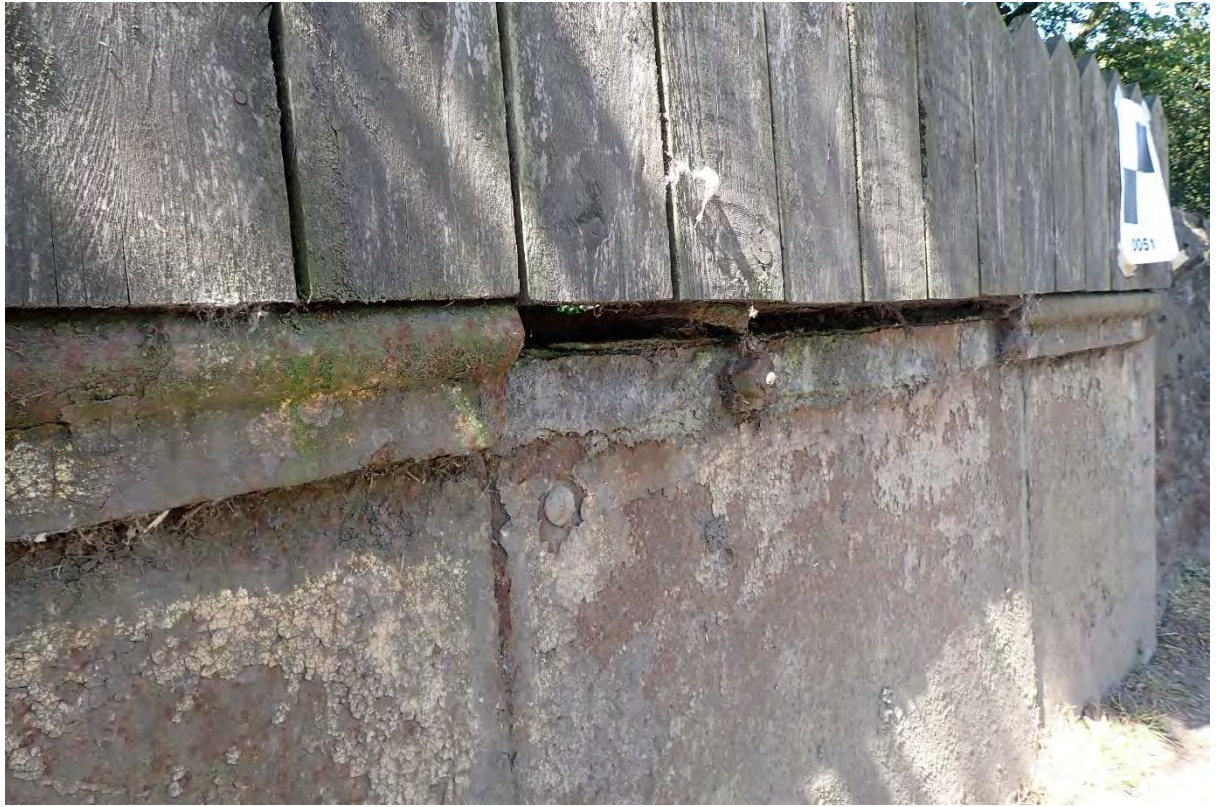
7. Further loss of cast iron section to top of parapet

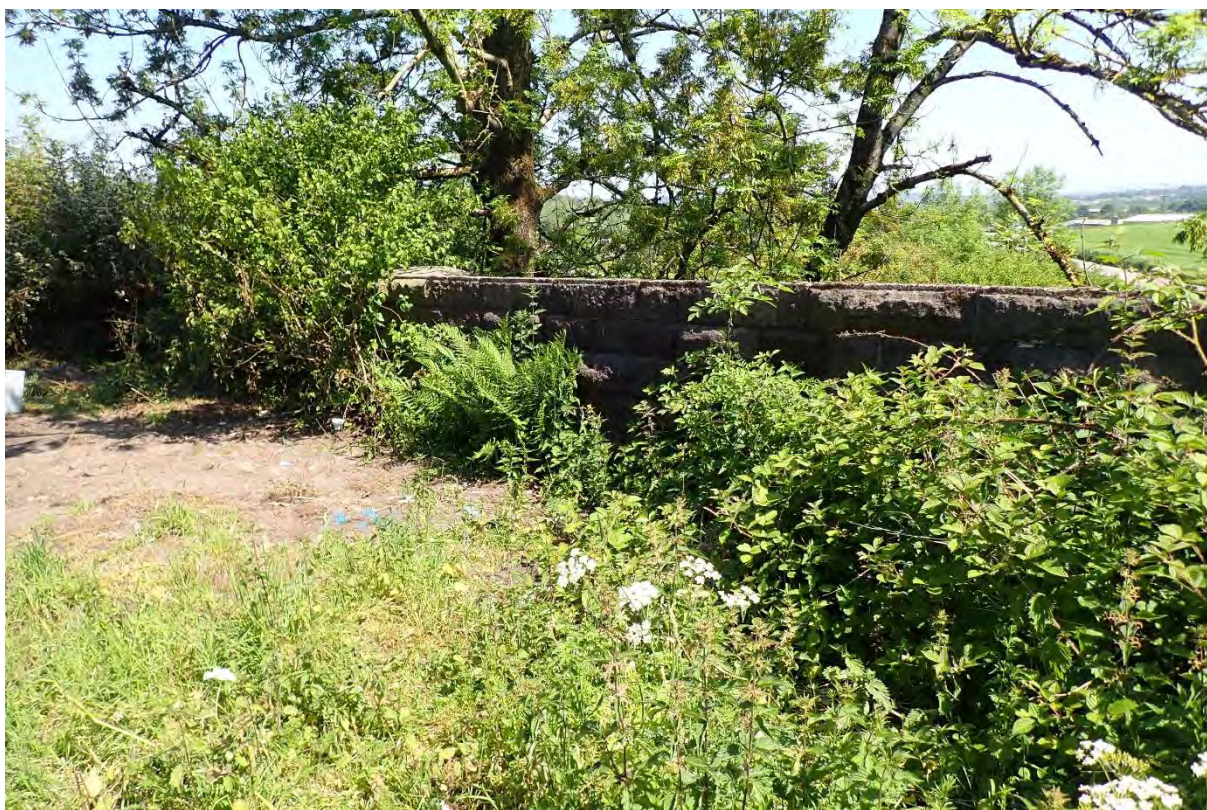
| Item No. | Defect 1 | | | Defect 2 | | | Defect 3 | | | Comments / Remarks |
|---|---|---|---|---|---|---|---|---|---|---|
| 25 | 3 | E | 5.2 | 3 | B | 5.1 | 2 | C | 9.6 | Overgrown vegetation growth to highway verge with large trees present. Displacement to flags on surfacing below bridge. Loss of timber rails to NW approach fence. Mortar loss to masonry approach walls. |

11. South West parapet and overgrown tree and vegetation growth to highway verge

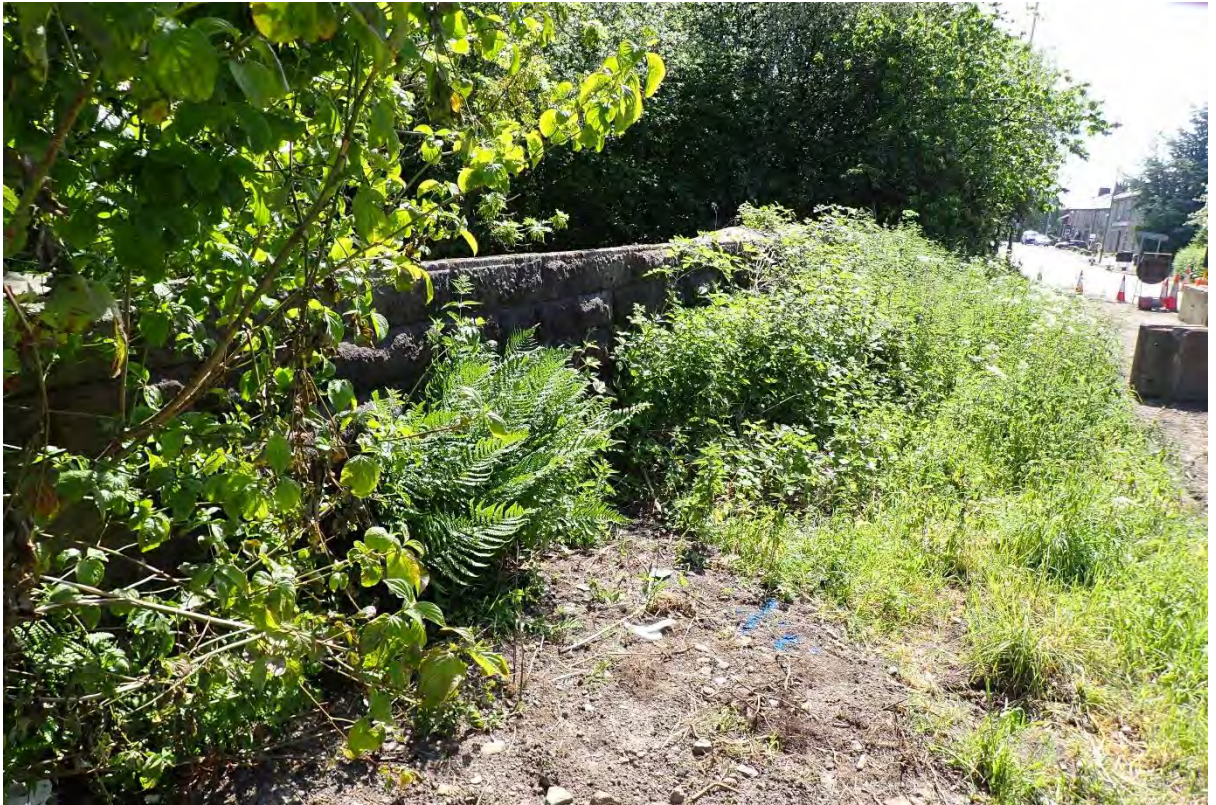
13. North East parapet and tree and vegetation growth along verge

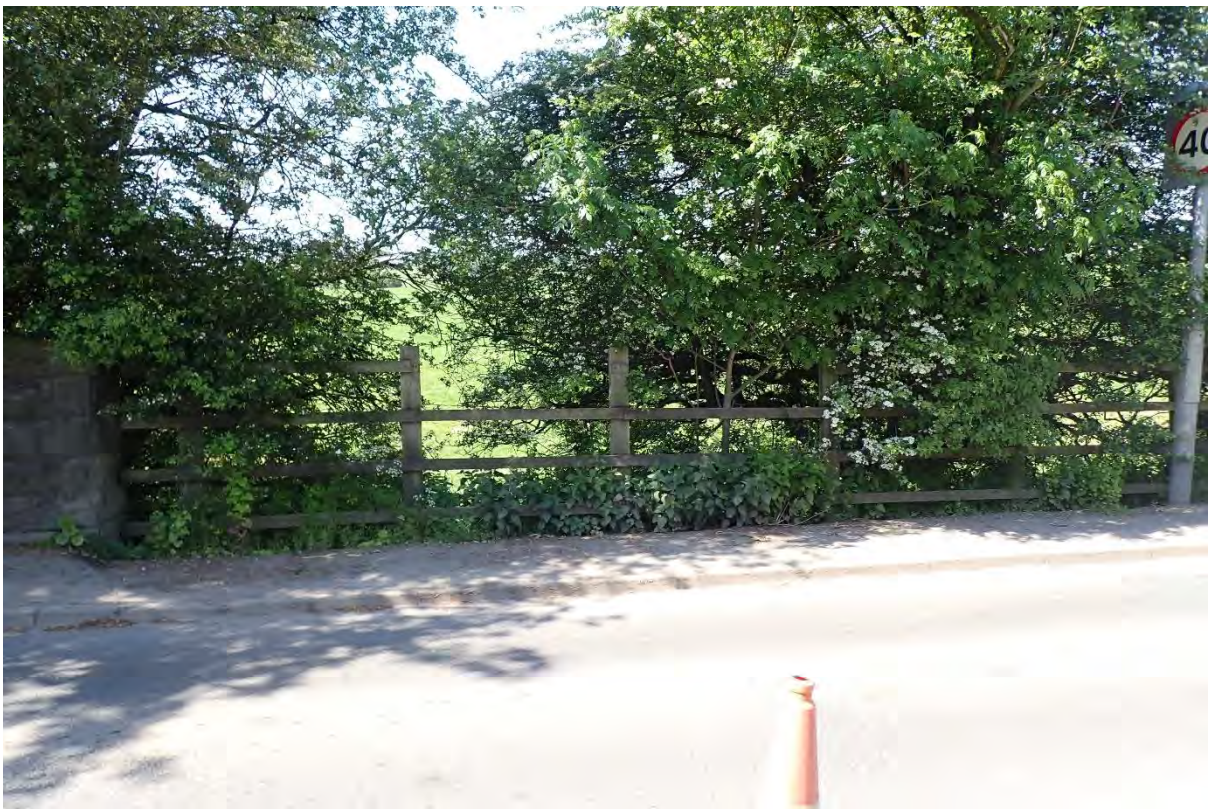
14. Missing timber rails to NW approach fencing

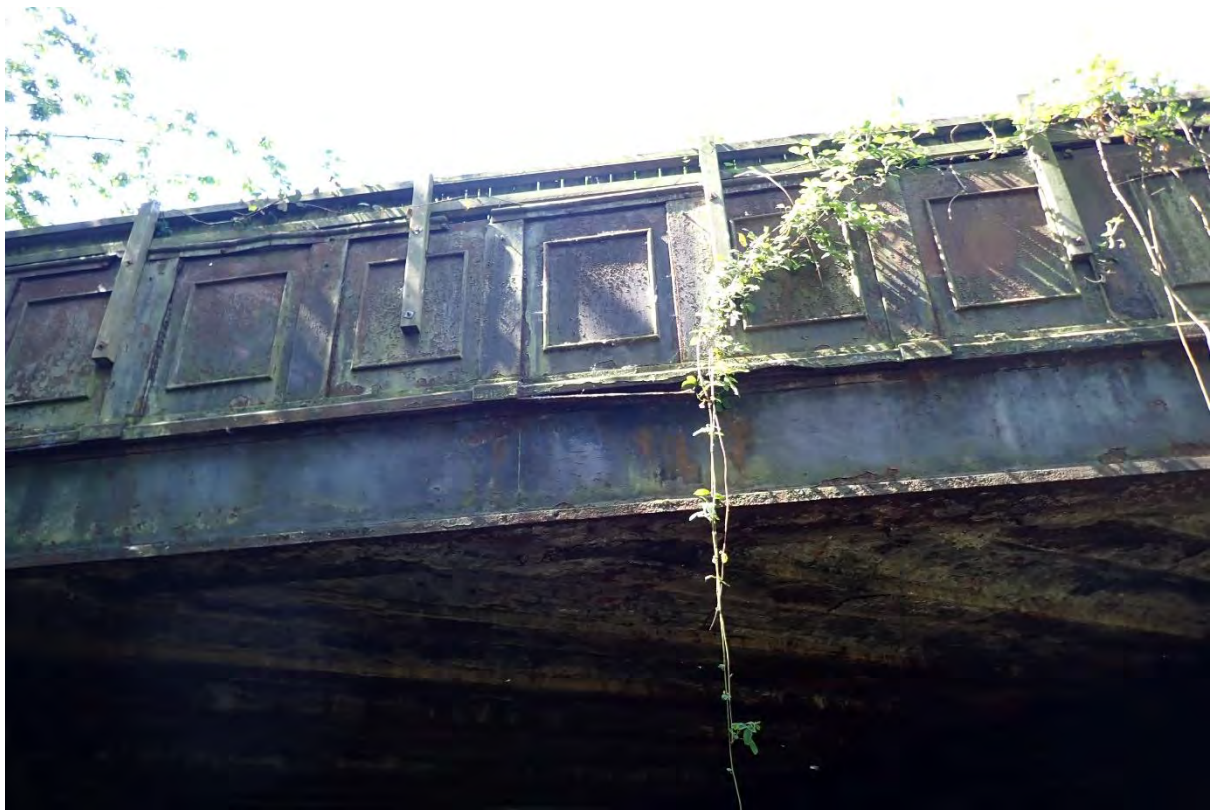
15. View of the rear of the NE parapet and external cast iron beam, with visible corrosion and damage to the top flange

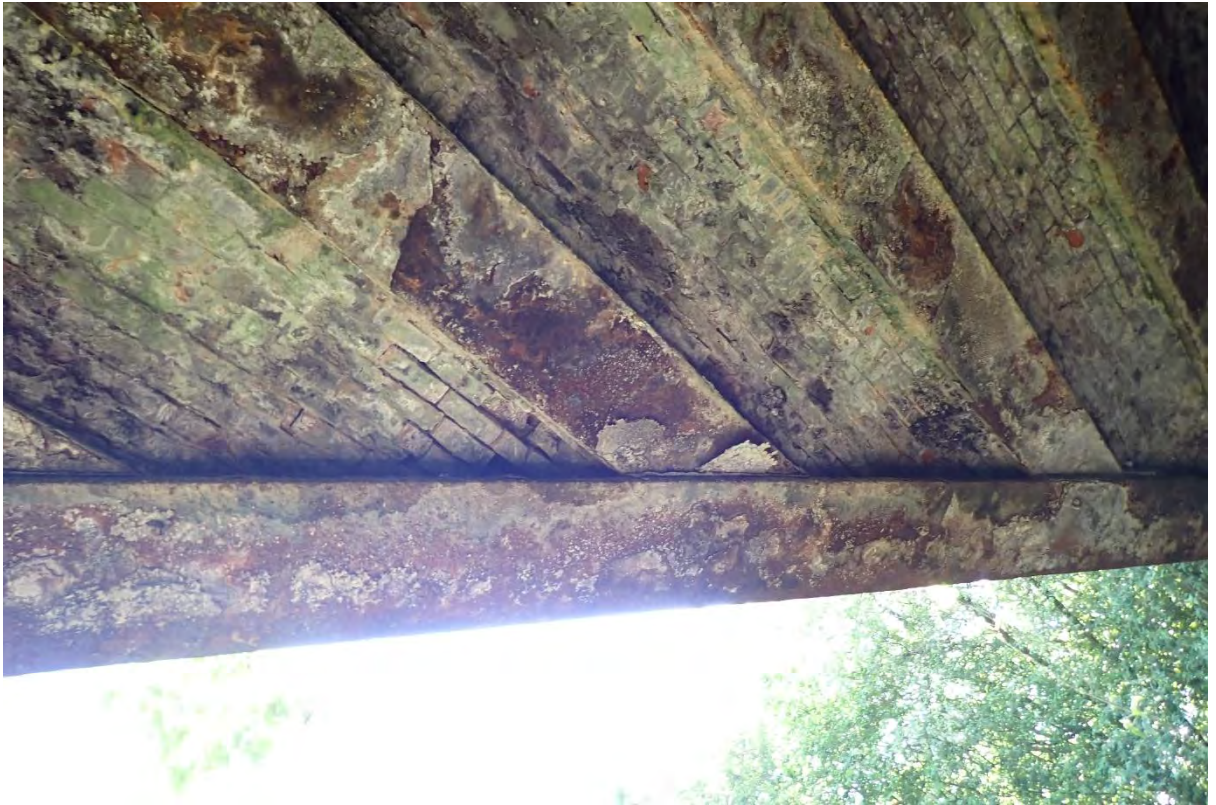
| Item No. | Defect 1 | | | Defect 2 | | | Defect 3 | | | Comments / Remarks |
|---|---|---|---|---|---|---|---|---|---|---|
| 1 | 3 | E | 1.1 | 2 | C | 1.2 | | | | Extensive corrosion to all cast iron beams with localised pitting. Localised delamination and section loss to bottom flanges. |

17. Corrosion and delamination to the cast iron beams at the SE end of the bridge

| Ref. No | Suggested Remedial Works | Priority | Estimated Cost | Action/Work Ordered |
|---|---|---|---|---|
| | Full deck and superstructure replacement scheme required as a high priority. | H | £6m | |

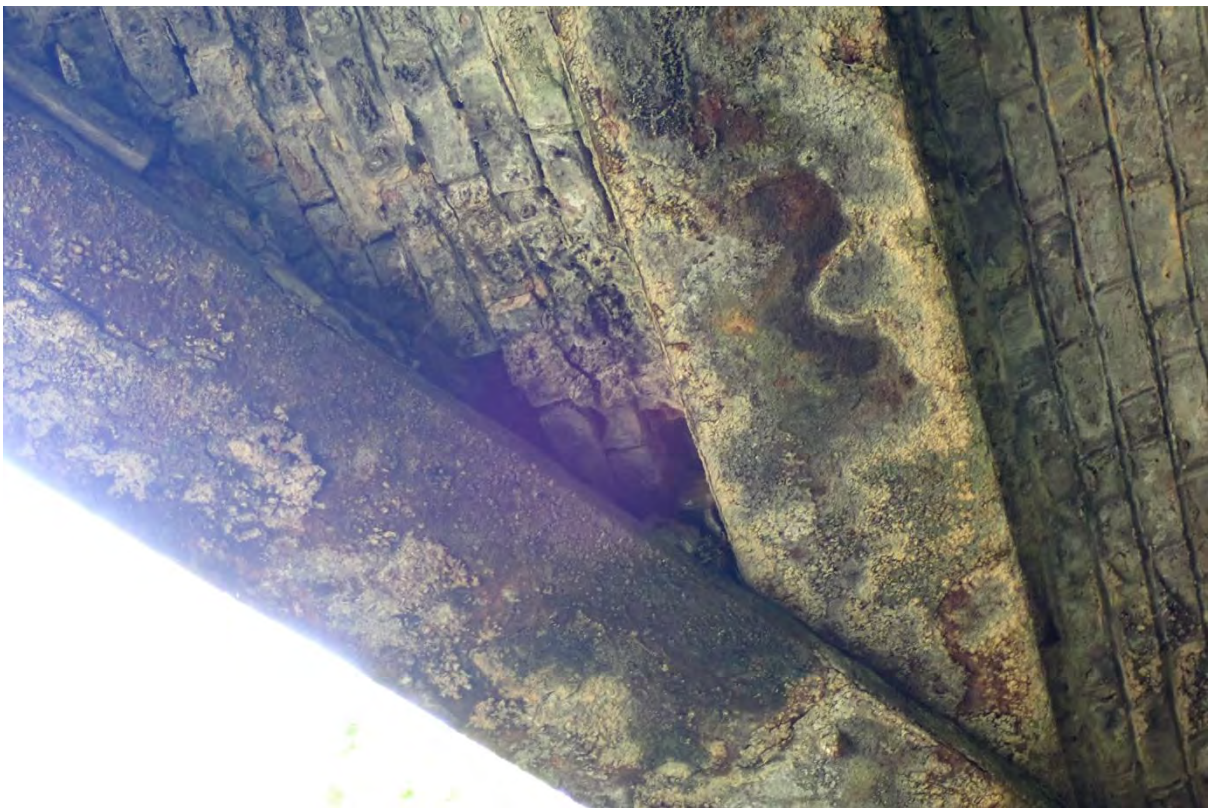
| Item No. | Defect 1 | | | Defect 2 | | | Defect 3 | | | Comments / Remarks |
|---|---|---|---|---|---|---|---|---|---|---|
| 3 | 4 | B | 3.1 | 3 | E | 3.2 | 3 | E | 3.6 | Partial collapse of jack arch at SE corner with missing bricks, extensive mortar loss to joints to all jack arches, spalls to over 50% of bricks, areas of displacement and flattening to arches. |

18. Missing bricks to the jack arch due to partial collapse

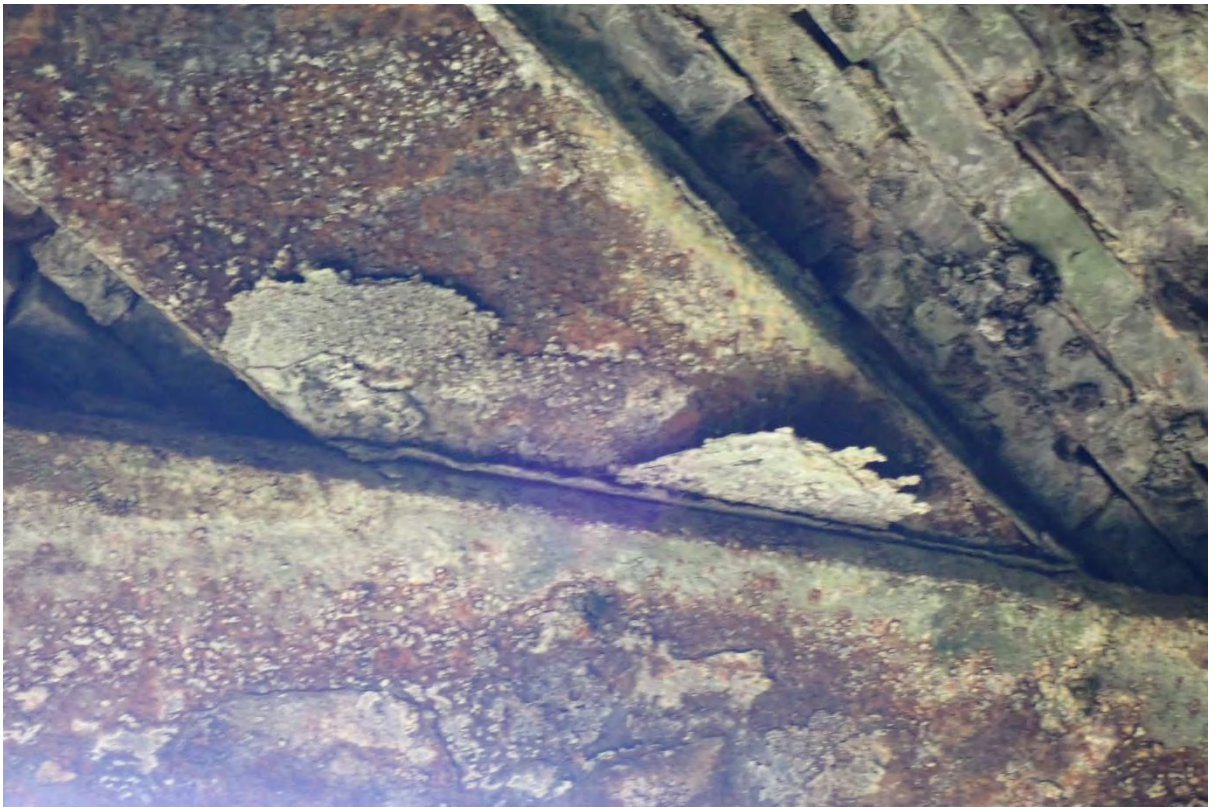
20. Visible delamination, corrosion and pitting to the deck girder along with missing bricks to the jack arch

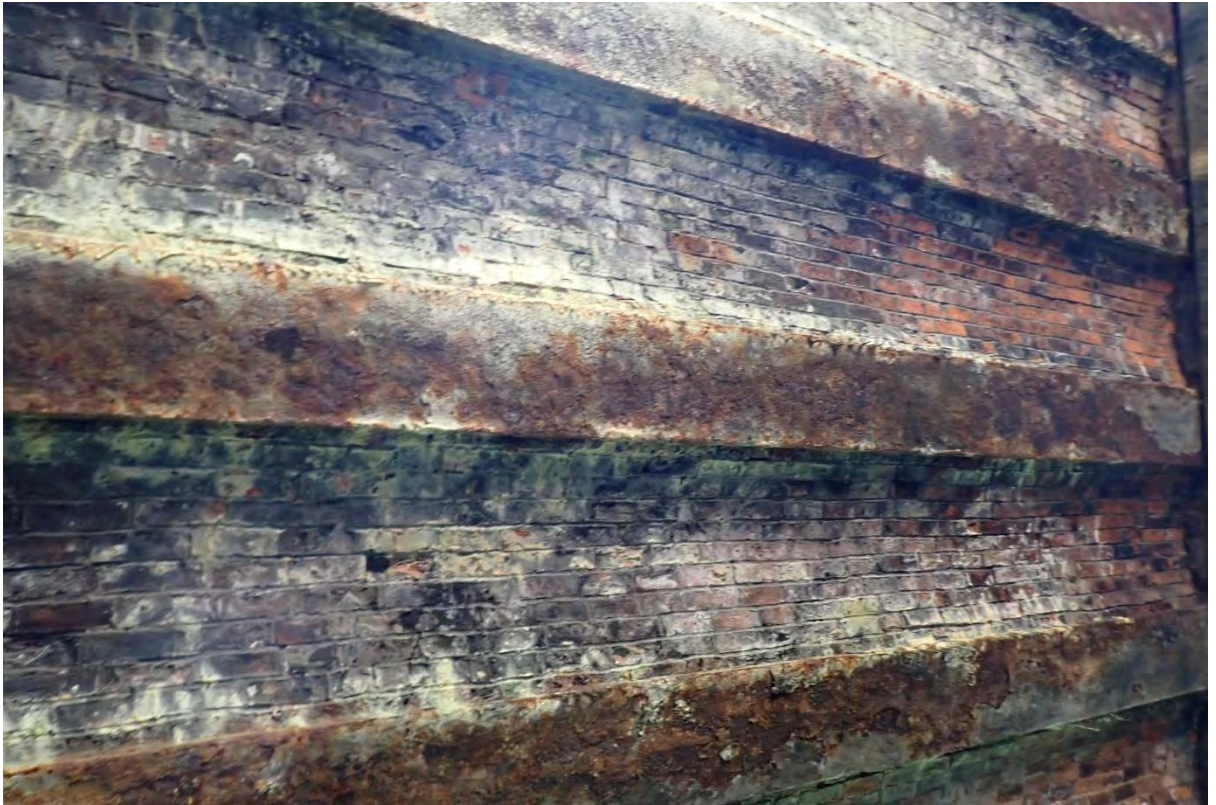
21. Photo showing corrosion to internal deck girders and spalls and mortar loss to brick jack arches

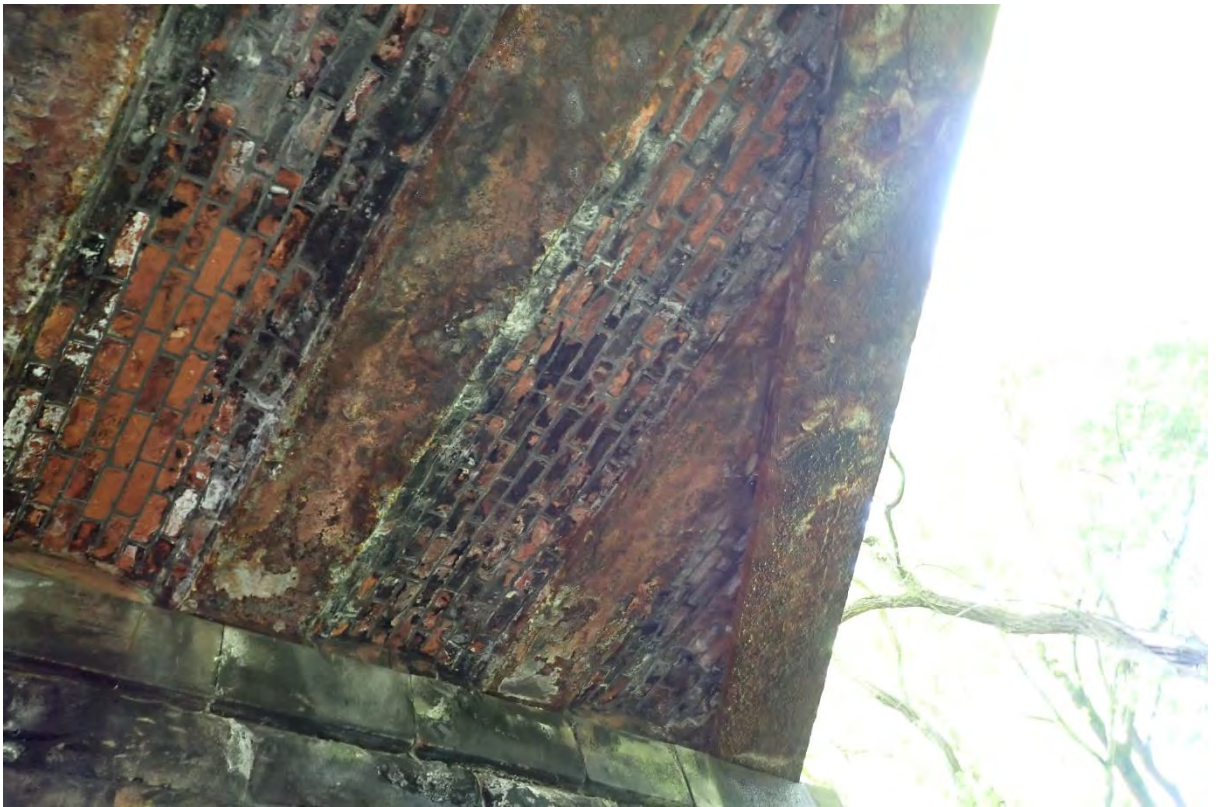
24. SW corner of deck. Visible water drips to external cast iron beam

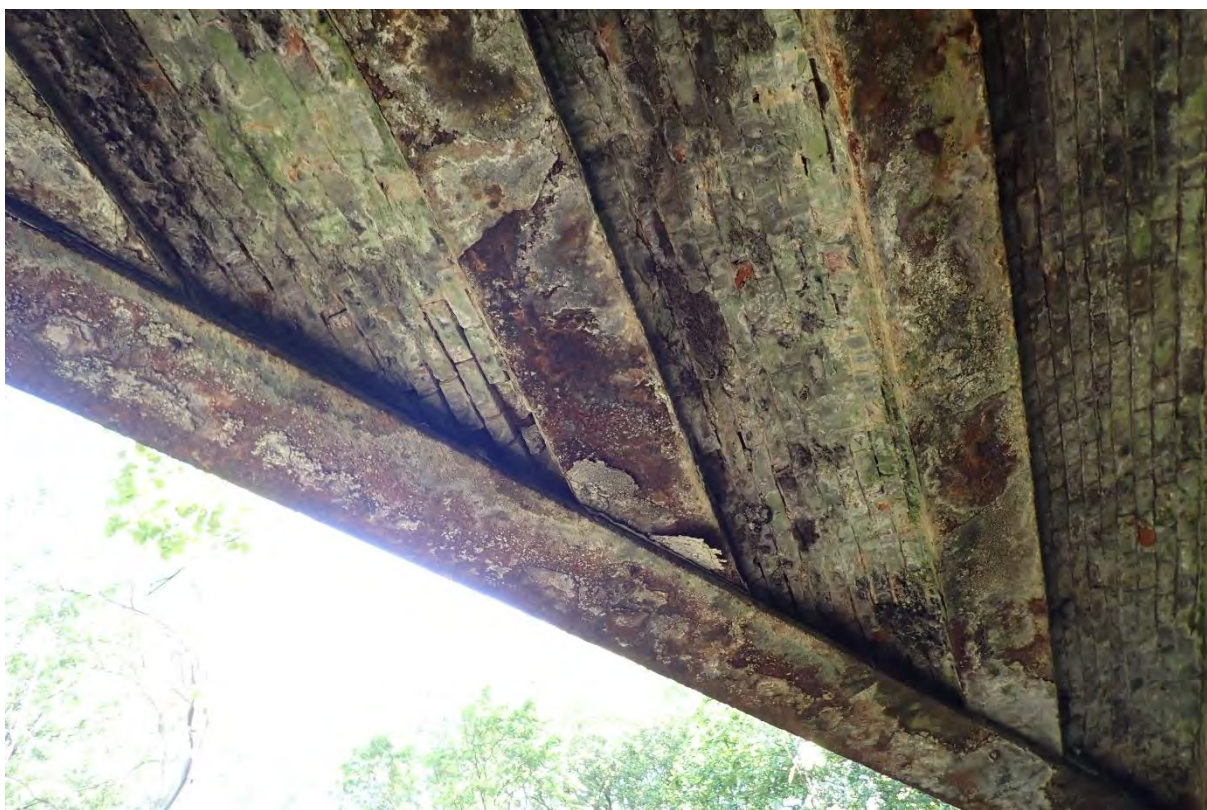
28. External end beam (east) – mortar loss and deformation can be seen to the jack arches

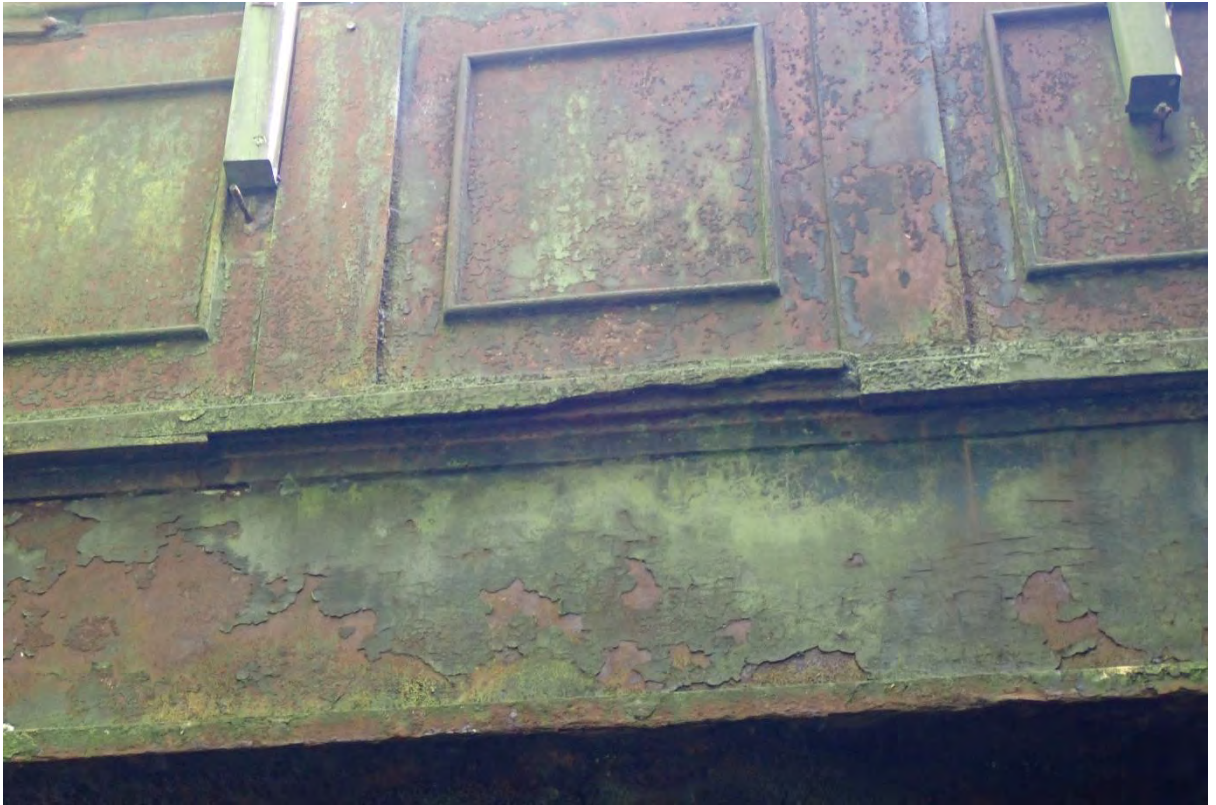
30. Corrosion and section loss to the top flange of the east beam

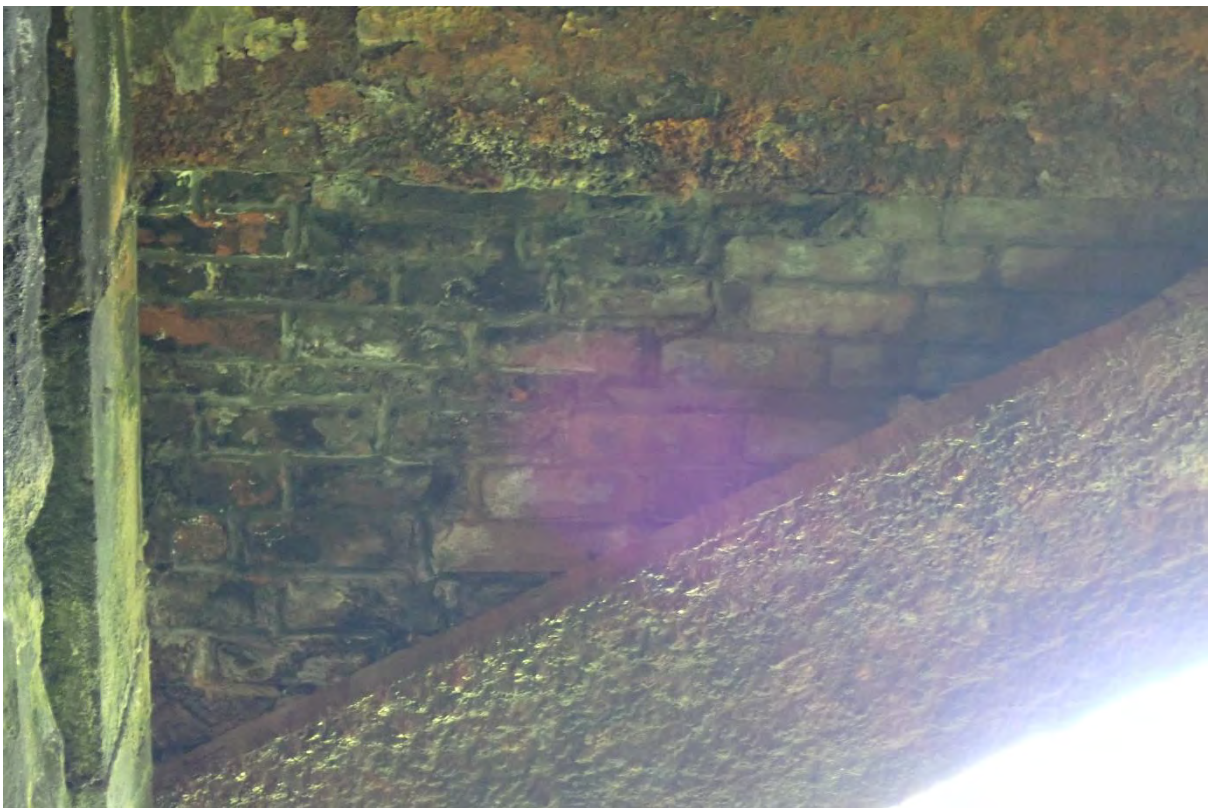
31. Spalls and displacement to the jack arch

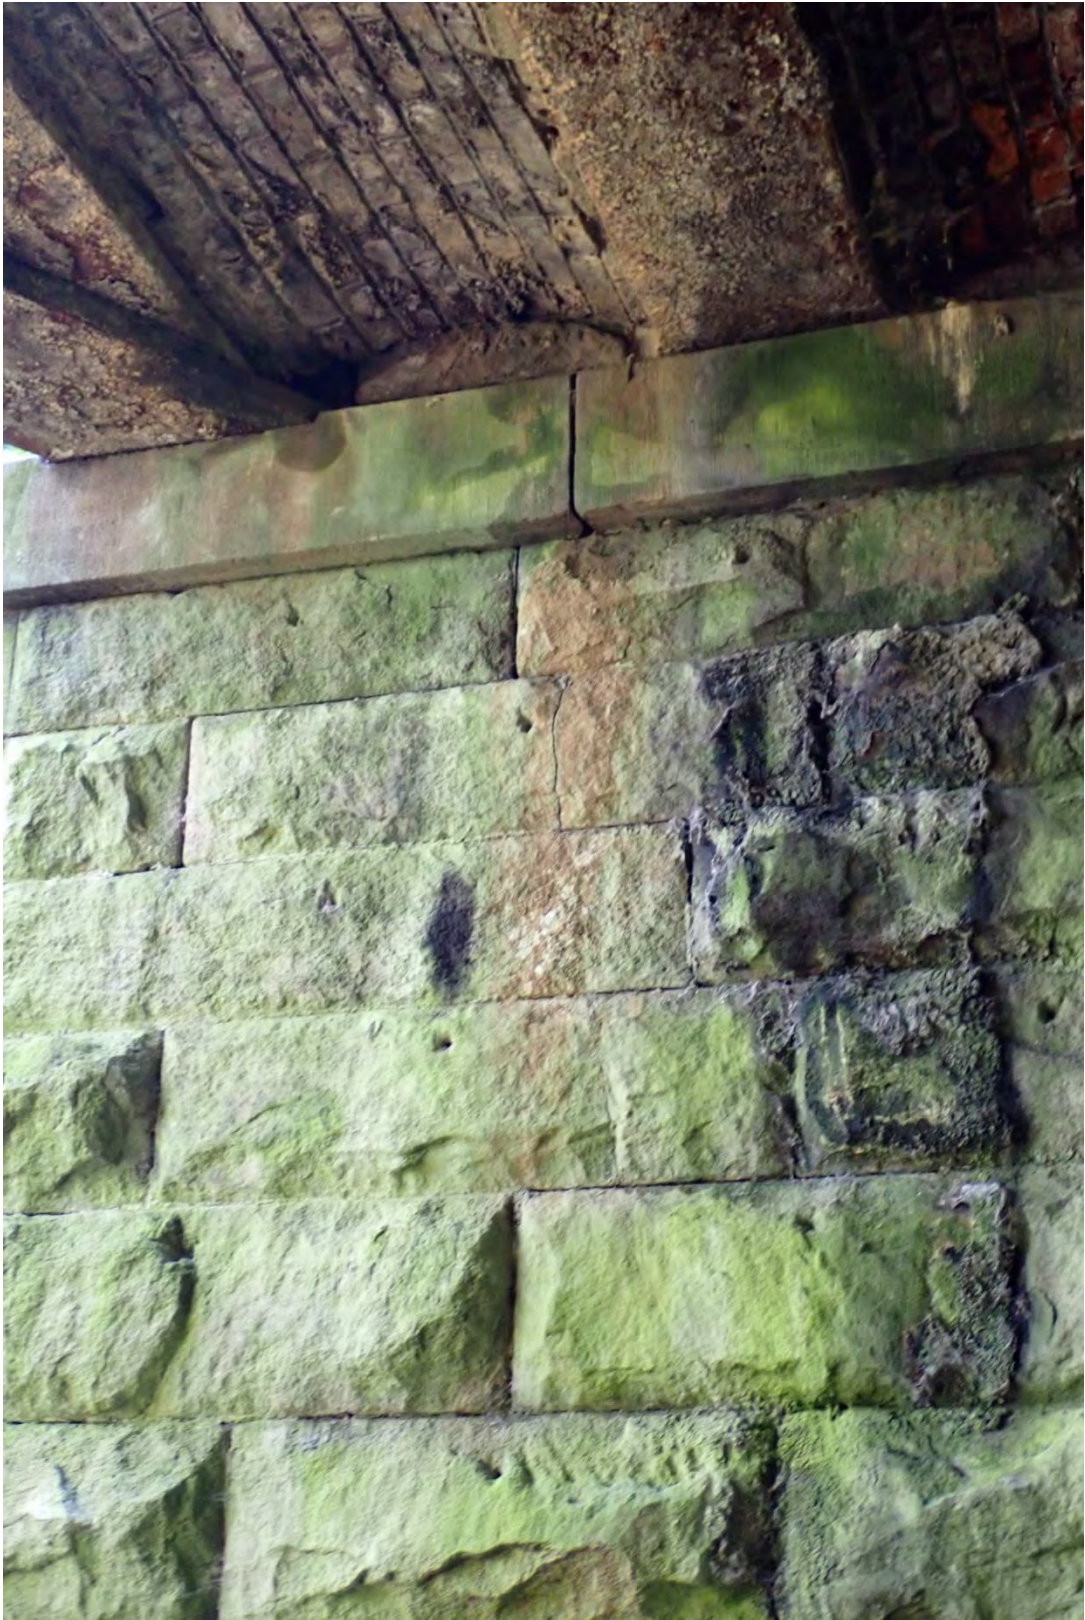
| Item No. | Defect 1 | | | Defect 2 | | | Defect 3 | | | Comments / Remarks |
|---|---|---|---|---|---|---|---|---|---|---|
| 9 | 3 | B | 3.5 | 2 | B | 14.1 | | | | Localised crack to bricks, seepage through east abutment. |

34. Localised crack to a single stone block

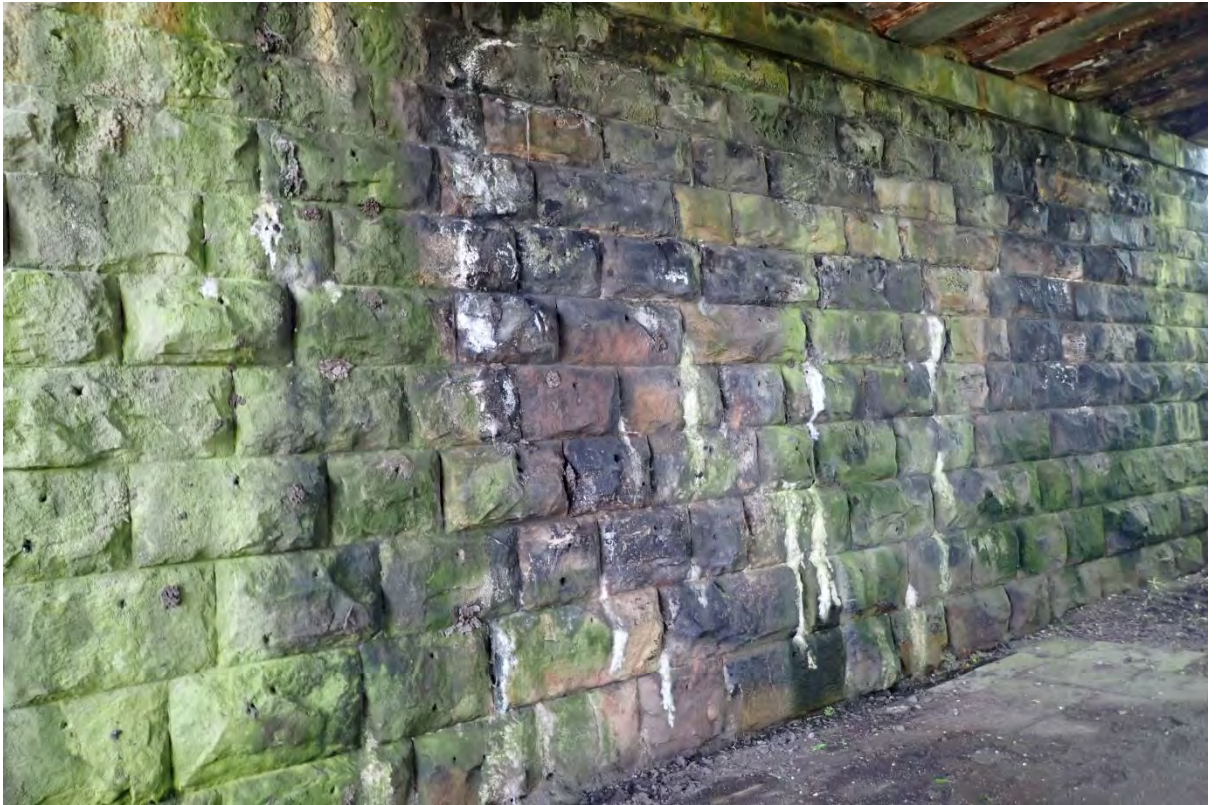
35. Seepage stains to the SE abutment

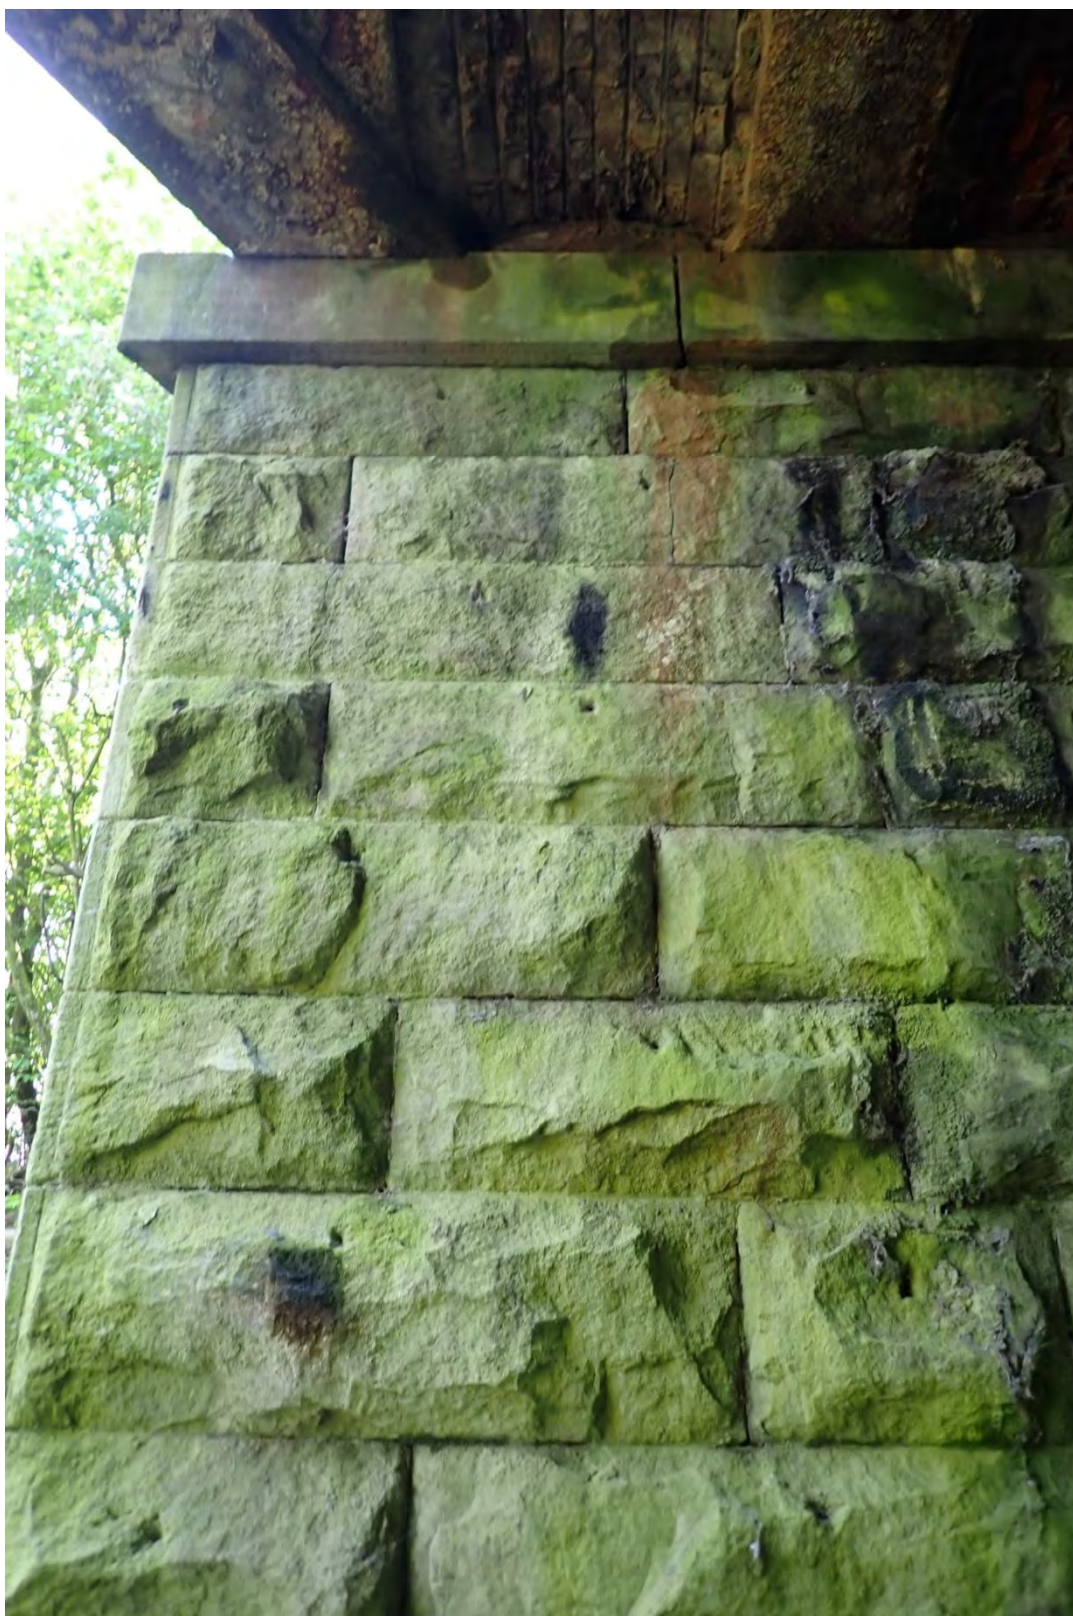
36. SE corner with a localised visible crack to a single stone

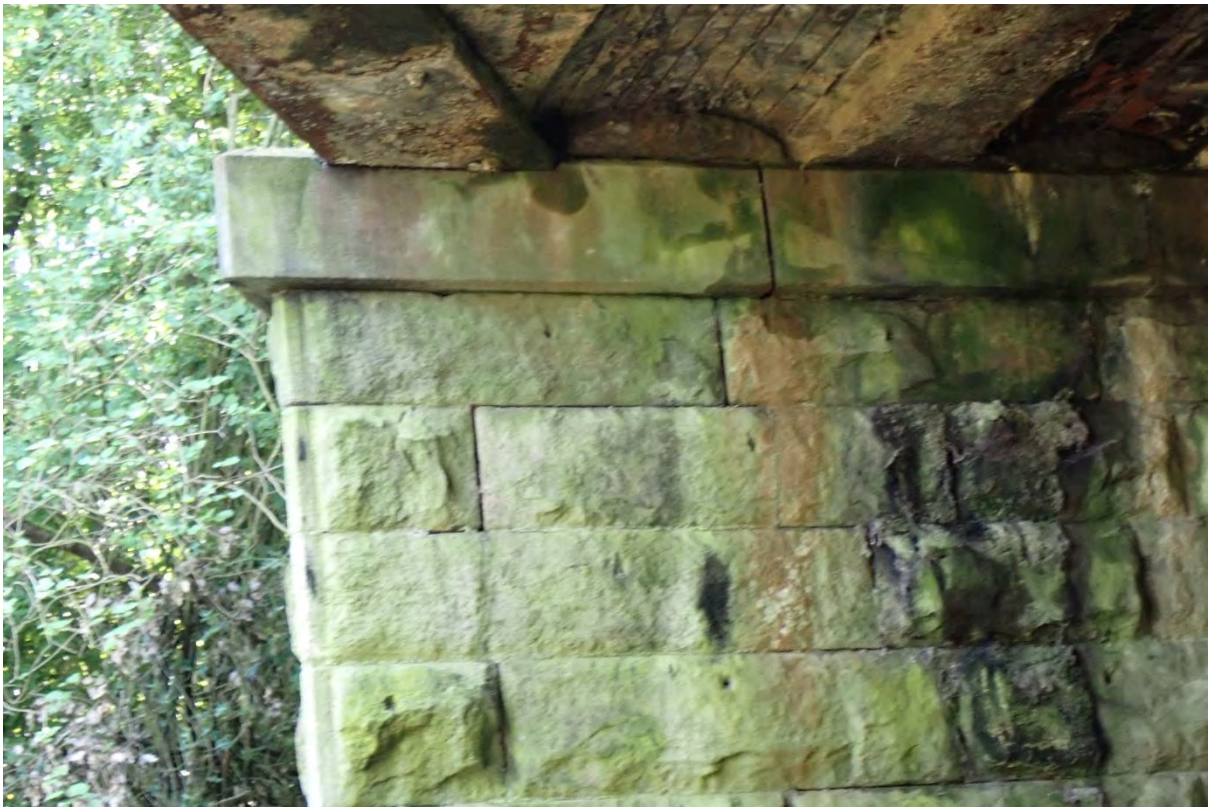
| Set | No | Element Description | S | Ex | Def | W | P | Cost | Comments / Remarks |
|---|---|---|---|---|---|---|---|---|---|
| Durability Elements | 15 | Bearing plinth/shelf | 2 | C | 3.2 | No | | | Mortar loss to stone bearing plinth joints |

38. Photo of the SE abutment and stone bearing plinth

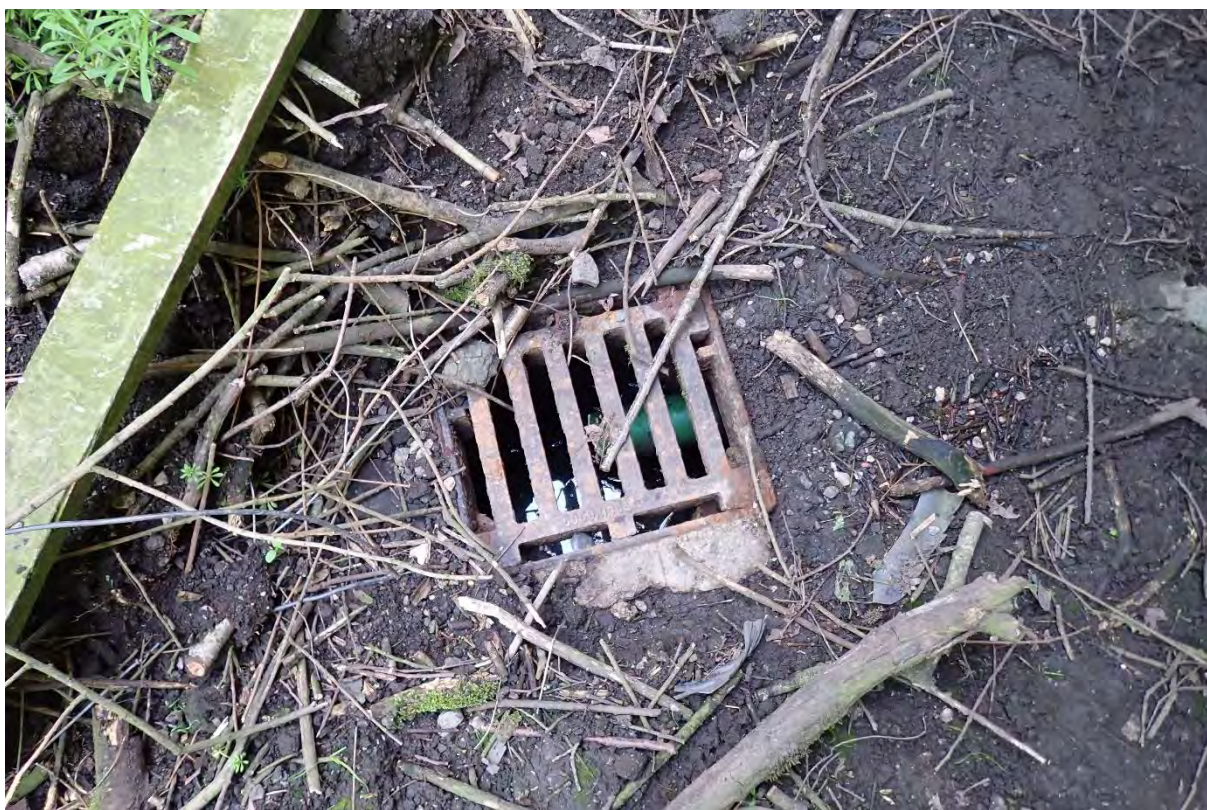
45. Drainage gully under the bridge is clear of blockages
