**PROPOSED SAND AND GRAVEL  
EXTRACTION  
LAND OFF BOURBLES LANE,  
PREESALL**

**Addendum to the Landscape and  
Visual Impact Assessment:  
Seasonal Variation Assessment  
and Winter Visualisations**

Prepared on behalf of The Baxter Group

February 2026

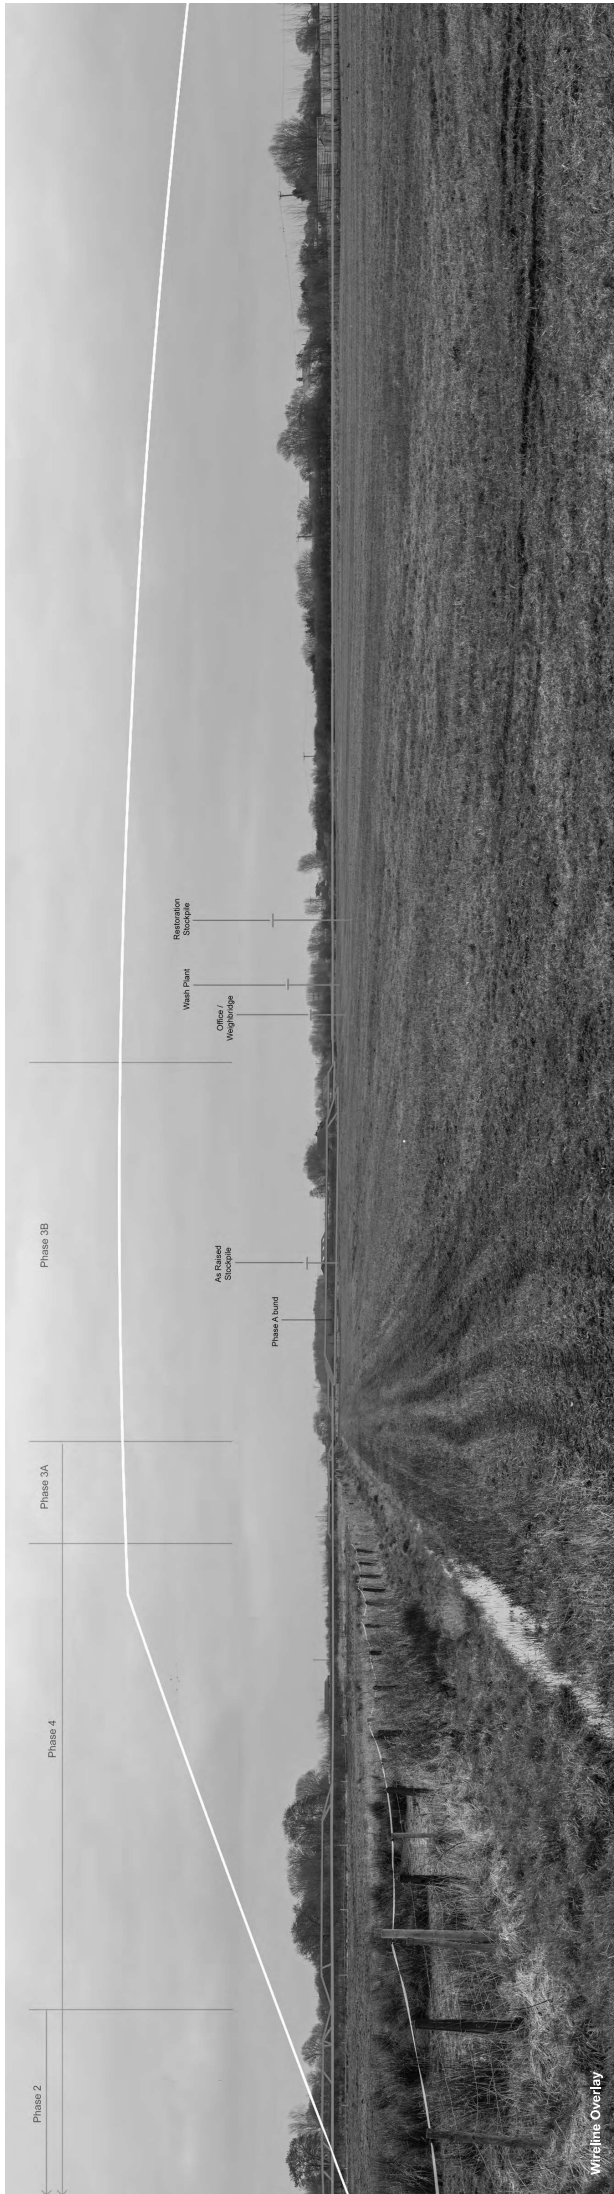
VIEWPOINT 1: View east from public footpath 23-PP 28 at Oureome - Winter

See Figure 8c in Appendix 1

3.2.1 The winter wireline indicates slightly reduced filtering from hedgerow and tree vegetation along field boundaries, allowing marginally clearer views of bunding associated with Phases 2, 3A and 4. Notwithstanding this, views would remain largely open and agricultural in character, and the magnitude of change would not be materially different from that assessed in the LVIA.

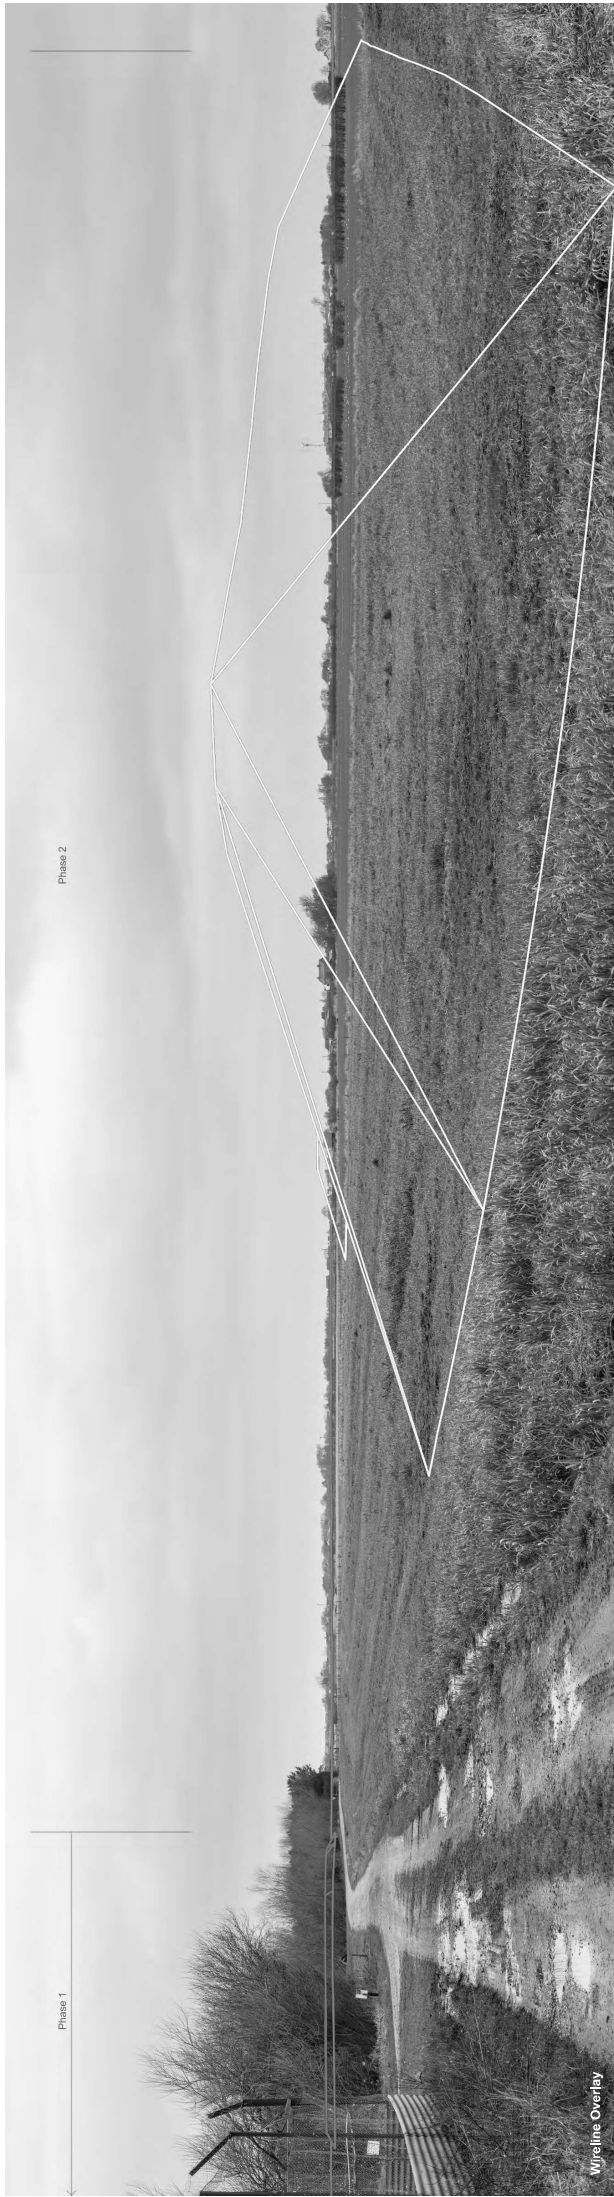
VIEWPOINT 2: View north-west from Bourbeles Lane to west of Bourbeles Farm House - Winter

See Figure 9c in Appendix 1

3.2.2 Vegetation associated with the fishing lakes along the lane would provide screening of the Phase 1 bund during summer months; however, winter

conditions may allow distant and filtered views of this feature. The bund within Phase 2 would continue to be experienced at close range within an existing farmed context, and the assessment of effects remains unchanged.

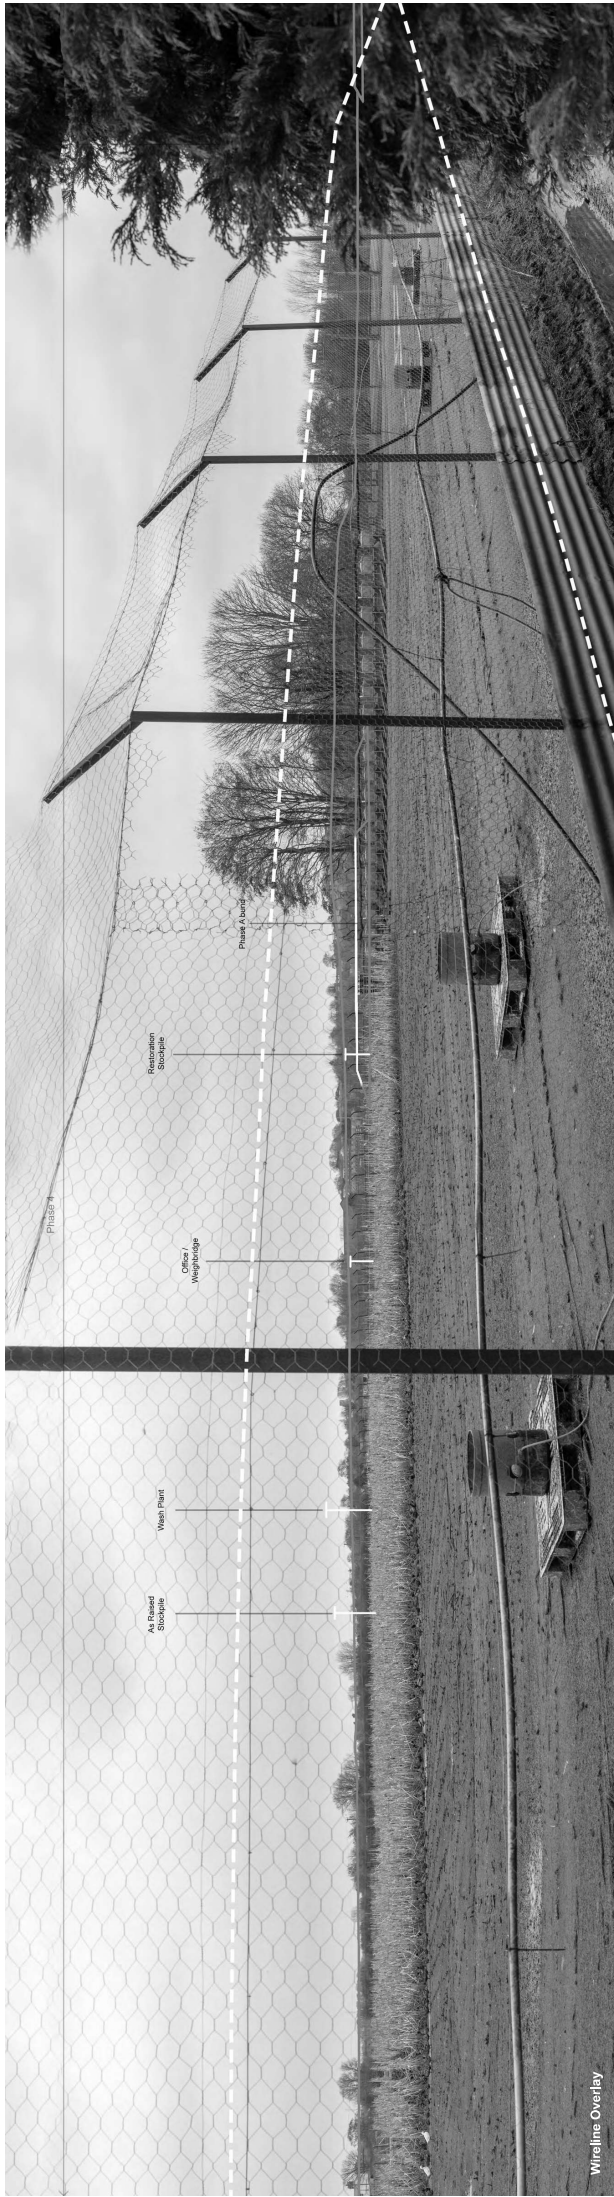
VIEWPOINT 3: View south-south-west from Bourbles Lane to south of Bourbles Farm House - Winter

See Figure 10c in Appendix 1

- 3.2.3 The winter scenario indicates reduced vegetation density along field boundaries and around the site perimeter, which may result in a marginal increase in visibility of the bund associated with Phase A; however, effects would remain localised and consistent with the original assessment of visual effects. The bund within Phase 4 would continue to be experienced at close range, replacing the existing view of a fenced field currently used for the rearing of fowl.
