## CCT/23 CS 454 Assessment and Inspection Report

### A675 Bolton Road Bridge, Lancashire

**National Highways – Historical Railways Estate**  
VAR9/7070

**HRE Assessment Programme**  
April 2023

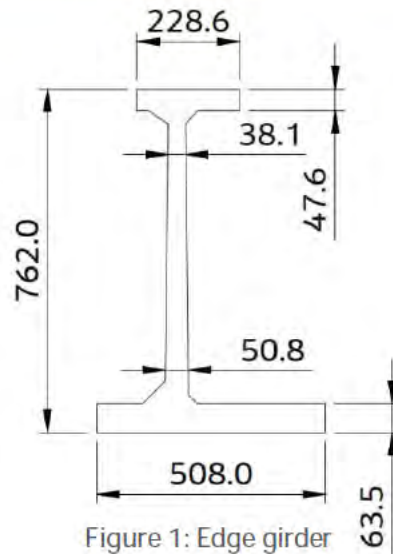
Figure 1: Edge girder

The bridge has two cast iron edge girders with a total depth of 762mm (2'6"). The bottom flange is 508mm wide with a thickness of 63.5mm. The upper flange is 228.6 (9") wide and 47.6mm thick. The web has a thickness of 50.8mm at the bottom flange tapering to 38.1mm at the top.

The edge girders are in a fair condition (Photograph 6 and 18). There is paint loss to the outer face of the webs with the exposed cast iron exhibiting minor corrosion.

There is full paint loss to the bottom flanges with moderate lamination and pitting corrosion to the underside. Corrosion was observed along the full length of the girder. Section loss up to 2mm deep was recorded at midspan.

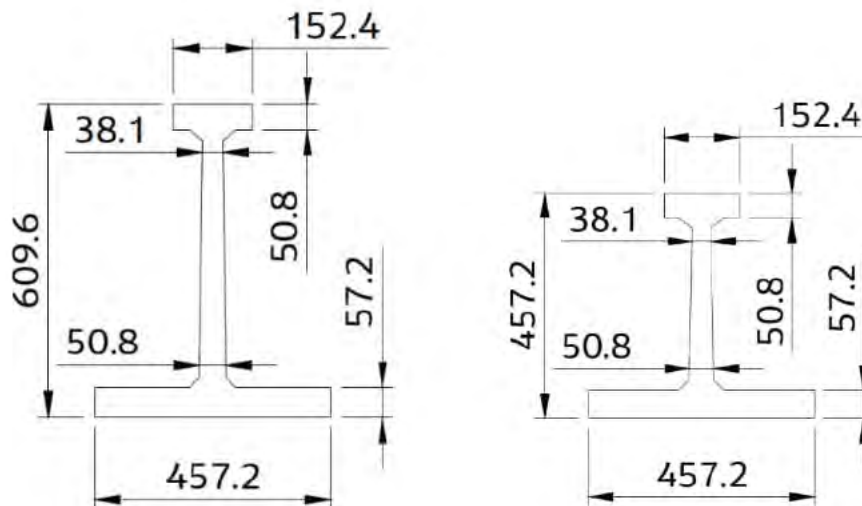
Figure 2: Internal girder at support (left) and midspan (right)

The full length internal girders are recorded as having a total depth of 609.6mm at midspan tapering to 457.2mm at supports. The shorter girders spanning between the abutments and edge girders appear to be cut from full length girders on the required skew.

The top flange is 152.4mm wide with a thickness of 50.8mm. The web has a thickness of 50.8mm at the bottom flange and tapers to 38.1mm at the top flange. The bottom flange was measured as 457.2mm wide with a thickness of 57.2mm.

The internal girders are in a fair condition (Photograph 6, 18 and 19) though there is moderate corrosion along the underside of the bottom flanges. De-lamination and pitting corrosion are evident along the full length of the girders. Section loss up to 1mm was recorded.

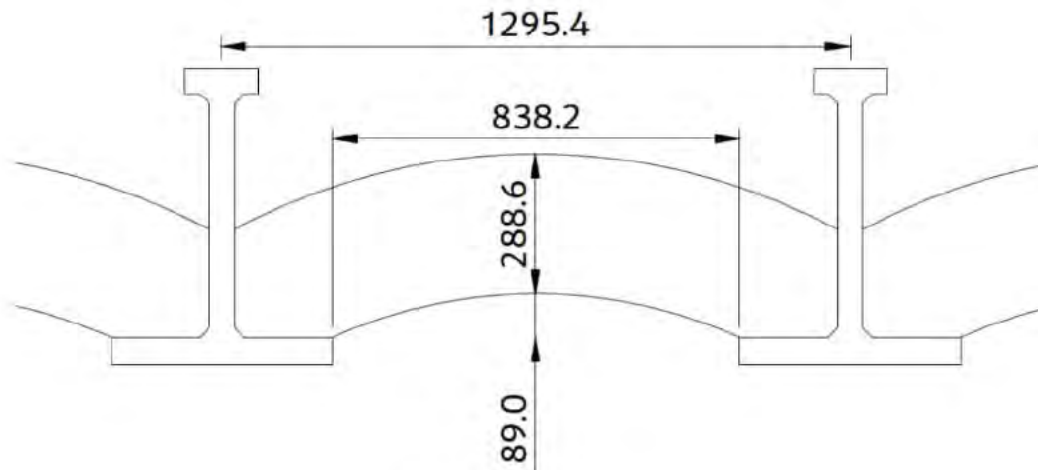
Figure 4: Jack arches

The jack arches have a thickness of 228.6mm (9") with a measured average rise of 89mm and a clear span of 838.2mm between internal girders. Tie bars are located above the jack arch extrados level, they are recorded as having a diameter of 28.56mm and are spaced at 3m centres.

The jack arches located below the carriageway are in a fair condition. Several of the jack arches display a distorted profile with two courses out of line at the most severe location (Photograph 17). In a number of bays, the jack arch rise appears flattened. Isolated areas of displaced brickwork were noted.

Spalling was visible across 50% of the arches with a depth of up to 10mm. Individual spalled bricks were observed with a depth of 50mm. There are isolated recessed and open joints primarily located within the damp areas of the jack arches.

Water staining and calcite deposits are visible, most notably at the interface between the jack arch and cast iron girders. Water was found to be actively dripping from several locations throughout the bridge soffit.

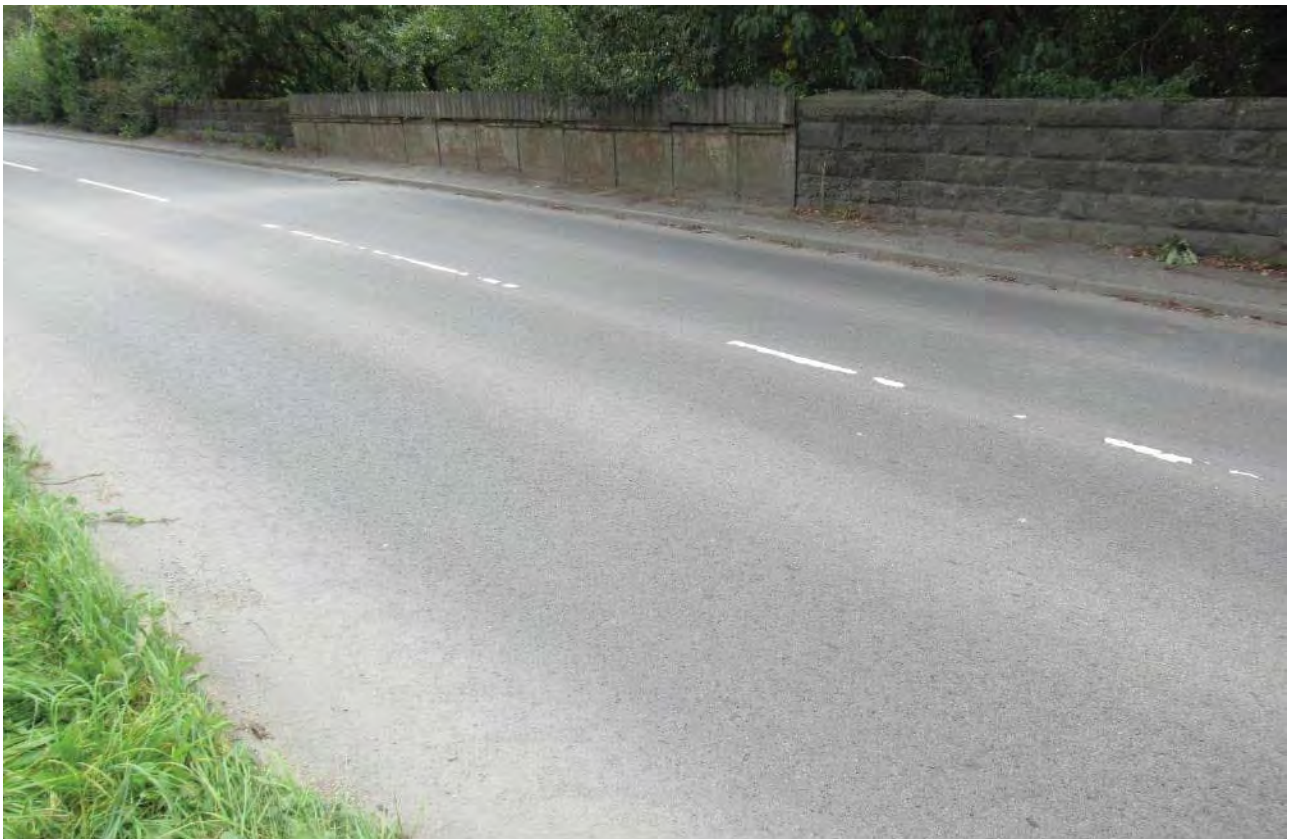
4. Road over deck

The road over the structure is in fair condition with no signs of settlement or tracking. There is some minor degradation to the surface. The road surface shall be taken as “good” for the purpose of this assessment.
