Project: Hurlston Brook Flood Event December 2015

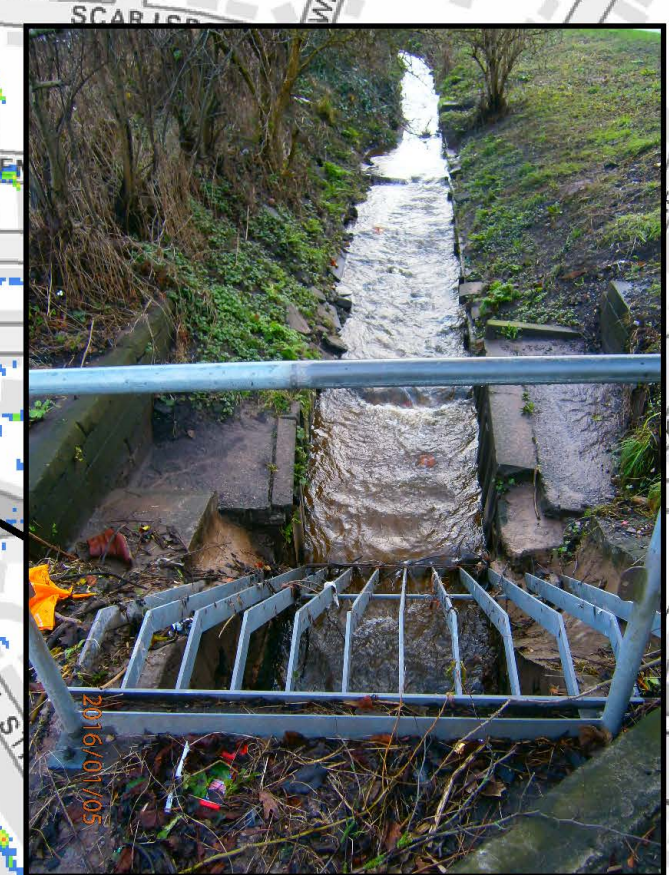
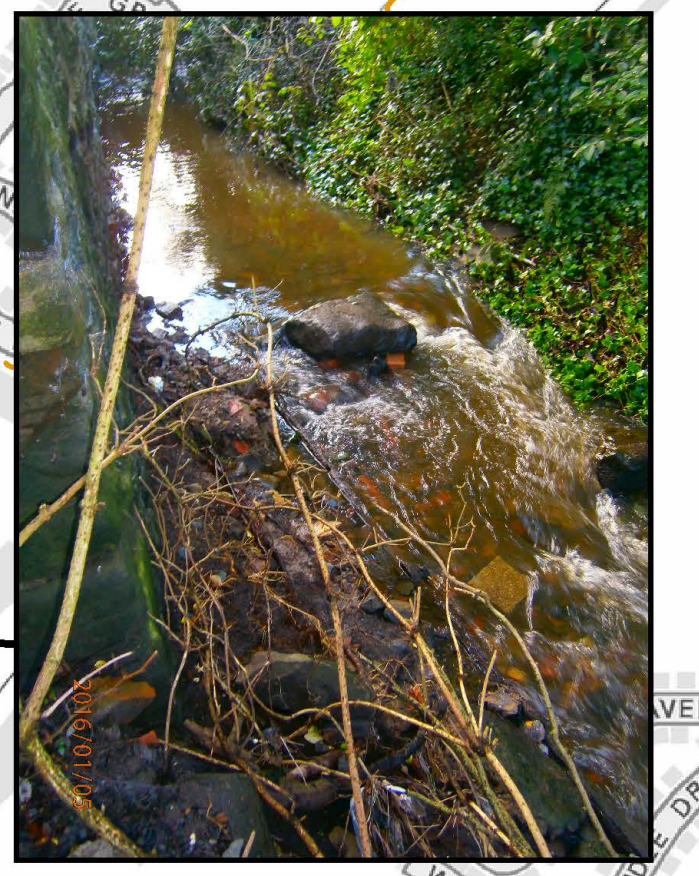
Property: 28 Halsall Lane
Property Flooded: No
Comment: 2 sources of flooding:
 - Blocked EA culvert screen at County Road
 - Fields from Little Hall Farm area
Officer Comment: 29/31 might be interested in drop in. Reported 12 and 14 Cotton Drive, 123 Southport Road also flooded.

Property: 11 Dyers Lane
Property Flooded: Yes
Comment: Flooded
Officer Comment: N/A

Property: 13 Dyers Lane
Property Flooded: Yes
Comment: Flooded
Officer Comment: Resigned about flooding.

Property: 17a Dyers Lane
Property Flooded: Yes
Comment: Flooded
Officer Comment: Wants to be involved in drop-in.
