Asbestos Survey Report –
Management Survey

**Accrington Union Street Area Office 44 Union Street,
Accrington, BB5 1PL**

Our Reference: MS579/24PB

Date(s) of Survey: 05/11/2024

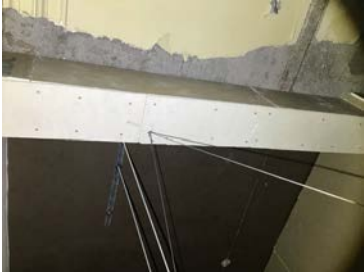
Site:	23300002200442000 - Accrington Union Street Area Office	Status:	NAD
Building:	23300002200443001 - MAIN BUILDING	Identified On:	05/11/2024
Room:	001	Identified By:	Paul Bibby - LOC
Description:	Boarding to rsj		
Position:	Ceiling void		
Material Type:		Sample:	REPRESENTATIVE
Material Subtype:		Asbestos Type:	99 - NAD
Quantity:	6 m2		
Sample Details		Sampled On:	05/11/2024
Code:	MS579/24PB_S03-LR8692B	Sampled By:	Paul Bibby - LOC
Origin:	Boarding	Analysed On:	08/11/2024
Analysis:	No Asbestos Detected	Analysed By:	Lorraine Rawcliffe - LOC

There is no current risk assessment for this ASR - ACM033294

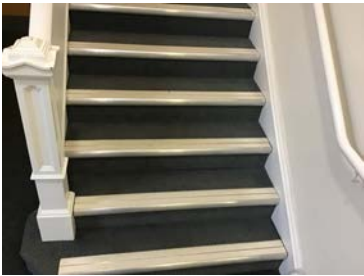
Status: NAD
Identified On: 05/11/2024
Identified By: Paul Bibby - LCC

Material Type:	Other Encapsulated Materials	Sample:	REPRESENTATIVE
Material Subtype:	Reinforced plastic and resin composites	Asbestos Type:	99 - NAD
Quantity:	m		
Sample Details		Sampled On:	05/11/2024
Code:	MS579/24PB_S10-LR8699B	Sampled By:	Paul Bibby - LCC
Origin:	Stair nosing	Analysed On:	08/11/2024
Analysis:	No Asbestos Detected	Analysed By:	Lorraine Rawcliffe - LCC

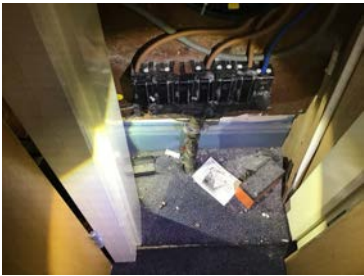
Site:	23300002200442000 - Accrington Union Street Area Office	Status:	NAD
Building:	23300002200443001 - MAIN BUILDING	Identified On:	05/11/2024
Room:	002	Identified By:	Paul Bibby - LCC
Description:	Bitumen cloth wrap to cable		
Position:	Floor		
Material Type:	Other Encapsulated Materials	Sample:	TAKEN
Material Subtype:	Bitumen products	Asbestos Type:	99 - NAD
Quantity:	1 m		
Sample Details		Sampled On:	05/11/2024
Code:	MS579/24PB_S04-LR8693B	Sampled By:	Paul Bibby - LCC
Origin:	Bitumen	Analysed On:	08/11/2024
Analysis:	No Asbestos Detected	Analysed By:	Lorraine Rawcliffe - LCC

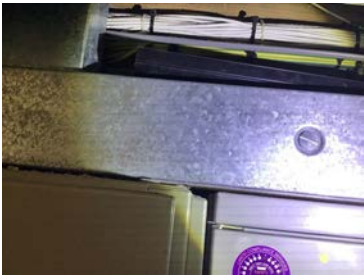
Site:	23300002200442000 - Accrington Union Street Area Office	Status:	NAD
Building:	23300002200443001 - MAIN BUILDING	Identified On:	05/11/2024
Room:	002	Identified By:	Paul Bibby - LCC
Description:	Resin panel to electrics		
Position:	Wall		
Material Type:	Other Encapsulated Materials	Sample:	TAKEN
Material Subtype:	Reinforced plastic and resin composites	Asbestos Type:	99 - NAD
Quantity:	2 m		
Sample Details		Sampled On:	05/11/2024
Code:	MS579/24PB_S05-LR8694B	Sampled By:	Paul Bibby - LCC
Origin:	Resin panel	Analysed On:	08/11/2024
Analysis:	No Asbestos Detected	Analysed By:	Lorraine Rawcliffe - LCC

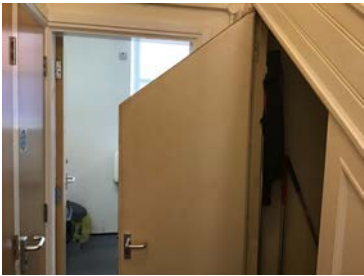
Status: NAD
Identified On: 05/11/2024
Identified By: Paul Bibby - LCC

Material Type:		Sample:	TAKEN
Material Subtype:		Asbestos Type:	99 - NAD
Quantity:	2 m2		
Sample Details		Sampled On:	05/11/2024
Code:	MS579/24PB_S03-LR8692B	Sampled By:	Paul Bibby - LCC
Origin:	Boarding	Analysed On:	08/11/2024
Analysis:	No Asbestos Detected	Analysed By:	Lorraine Rawcliffe - LCC

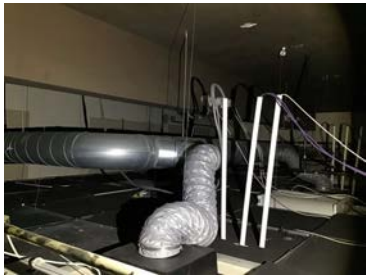
Site:	23300002200442000 - Accrington Union Street Area Office	Status:	NAD
Building:	23300002200443001 - MAIN BUILDING	Identified On:	05/11/2024
Room:	011A	Identified By:	Paul Bibby - LCC
Description:	Mastic to ducting limited sample		
Position:	Ceiling void		
Material Type:	Other Encapsulated Materials	Sample:	TAKEN
Material Subtype:		Asbestos Type:	99 - NAD
Quantity:	Small, amounts		
Sample Details		Sampled On:	05/11/2024
Code:	MS579/24PB_S01-LR8690B	Sampled By:	Paul Bibby - LCC
Origin:	Mastic	Analysed On:	08/11/2024
Analysis:	No Asbestos Detected	Analysed By:	Lorraine Rawcliffe - LCC

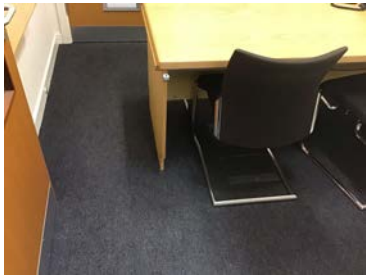
Site:	23300002200442000 - Accrington Union Street Area Office	Status:	NAD
Building:	23300002200443001 - MAIN BUILDING	Identified On:	05/11/2024
Room:	011B	Identified By:	Paul Bibby - LCC
Description:	Adhesive and screed under carpet		
Position:	Floor		
Material Type:	Other Encapsulated Materials	Sample:	TAKEN
Material Subtype:	Flooring	Asbestos Type:	99 - NAD
Quantity:	6 m2		
Sample Details		Sampled On:	05/11/2024
Code:	MS579/24PB_S02-LR8691B	Sampled By:	Paul Bibby - LCC
Origin:	Adhesive	Analysed On:	08/11/2024
Analysis:	No Asbestos Detected	Analysed By:	Lorraine Rawcliffe - LCC

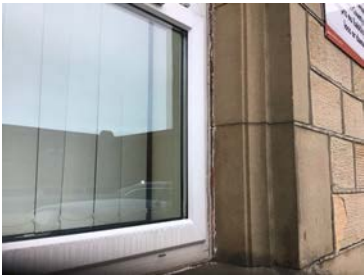
Site:	23300002200442000 - Accrington Union Street Area Office	Status:	NAD
Building:	23300002200443001 - MAIN BUILDING	Identified On:	05/11/2024
Room:	011D	Identified By:	Paul Bibby - LCC
Description:	Red Mastic to timber windows		
Position:	Windows		
Material Type:	Other Encapsulated Materials	Sample:	TAKEN
Material Subtype:	Reinforced plastic and resin composites	Asbestos Type:	99 - NAD
Quantity:	Throughout		
Sample Details		Sampled On:	05/11/2024
Code:	MS579/24PB_S20-LR8709B	Sampled By:	Paul Bibby - LCC
Origin:	Mastic to window	Analysed On:	08/11/2024
Analysis:	No Asbestos Detected	Analysed By:	Lorraine Rawcliffe - LCC

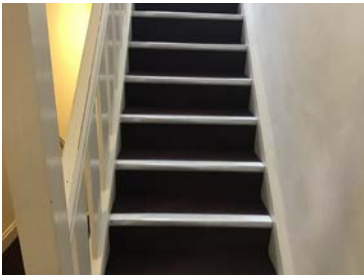
Site:	23300002200442000 - Accrington Union Street Area Office	Status:	NAD
Building:	23300002200443001 - MAIN BUILDING	Identified On:	05/11/2024
Room:	016	Identified By:	Paul Bibby - LCC
Description:	White stair nosing		
Position:	Stairs		
Material Type:	Other Encapsulated Materials	Sample:	TAKEN
Material Subtype:	Reinforced plastic and resin composites	Asbestos Type:	99 - NAD
Quantity:	15 m		
Sample Details		Sampled On:	05/11/2024
Code:	MS579/24PB_S10-LR8699B	Sampled By:	Paul Bibby - LCC
Origin:	Stair nosing	Analysed On:	08/11/2024
Analysis:	No Asbestos Detected	Analysed By:	Lorraine Rawcliffe - LCC

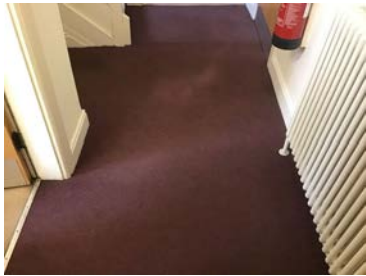
Site:	23300002200442000 - Accrington Union Street Area Office	Status:	NAD
Building:	23300002200443001 - MAIN BUILDING	Identified On:	05/11/2024
Room:	016	Identified By:	Paul Bibby - LCC
Description:	Adhesive on screed under modern flooring		
Position:	Floor		
Material Type:	Other Encapsulated Materials	Sample:	REPRESENTATIVE
Material Subtype:	Flooring	Asbestos Type:	99 - NAD
Quantity:	9 m2		
Sample Details		Sampled On:	05/11/2024
Code:	MS579/24PB_S08-LR8697B	Sampled By:	Paul Bibby - LCC
Origin:	Adhesive	Analysed On:	08/11/2024
Analysis:	No Asbestos Detected	Analysed By:	Lorraine Rawcliffe - LCC

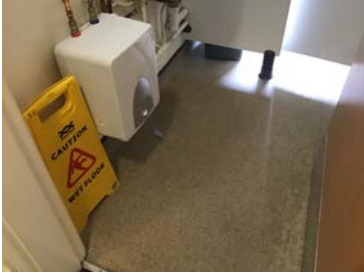
Status: NOACCESS
Identified On: 05/11/2024
Identified By: Paul Bibby - LOC

Material Type:		Sample:	REQUIRED
Material Subtype:		Asbestos Type:	
Quantity:	5 m2		
Sample Details		Sampled On:	
Code:		Sampled By:	
Origin:		Analysed On:	
Analysis:		Analysed By:

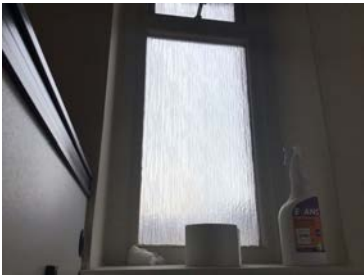
Sample Details
Code: MS579/24PB_S09-LR8698B
Origin: Mastic
Analysis: No Asbestos Detected

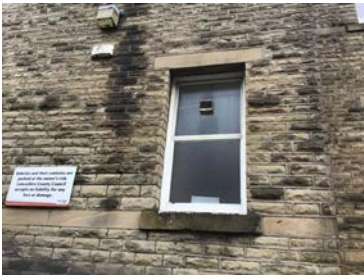
Sample Details
Code: MS579/24PB_S19-LR8708B
Origin: Window mastic
Analysis: No Asbestos Detected

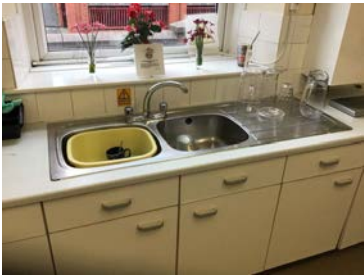
Site:	23300002200442000 - Accrington Union Street Area Office	Status:	NAD
Building:	23300002200443001 - MAIN BUILDING	Identified On:	05/11/2024
Room:	018	Identified By:	Paul Bibby - LCC
Description:	Sink pad		
Position:	Sink		
Material Type:	Other Encapsulated Materials	Sample:	TAKEN
Material Subtype:	Reinforced plastic and resin composites	Asbestos Type:	99 - NAD
Quantity:	3 Unit		
Sample Details		Sampled On:	05/11/2024
Code:	MS579/24PB_S07-LR8696B	Sampled By:	Paul Bibby - LCC
Origin:	Sink pad	Analysed On:	08/11/2024
Analysis:	No Asbestos Detected	Analysed By:	Lorraine Rawcliffe - LCC

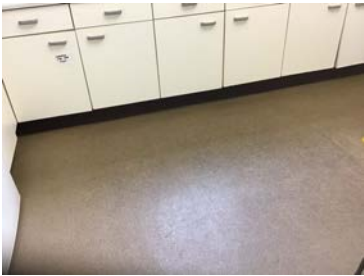
Site:	23300002200442000 - Accrington Union Street Area Office	Status:	NAD
Building:	23300002200443001 - MAIN BUILDING	Identified On:	05/11/2024
Room:	018	Identified By:	Paul Bibby - LCC
Description:	Adhesive on screed under modern flooring		
Position:	Floor		
Material Type:	Other Encapsulated Materials	Sample:	TAKEN
Material Subtype:	Flooring	Asbestos Type:	99 - NAD
Quantity:	15 m ²		
Sample Details		Sampled On:	05/11/2024
Code:	MS579/24PB_S08-LR8697B	Sampled By:	Paul Bibby - LCC
Origin:	Adhesive	Analysed On:	08/11/2024
Analysis:	No Asbestos Detected	Analysed By:	Lorraine Rawcliffe - LCC

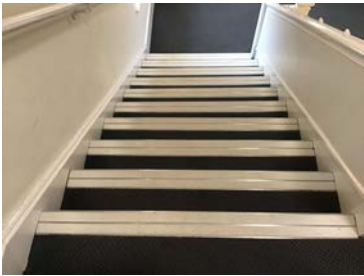
Site:	23300002200442000 - Accrington Union Street Area Office	Status:	NAD
Building:	23300002200443001 - MAIN BUILDING	Identified On:	05/11/2024
Room:	020	Identified By:	Paul Bibby - LCC
Description:	White stair nosing		
Position:	Stairs		
Material Type:	Other Encapsulated Materials	Sample:	REPRESENTATIVE
Material Subtype:	Reinforced plastic and resin composites	Asbestos Type:	99 - NAD
Quantity:	16 m		
Sample Details		Sampled On:	05/11/2024
Code:	MS579/24PB_S10-LR8699B	Sampled By:	Paul Bibby - LCC
Origin:	Stair nosing	Analysed On:	08/11/2024
Analysis:	No Asbestos Detected	Analysed By:	Lorraine Rawcliffe - LCC

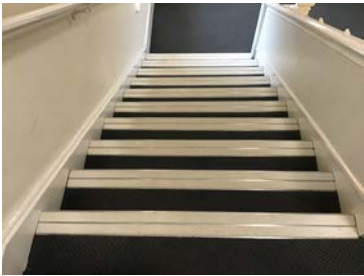
Site:	23300002200442000 - Accrington Union Street Area Office	Status:	NAD
Building:	23300002200443001 - MAIN BUILDING	Identified On:	05/11/2024
Room:	034	Identified By:	Paul Bibby - LCC
Description:	White stair nosing		
Position:	Floor		
Material Type:	Other Encapsulated Materials	Sample:	REPRESENTATIVE
Material Subtype:	Reinforced plastic and resin composites	Asbestos Type:	99 - NAD
Quantity:	16 m		
Sample Details		Sampled On:	05/11/2024
Code:	MS579/24PB_S10-LR8699B	Sampled By:	Paul Bibby - LCC
Origin:	Stair nosing	Analysed On:	08/11/2024
Analysis:	No Asbestos Detected	Analysed By:	Lorraine Rawcliffe - LCC

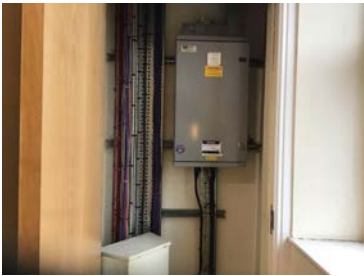
Status: NOACCESS
Identified On: 05/11/2024
Identified By: Paul Bibby - LOC

Material Type:		Sample:	REQUIRED
Material Subtype:		Asbestos Type:	
Quantity:	1 Unit		
Sample Details		Sampled On:	
Code:		Sampled By:	
Origin:		Analysed On:	
Analysis:		Analysed By:

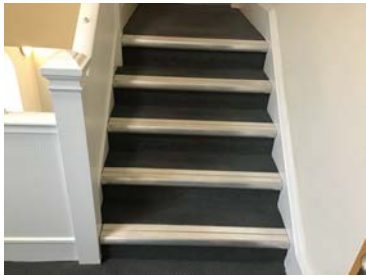
Site:	23300002200442000 - Accrington Union Street Area Office	Status:	NAD
Building:	23300002200443001 - MAIN BUILDING	Identified On:	05/11/2024
Room:	036	Identified By:	Paul Bibby - LCC
Description:	White stair nosing		
Position:	Stairs		
Material Type:	Other Encapsulated Materials	Sample:	REPRESENTATIVE
Material Subtype:	Reinforced plastic and resin composites	Asbestos Type:	99 - NAD
Quantity:	m		
Sample Details		Sampled On:	05/11/2024
Code:	MS579/24PB_S10-LR8699B	Sampled By:	Paul Bibby - LCC
Origin:	Stair nosing	Analysed On:	08/11/2024
Analysis:	No Asbestos Detected	Analysed By:	Lorraine Rawcliffe - LCC

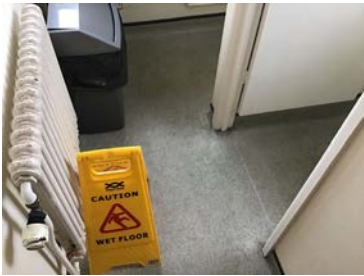
Status: NOACCESS
Identified On: 05/11/2024
Identified By: Paul Bibby - LOC

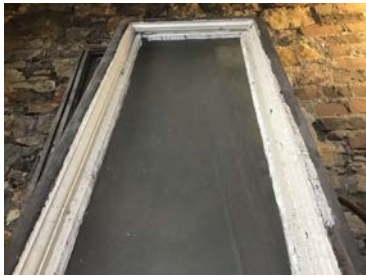
Status: NAD
Identified On: 05/11/2024
Identified By: Paul Bibby - LCC

Material Type:	Other Encapsulated Materials	Sample:	TAKEN
Material Subtype:	Reinforced plastic and resin composites	Asbestos Type:	99 - NAD
Quantity:	8 m		
Sample Details		Sampled On:	05/11/2024
Code:	MS579/24PB_S18-LR8707B	Sampled By:	Paul Bibby - LCC
Origin:	Mastic	Analysed On:	08/11/2024
Analysis:	No Asbestos Detected	Analysed By:	Lorraine Rawcliffe - LCC

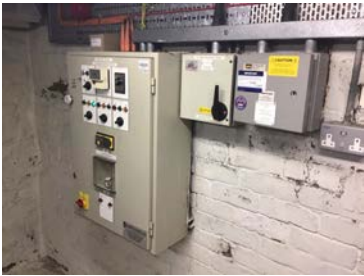
Status: NOACCESS
Identified On: 05/11/2024
Identified By: Paul Bibby - LOC

Material Type:		Sample:	REQUIRED
Material Subtype:		Asbestos Type:	
Quantity:	2 Unit		
Sample Details		Sampled On:	
Code:		Sampled By:	
Origin:		Analysed On:	
Analysis:		Analysed By:

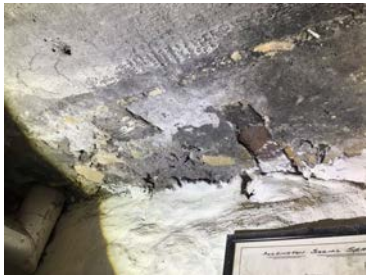
Status: NAD
Identified On: 05/11/2024
Identified By: Paul Bibby - LCC

Material Type:	Thermal Insulation	Sample:	TAKEN
Material Subtype:	Hand-applied thermal lagging	Asbestos Type:	99 - NAD
Quantity:	22 m ²		
Sample Details		Sampled On:	05/11/2024
Code:	MS579/24PB_S12-LR8701B	Sampled By:	Paul Bibby - LCC
Origin:	Thermal residues	Analysed On:	08/11/2024
Analysis:	No Asbestos Detected	Analysed By:	Lorraine Rawcliffe - LCC

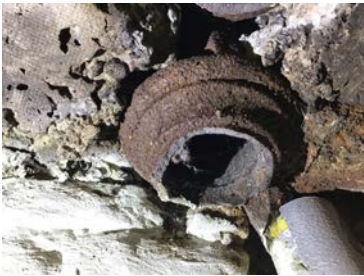
Site:	23300002200442000 - Accrington Union Street Area Office	Status:	NAD
Building:	23300002200443001 - MAIN BUILDING	Identified On:	05/11/2024
Room:	040	Identified By:	Paul Bibby - LCC
Description:	Mastic to pipe collar		
Position:	Ceiling		
Material Type:	Friction Products	Sample:	TAKEN
Material Subtype:	Resin based materials	Asbestos Type:	99 - NAD
Quantity:	Small amounts		
Sample Details		Sampled On:	05/11/2024
Code:	MS579/24PB_S13-LR8702B	Sampled By:	Paul Bibby - LCC
Origin:	Mastic	Analysed On:	08/11/2024
Analysis:	No Asbestos Detected	Analysed By:	Lorraine Rawcliffe - LCC

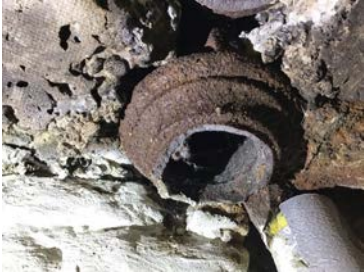
Site:	23300002200442000 - Accrington Union Street Area Office	Status:	NAD
Building:	23300002200443001 - MAIN BUILDING	Identified On:	05/11/2024
Room:	040	Identified By:	Paul Bibby - LCC
Description:	Paper with in pipe		
Position:	Ceiling		
Material Type:	Paper, Felt & Cardboard	Sample:	TAKEN
Material Subtype:	Paper	Asbestos Type:	99 - NAD
Quantity:	Small amounts		
Sample Details		Sampled On:	05/11/2024
Code:	MS579/24PB_S14-LR8703B	Sampled By:	Paul Bibby - LCC
Origin:	Paper	Analysed On:	08/11/2024
Analysis:	No Asbestos Detected	Analysed By:	Lorraine Rawcliffe - LCC

There is no current risk assessment for this ASR - ACM033285

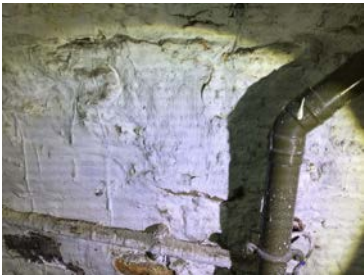
Site:	23300002200442000 - Accrington Union Street Area Office	Status:	NAD
Building:	23300002200443001 - MAIN BUILDING	Identified On:	05/11/2024
Room:	040	Identified By:	Paul Bibby - LCC
Description:	Thermal residue to walls,		
Position:	Wall		
Material Type:	Thermal Insulation	Sample:	TAKEN
Material Subtype:	Hand-applied thermal lagging	Asbestos Type:	99 - NAD
Quantity:	Throughout		
Sample Details		Sampled On:	05/11/2024
Code:	MS579/24PB_S16-LR8705B	Sampled By:	Paul Bibby - LCC
Origin:	Thermal residues	Analysed On:	08/11/2024
Analysis:	No Asbestos Detected	Analysed By:	Lorraine Rawcliffe - LCC

There is no current risk assessment for this ASR - ACM033286

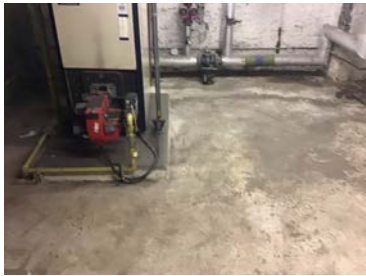
Status: NAD
Identified On: 05/11/2024
Identified By: Paul Bibby - LCC

Material Type:		Sample:	TAKEN
Material Subtype:		Asbestos Type:	99 - NAD
Quantity:	2 m2		
Sample Details		Sampled On:	05/11/2024
Code:	MS579/24PB_S17-LR8706B	Sampled By:	Paul Bibby - LCC
Origin:	Flaking paint	Analysed On:	08/11/2024
Analysis:	No Asbestos Detected	Analysed By:	Lorraine Rawcliffe - LCC

There is no current risk assessment for this ASR - ACM033288
