# Golden Hill (Short Stay) School, Earnshaw Drive, Leyland

**Feasibility Report**

**Geotechnical Report No. 16-26-01 FS**

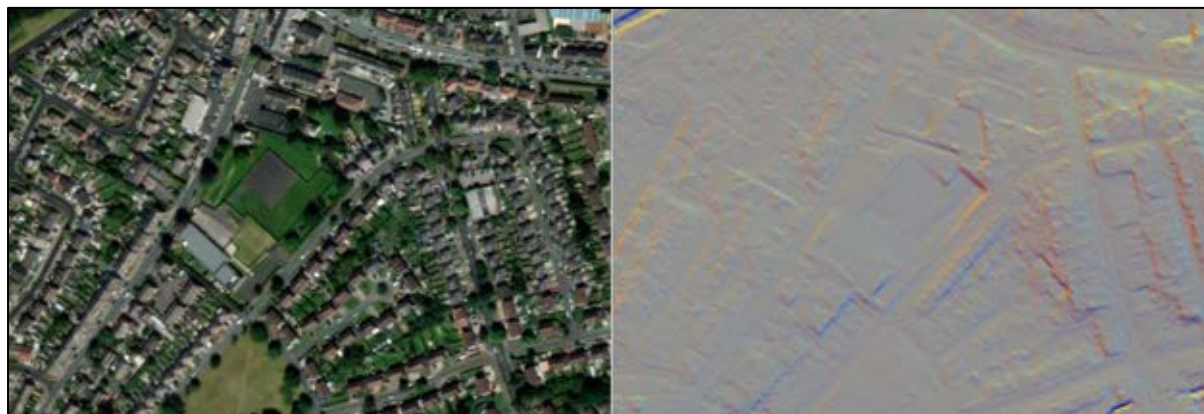
Figure 2: A satellite image of the site next to LiDAR data (NLS: <https://maps.nls.uk/>).

LiDAR data obtained from the NLS website (shown in Figure 2 below) indicates that the fenced section appears to be located within a shallow cutting, and is located at a slightly lower topographical height than the surrounding land. This topographical difference is particularly prominent in the northeast corner of the site.

Both the Mapzone topographical plan and the above LiDAR imagery are enclosed within Appendix B.

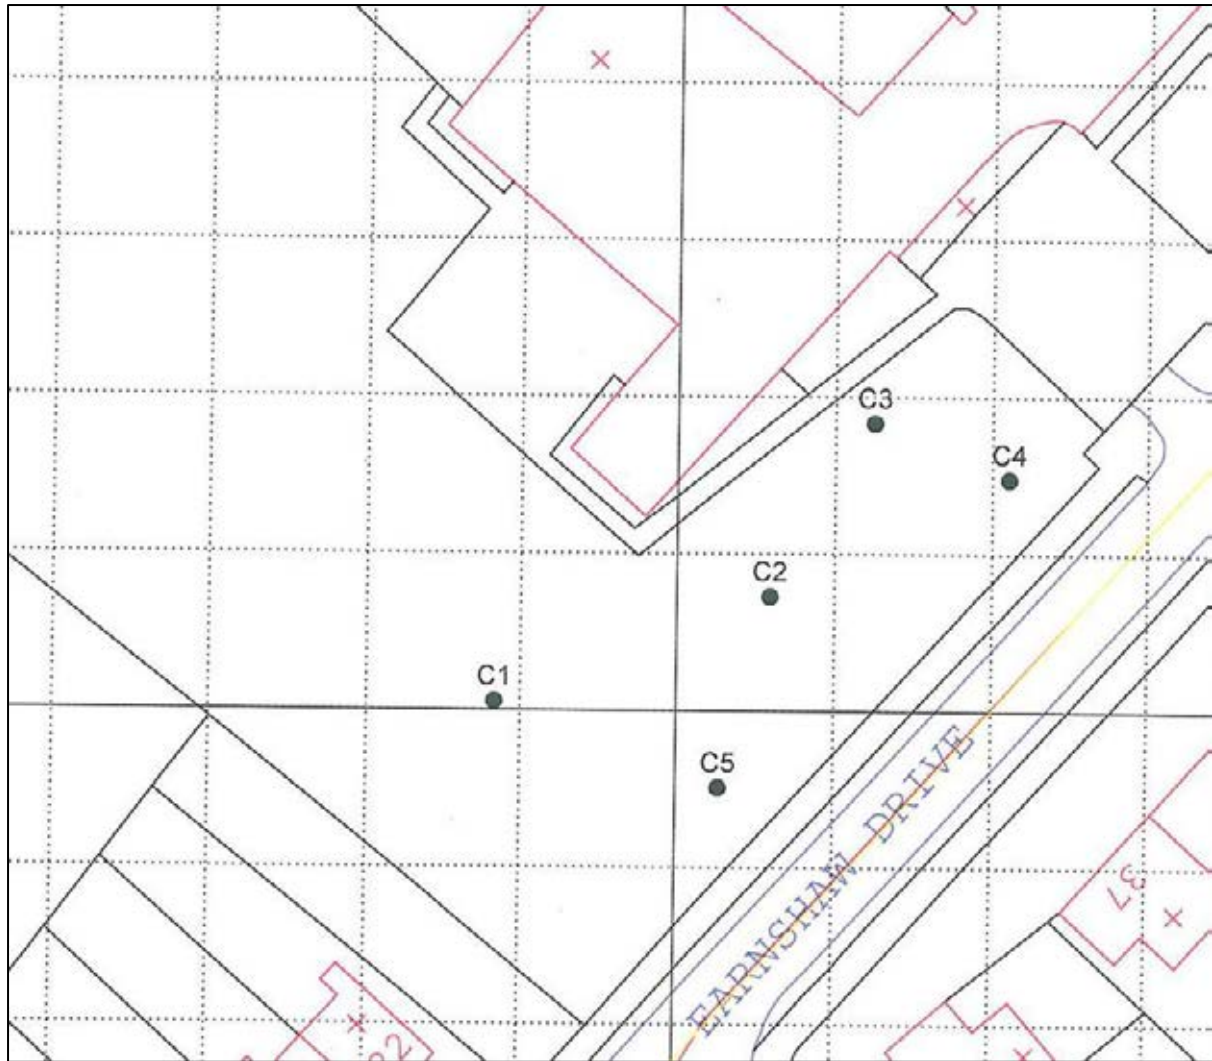
Figure 3: The borehole plan from the 2006 site investigation.

The investigation comprised five boreholes (C1 to C5; see Figure 3 above), drilled to depths of between 1.10mbgl and 1.50mbgl. The boreholes recorded topsoil to between 0.13mbgl and 0.18mbgl, which overlay fill. The fill was comprised of variable material, including clayey silty soil, firm sandy silty clay and brick rubble, to maximum depths of between 0.56mbgl and 1.50mbgl. Natural clayey silty sand was then recorded in three boreholes (C1, C2 and C5) to maximum depths of between 1.30mbgl to 1.60mbgl. Natural firm to stiff sandy silty clay was recorded in the remaining two boreholes (C3 and C4) to maximum depths of 1.10mbgl and 1.20mbgl.

An LCC site investigation was undertaken in 2006 to obtain contamination samples prior to the construction of the car park south of the building.

The values were also compared to the figures given in the HSE document 'Protection of Workers and the General Public During the Development of Contaminated Land'. This indicates that the soil from Boreholes C1 and C3 were similar to that for natural soils, although slight Nickel contamination was recorded. The sample from Borehole C5 revealed slight Cadmium, Mercury and Nickel contamination. It is therefore recommended that the contractor follow the guidelines outlined in the aforementioned HSE document.

Finally, the results were compared to the EA document "Guidance for waste destined for disposal in landfills" with the majority of the values appearing to indicate that the soils are inert. However, the value for Antimony in Borehole C5 was found to be double the value for inert waste. This sample was brick fill and is classed as non-hazardous by a landfill site. It is recommended that any brick fill or rubble be stockpiled and disposed of separately from the soil and clay.

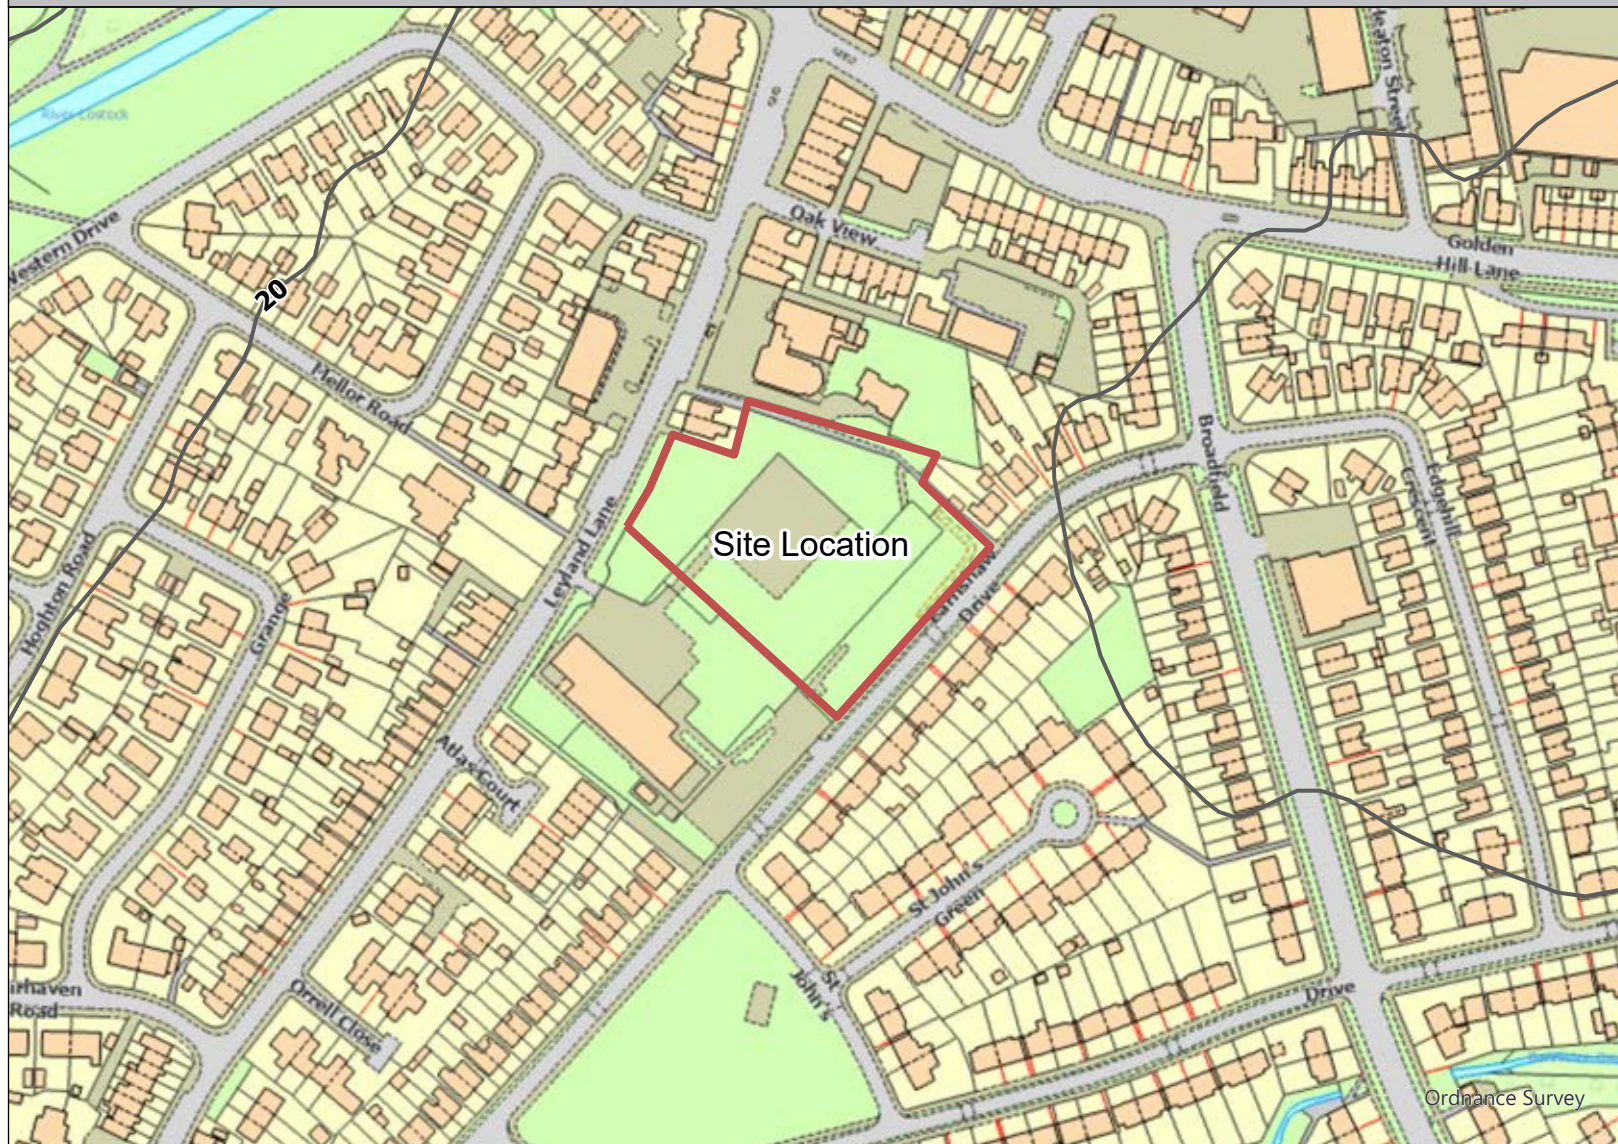
— Contours 5m

Map Scale: 1:2,500  
Map Centre: 353033E 422574N

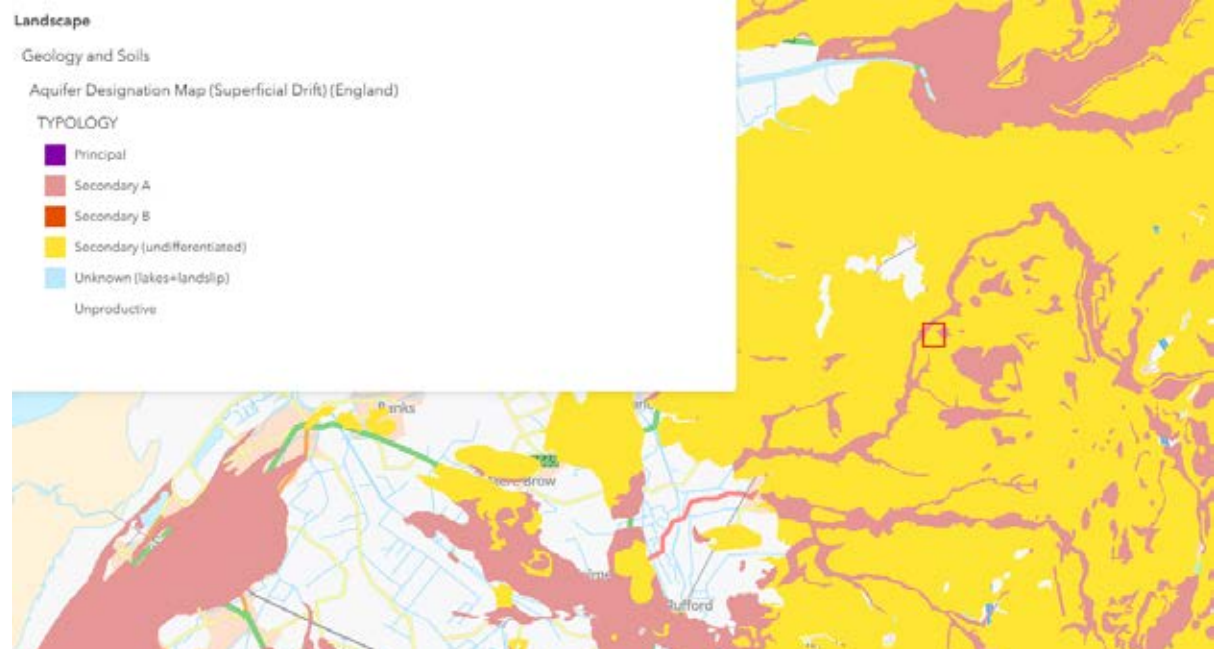
## Magic Maps - Aquifer Designations

- Principal
- Secondary A
- Secondary B
- Secondary (undifferentiated)
- Unproductive

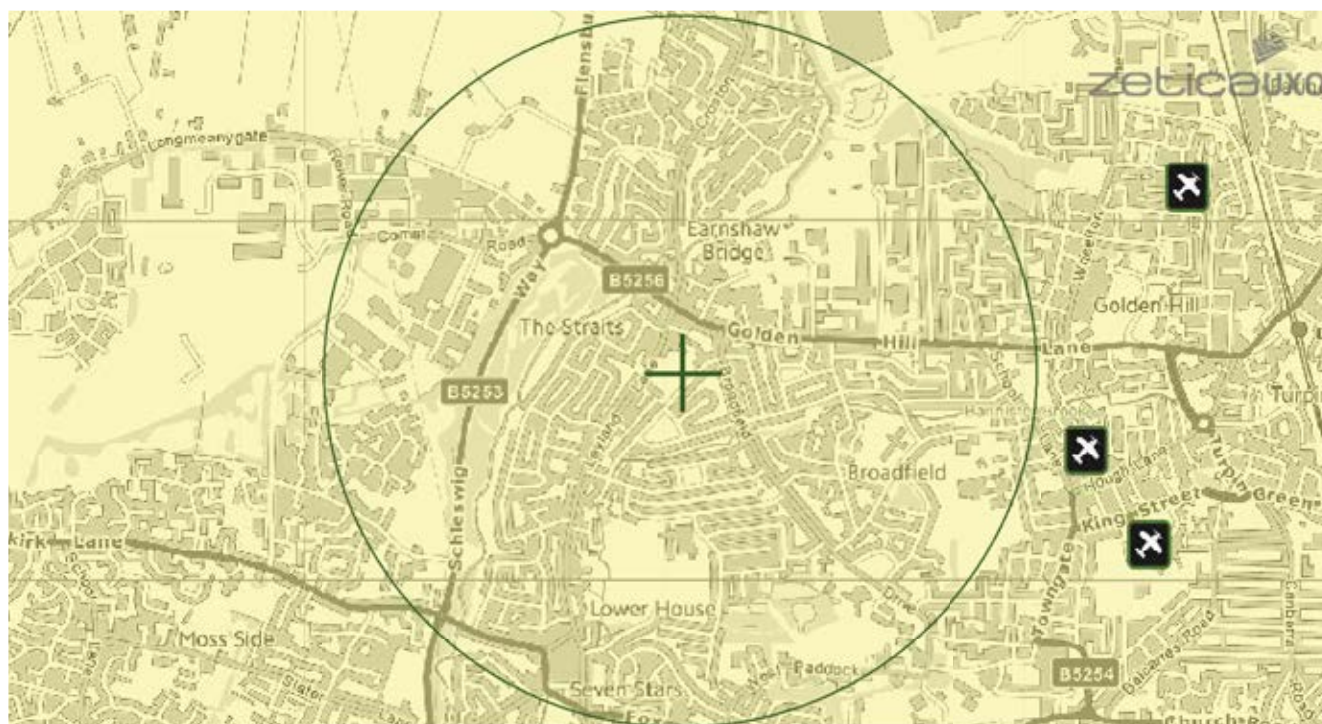
### Unexploded Ordnance Risk Map

This map principally indicates a hazard from Unexploded Bombs (UXB) due to WWII bombardment. Other sources of Unexploded Ordnance (UXO) may be present. It should be noted that this map does not represent UXO risk and should not be reported as such when reproduced.
