Greyhound Bridge

Major maintenance

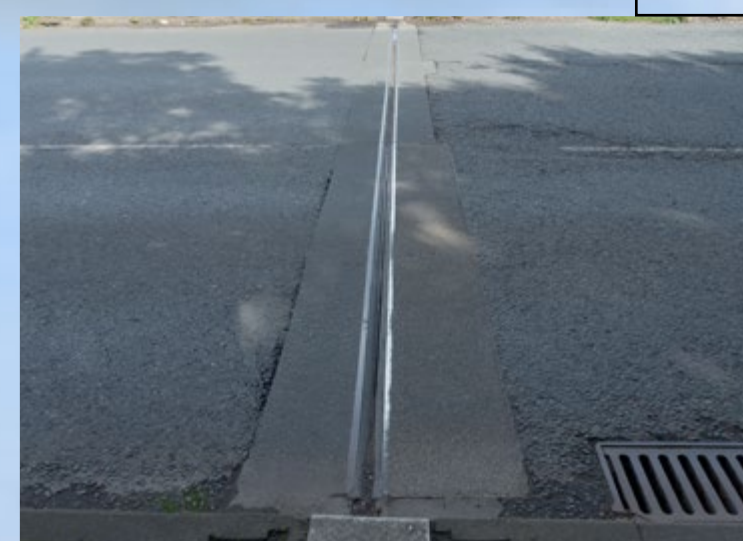
Deck joints to be replaced to prevent further water ingress and to safeguard the deck against future corrosion

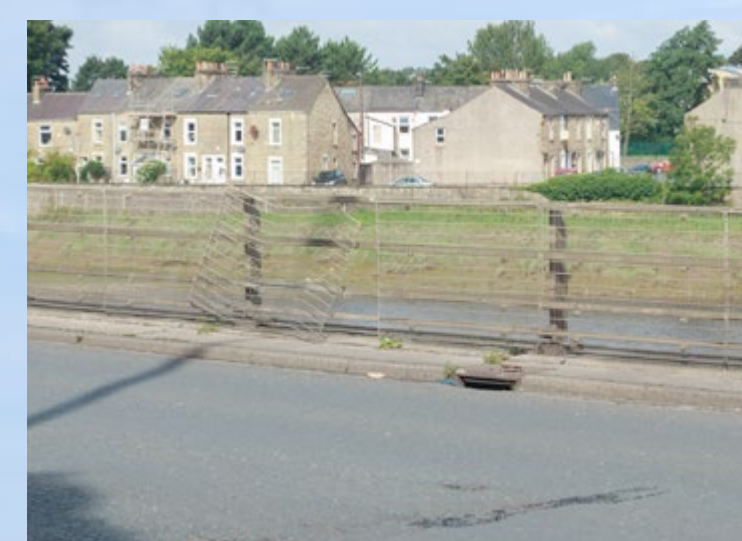
Bridge Parapet to be repaired and repainted to ensure vehicle safety.

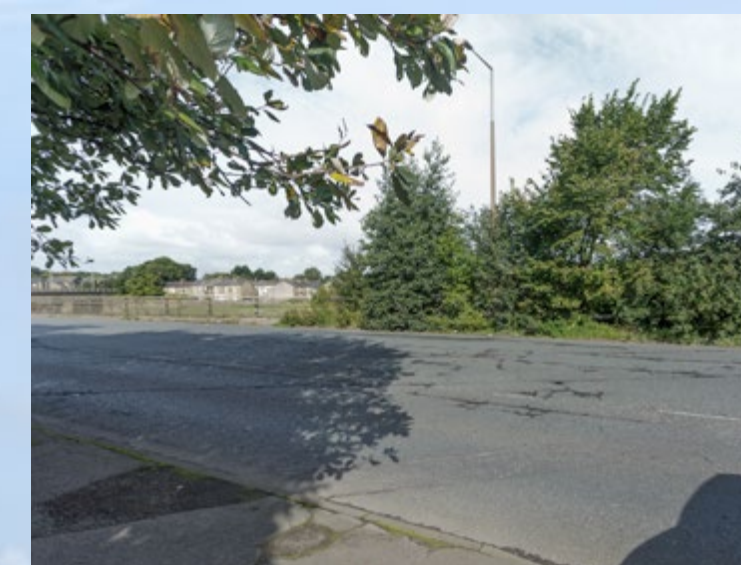
Carriageway to be waterproofed and re-surfaced

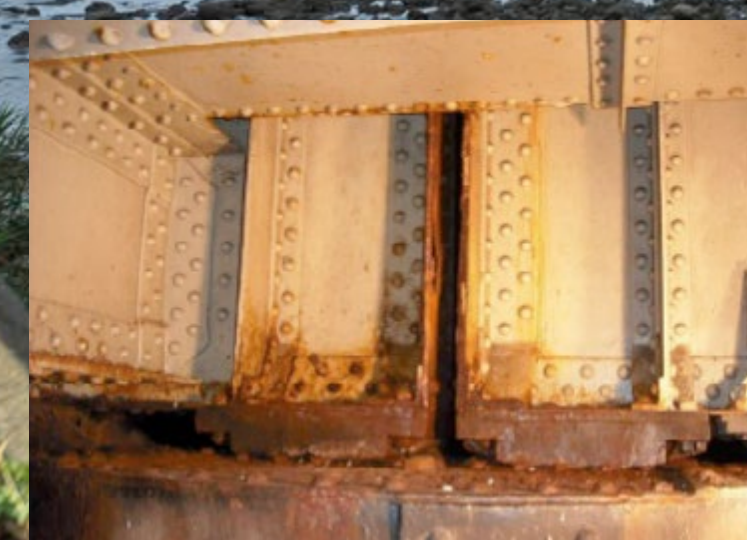
Bridge Bearings to be cleaned, repainted and greased to maintain movement of the bridge deck

Steel deck and piers repainted to protect against future corrosion

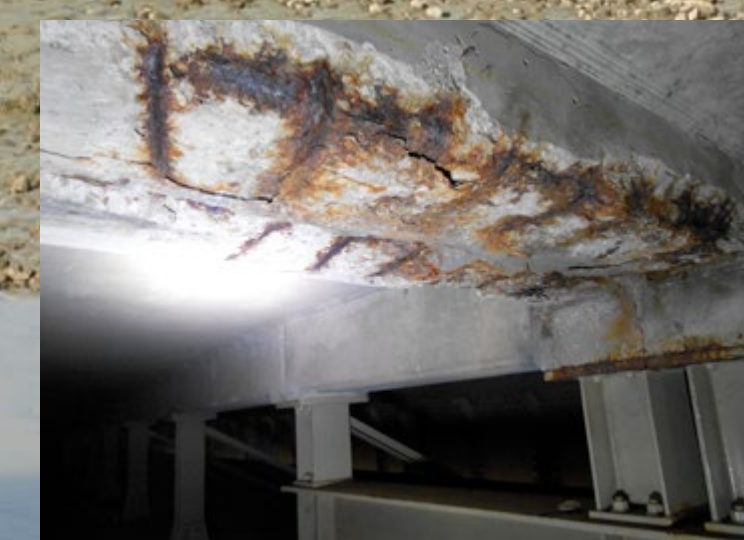
Areas of damaged concrete to be broken out and recast in order to restore structural integrity of the bridge
